Compendium

Transitional Learning Spaces (TLS)

Design and Construction in Emergency

2011

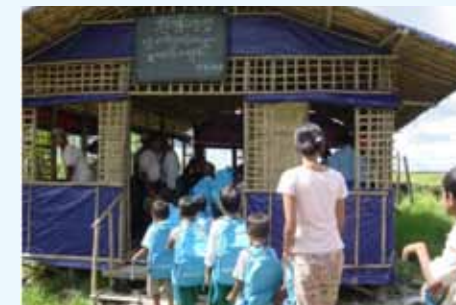
Myanmar: Bamboo TLS built with local materials rapidly after cyclone Nagris.

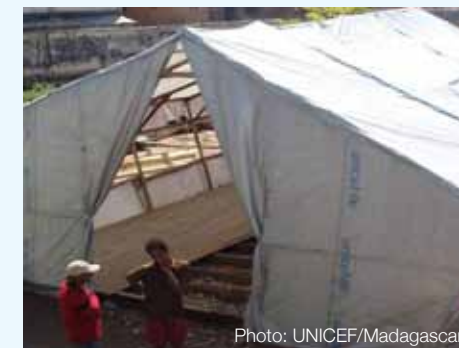
Photo: UNICEF/Madagascar
Madagascar: Upgrading of a TLS tent for with re-claimed flooring from damaged classrooms

The documented case studies have used various strategies to respond to their specific emergency situation and to achieve the commencement of education as soon as possible. In the case of Haiti C 10.0 P142 a phased approach was taken, where the imported classroom tents were upgraded to semi-permanent structures in the second phase. In the case of Madagascar C 3.0 P50 an already field-tested locally sourced structure was erected by the community within a day and was gradually upgraded by the re-use of materials from the damaged classrooms.

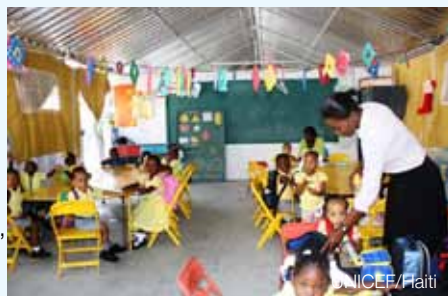
Haiti: upgraded imported steel structure TLS tent

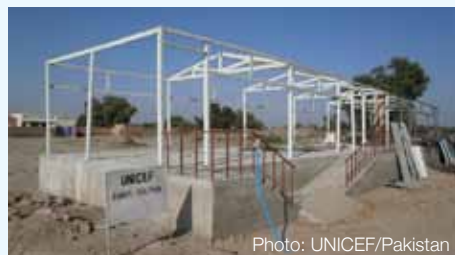
Photo: UNICEF/Pakistan
Pakistan: raised floor level to prevent flooding

In areas with risk of flooding, low lying sites or sites close to rivers or sea shores should be avoided if possible. If this is not feasible, the design of the TLS must take future flooding into consideration, as in the case study of Myanmar C 6.0 P92 and Pakistan C 13.0 P192

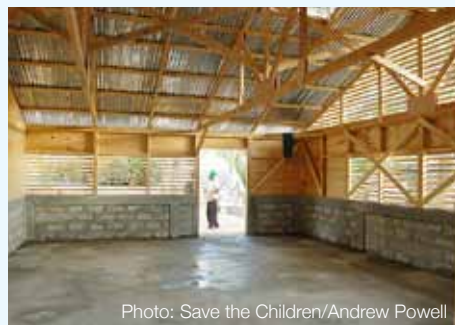
Photo: Save the Children/Andrew Powell
Haiti: Louvres protect from sun

In the case study of Haiti C12.0 P170, timber wooden louvers on the outside diffused the sunlight to give even filtered lighting condition.

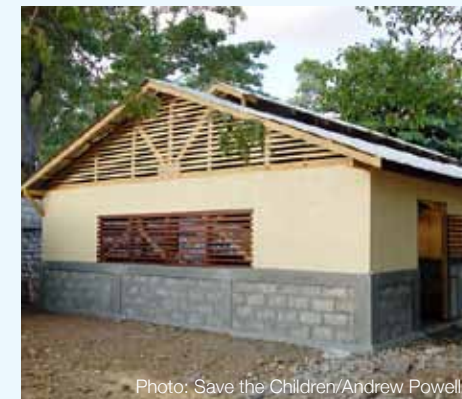
Photo: Save the Children/Andrew Powell
Haiti: roof ridge ventilation detail

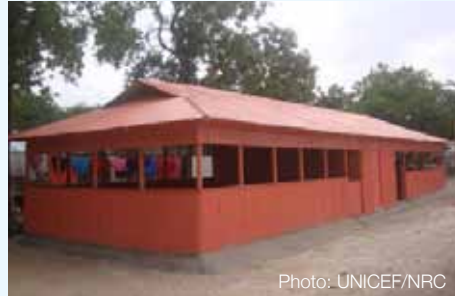
Somalia: storage space in between classroom as acoustic separation

A successful design solution was found in Somalia C 7.0 P104 by placing an office/store room in between two classrooms to create a sound buffer.

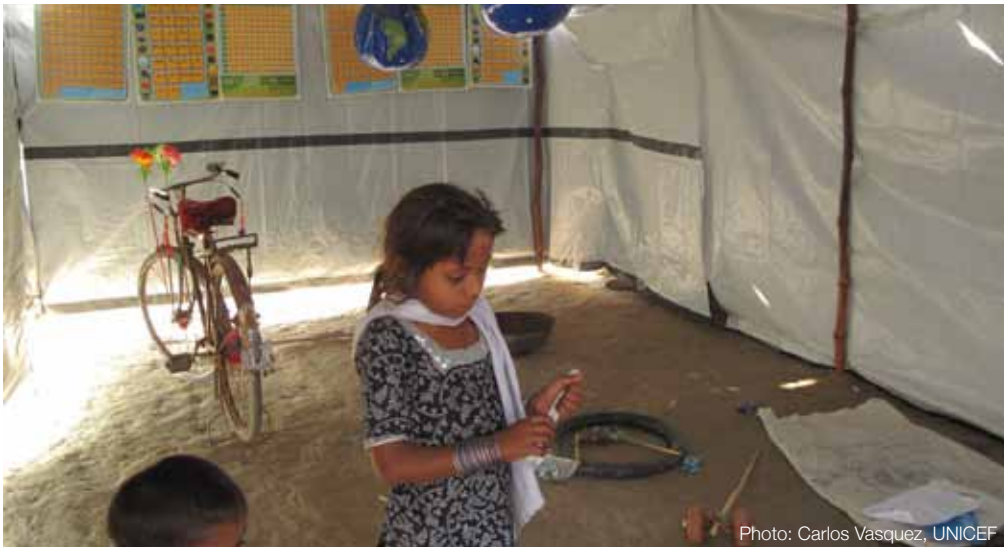
Interior of TLS with mud floor

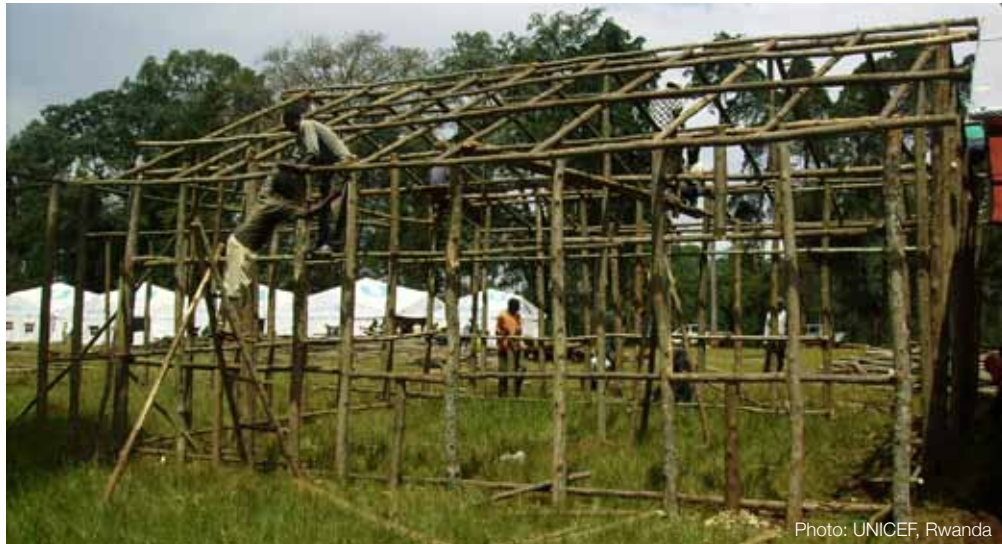
Wooden pole lattice structure, TLS under construction

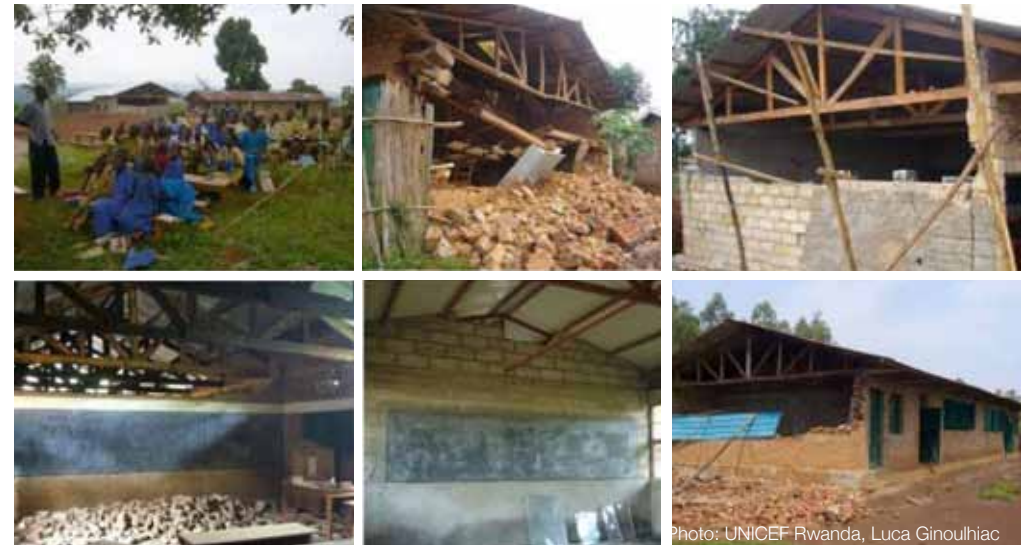
Earthquake damage on school buildings

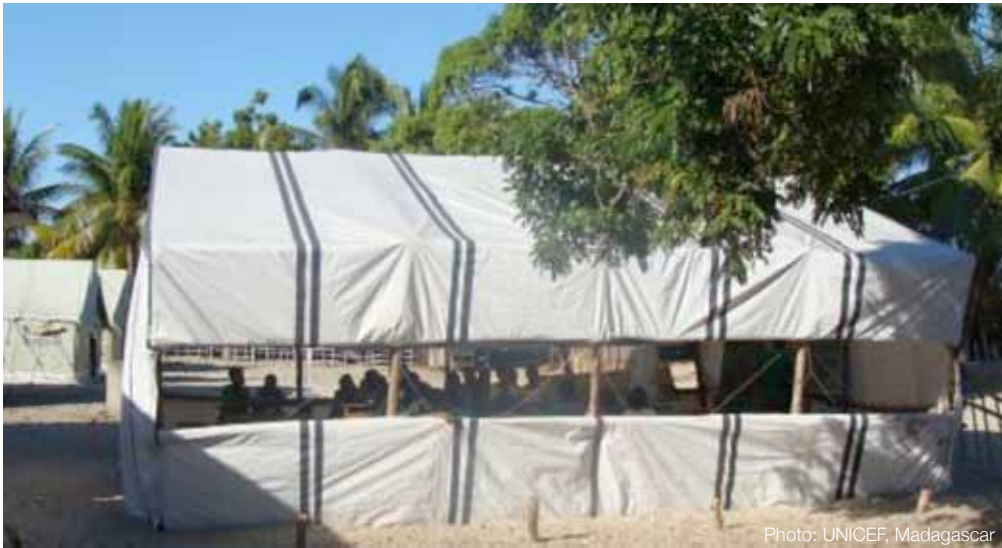
Existing vegetation providing shadow

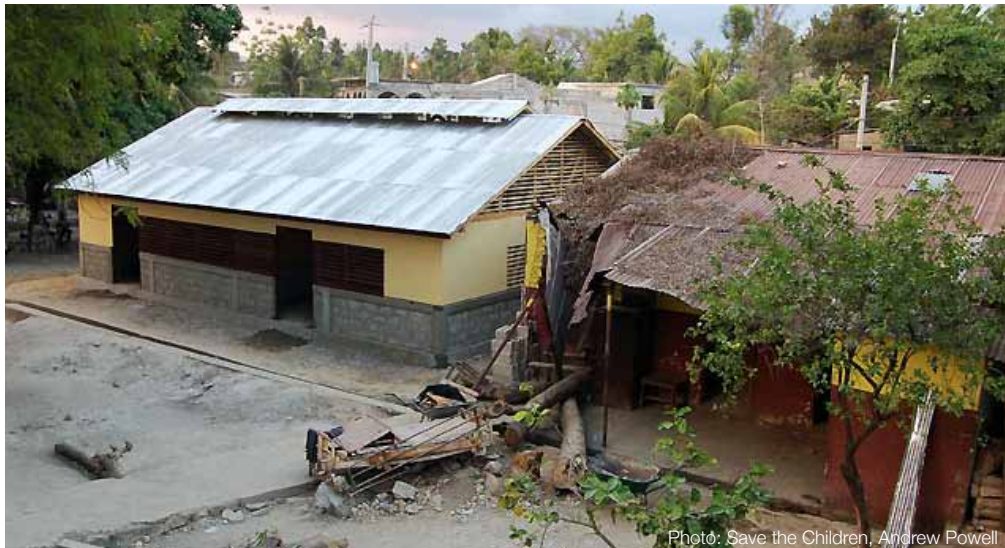
External view of masonry/timber TLS version for Ecole Siloe in Jacmel, next to damaged school building

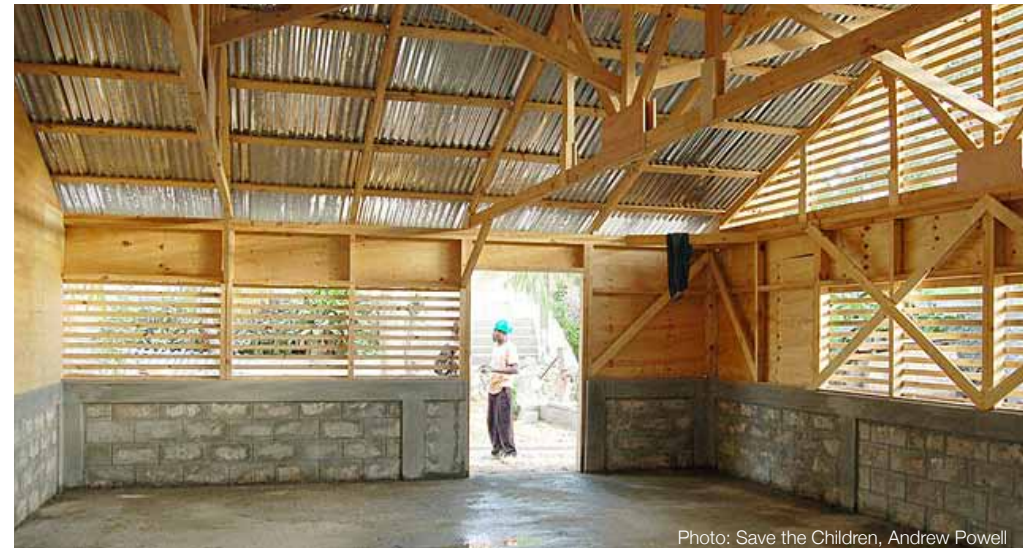
Internal view of masonry/timber TLS version for Ecole Siloe in Jacmel, showing internal natural lighting condition
