# SHELTER PROJECTS

## EAST & HORN OF AFRICA: 14 Case Studies

*CASE STUDIES OF HUMANITARIAN SHELTER AND SETTLEMENT RESPONSES RELEVANT TO EAST AFRICA*

VERSION 1 -- 18 June 2018

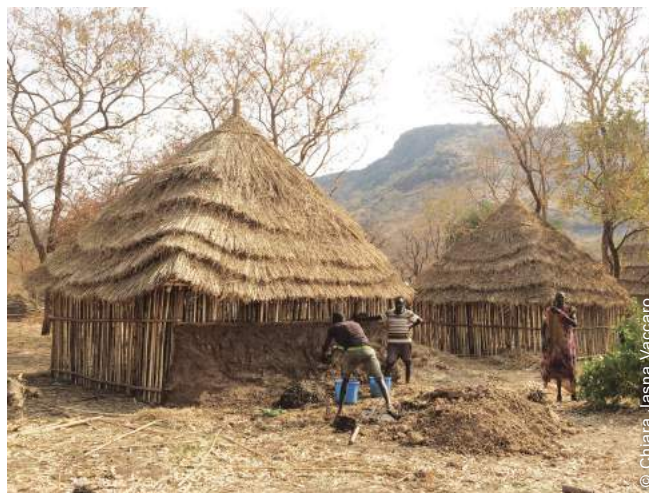
South Sudanese refugees in Tierkidi camp in Gambella, Ethiopia, plastering the walls of the shelters with mud sourced locally by themselves, in areas agreed with authorities and host communities.

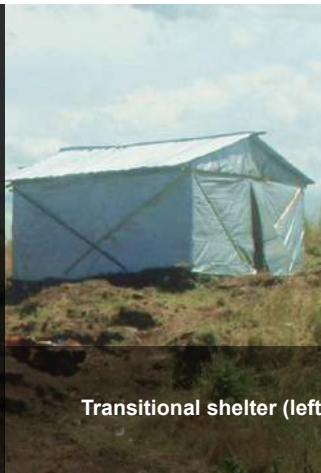
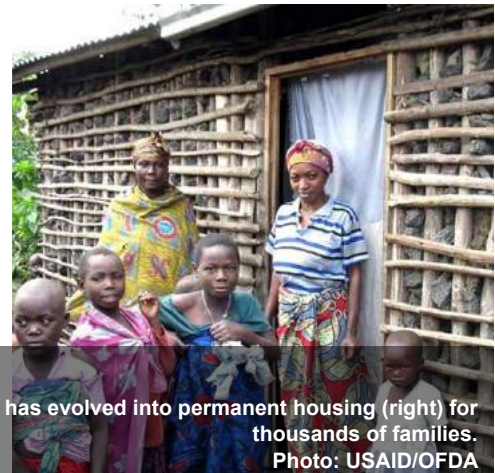
Transitional shelter (left) has evolved into permanent housing (right) for thousands of families. Photo: USAID/OFDA

+ *Transitional shelter really can facilitate the transition to permanent housing.* As intended, nearly all of the original 5,000 “t-shelters” have been improved in some way as part of making it a permanent home. A site visit 2012 noted that most beneficiary families continue to live in their transformed transitional shelters. After ten years, some families are still making improvements leading to permanence, suggesting that the process of incremental housing development is both evident and likely to continue in the foreseeable future.

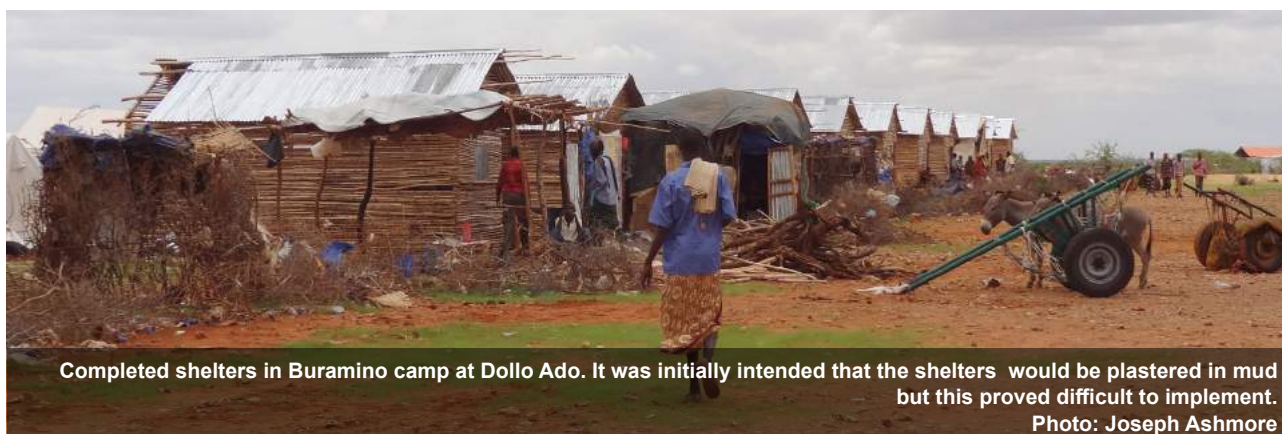
Completed shelters in Buramino camp at Dollo Ado. It was initially intended that the shelters would be plastered in mud but this proved difficult to implement.  
Photo: Joseph Ashmore

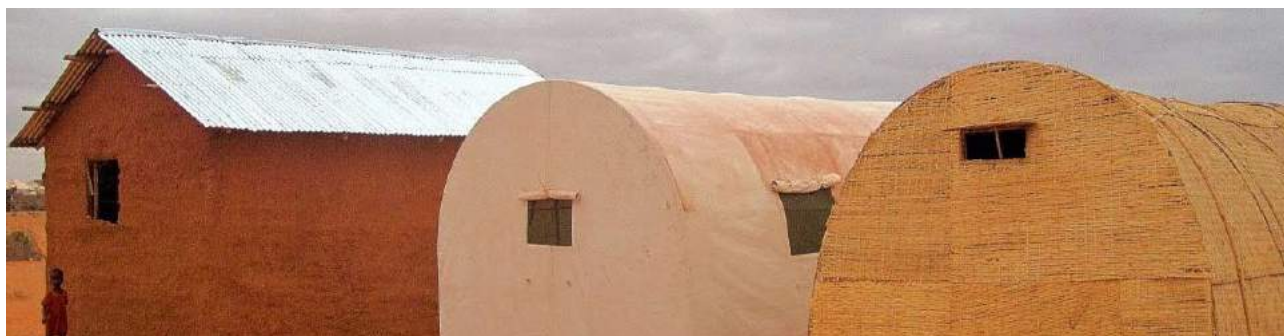
Three different prototype shelters were built and a group of refugee representatives, the government and the key organisations agreed on a common design  
Image: NRC

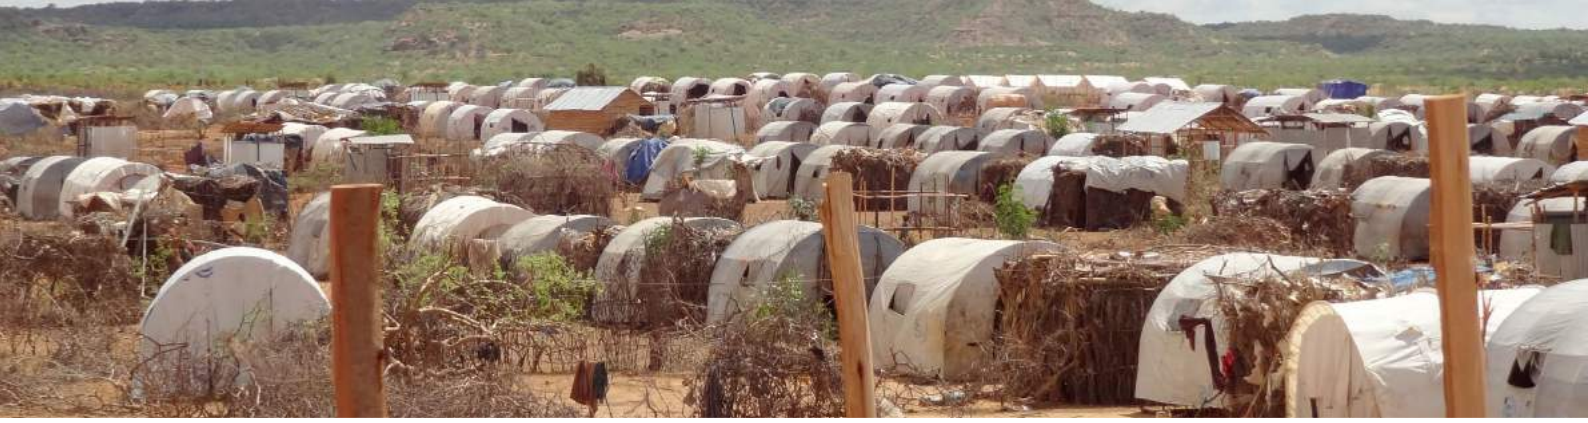
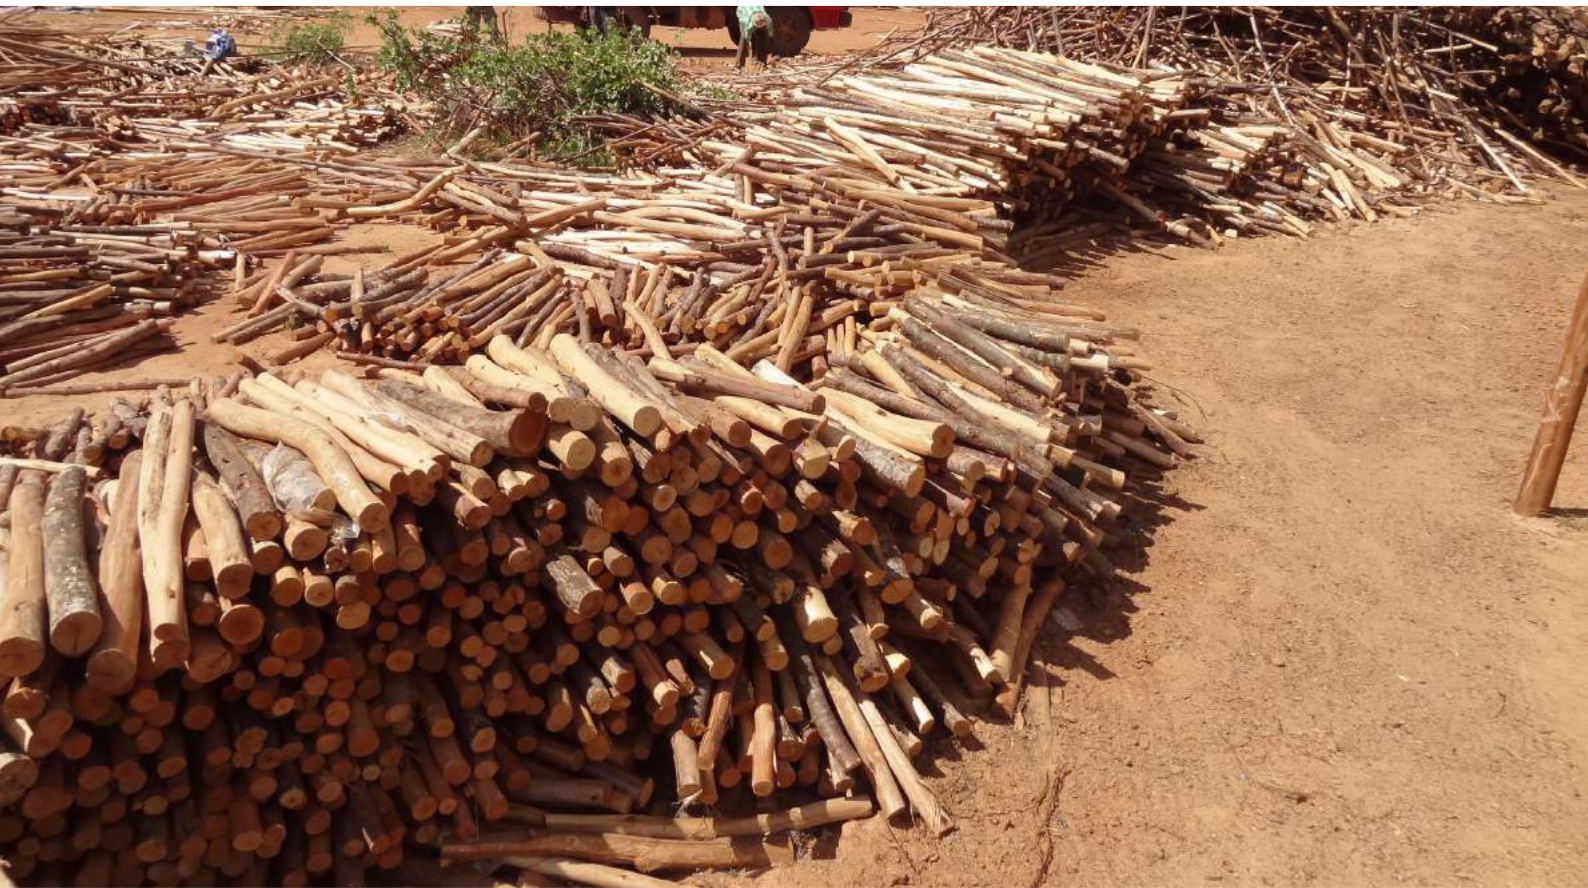
Top: View of a camp before construction.  
Each organisation established a large workshop in each camp to store materials and prefabricate components.  
Images: Joseph Ashmore

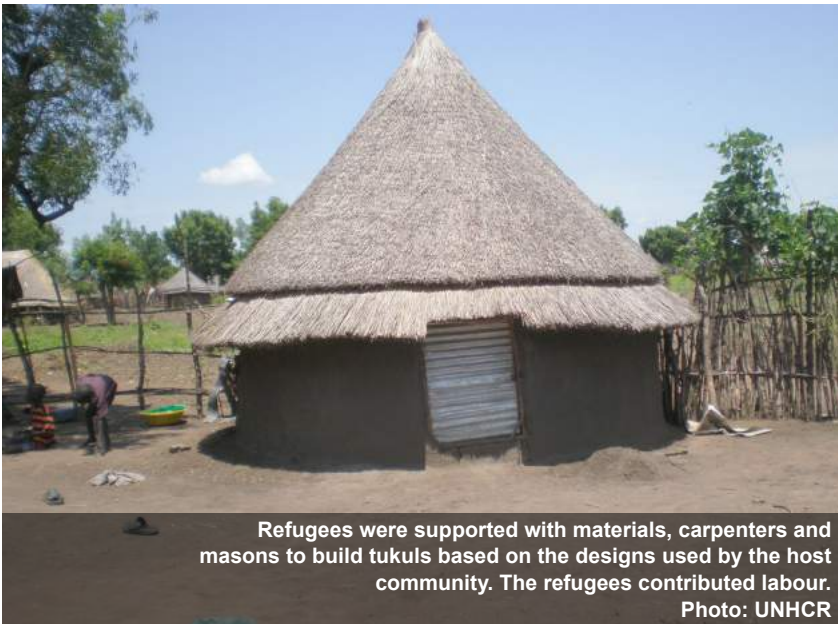
Refugees were supported with materials, carpenters and masons to build tukuls based on the designs used by the host community. The refugees contributed labour. Photo: UNHCR

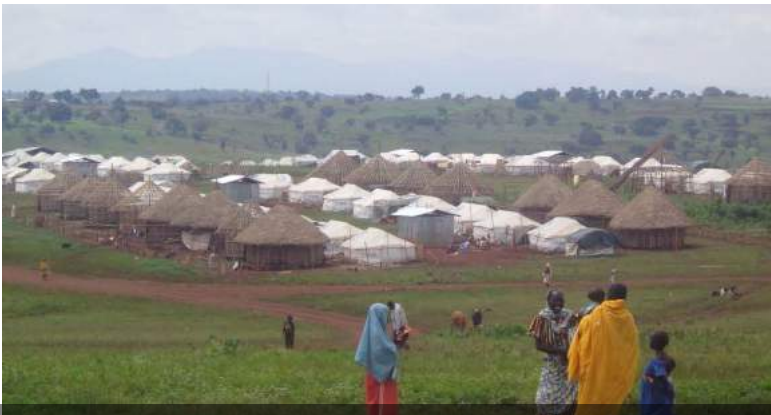
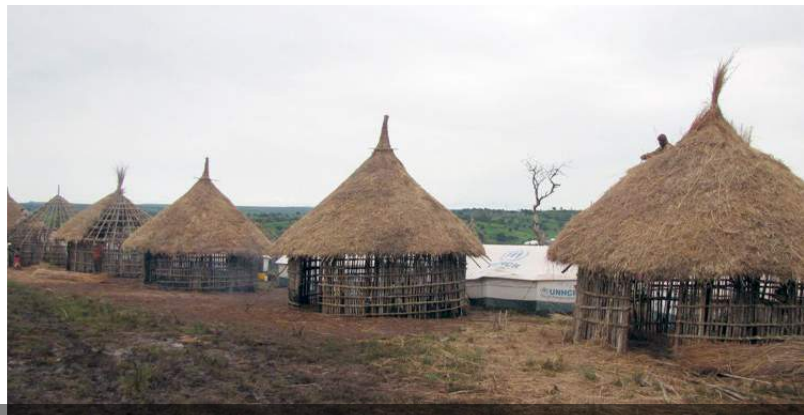
Timber and bamboo frames shelters were built with thatched roofs as a more durable shelter solution than tents. It proved challenging to source mud to plaster the walls as originally intended.  
Photos: Left: UNHCR, Right: Demissew Bizuwerk / IOM Ethiopia.

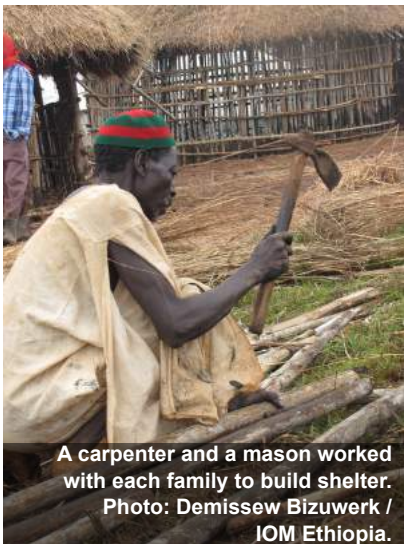
A carpenter and a mason worked with each family to build shelter.  
Photo: Demissew Bizuwerk / IOM Ethiopia.

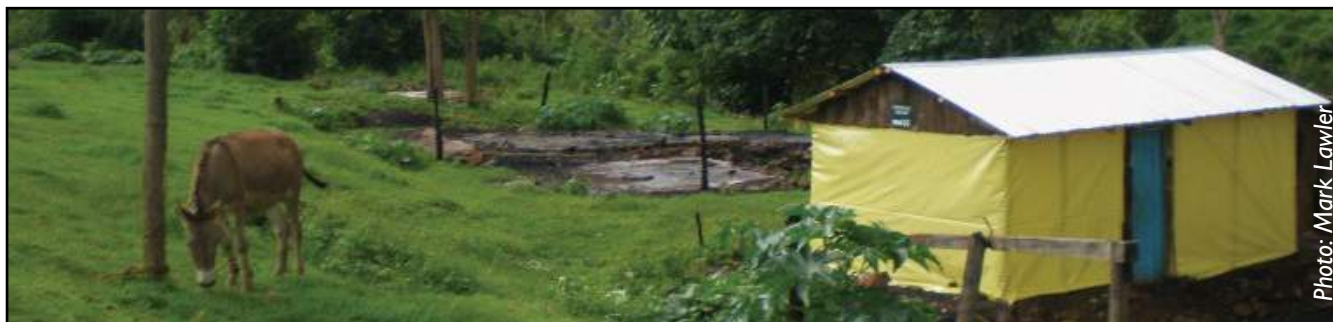
*Transitional shelter built on the family's own land*

The use of plastic sheeting allowed shelters to be built and occupied very quickly, though some beneficiaries replaced the plastic sheeting walls immediately with adobe or reclaimed building parts, such as doors or timber. The plastic sheeting could then be sold or used for temporary house extensions, and provided waterproof storage for seeds and fertilisers.

The use of regular frame and roof sections made the construction modular – it could be easily extended or adapted. The choice of materials meant that there was no part of the building that could not be fixed or replaced locally.

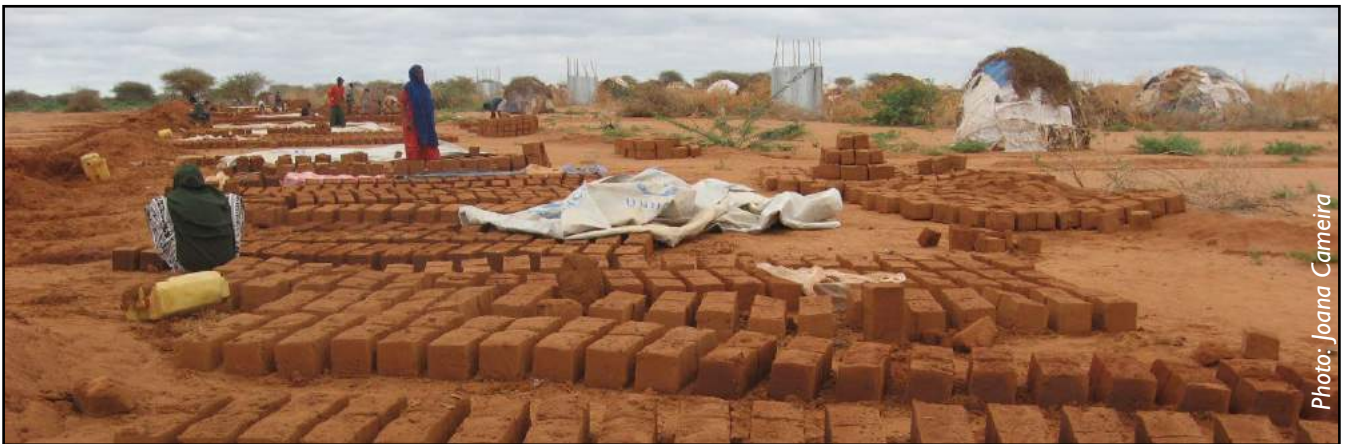
Brick production

The 6m x 3m houses required 1,700 bricks, considerably more than previous designs implemented in the camp. While disaster mitigation was primarily achieved by relocating refugees to the higher ground of Section N, extra bricks were necessary to build a thick foundation and lower wall to improve the structure's performance in heavy rains.

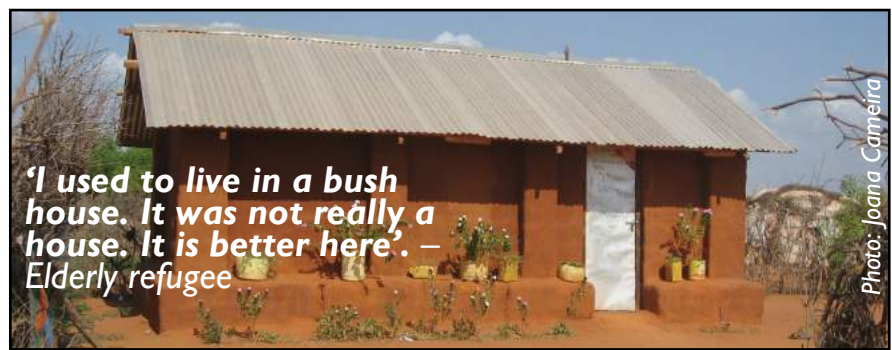
Eight pillars provided support for the walls and roof trusses, increasing the stability of the roof itself. Mud-brick walls were plastered with

mortar or cow dung and the roof was covered with iron sheeting. Improvements were made to ventilation to decrease the high internal temperature of previous designs.

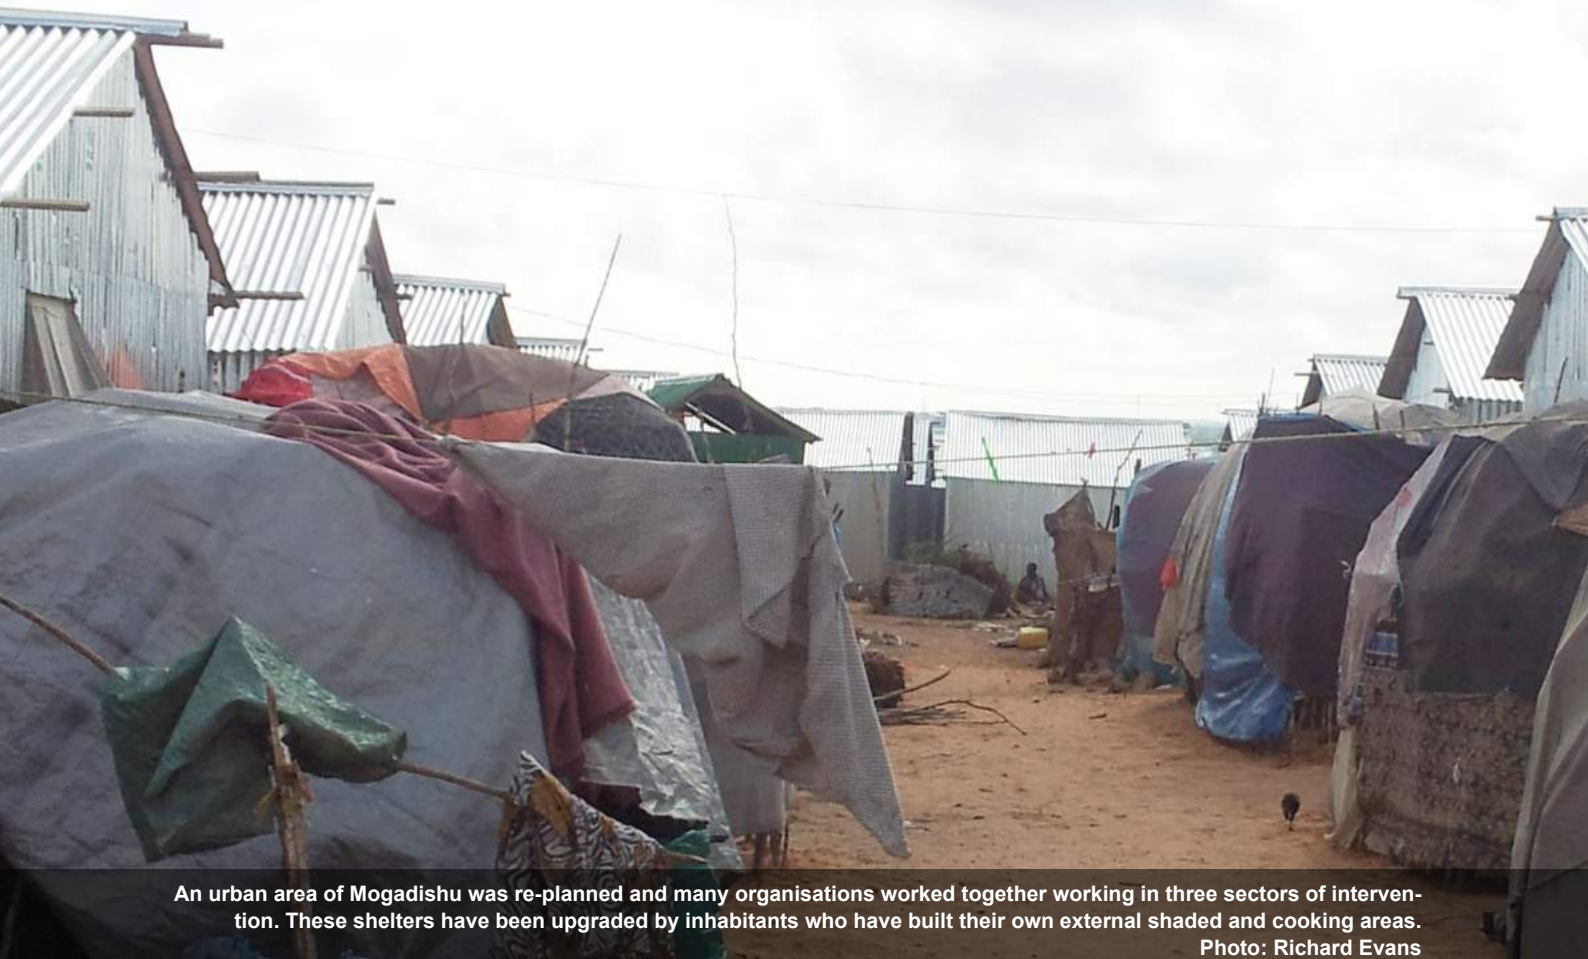
An urban area of Mogadishu was re-planned and many organisations worked together working in three sectors of intervention. These shelters have been upgraded by inhabitants who have built their own external shaded and cooking areas. Photo: Richard Evans

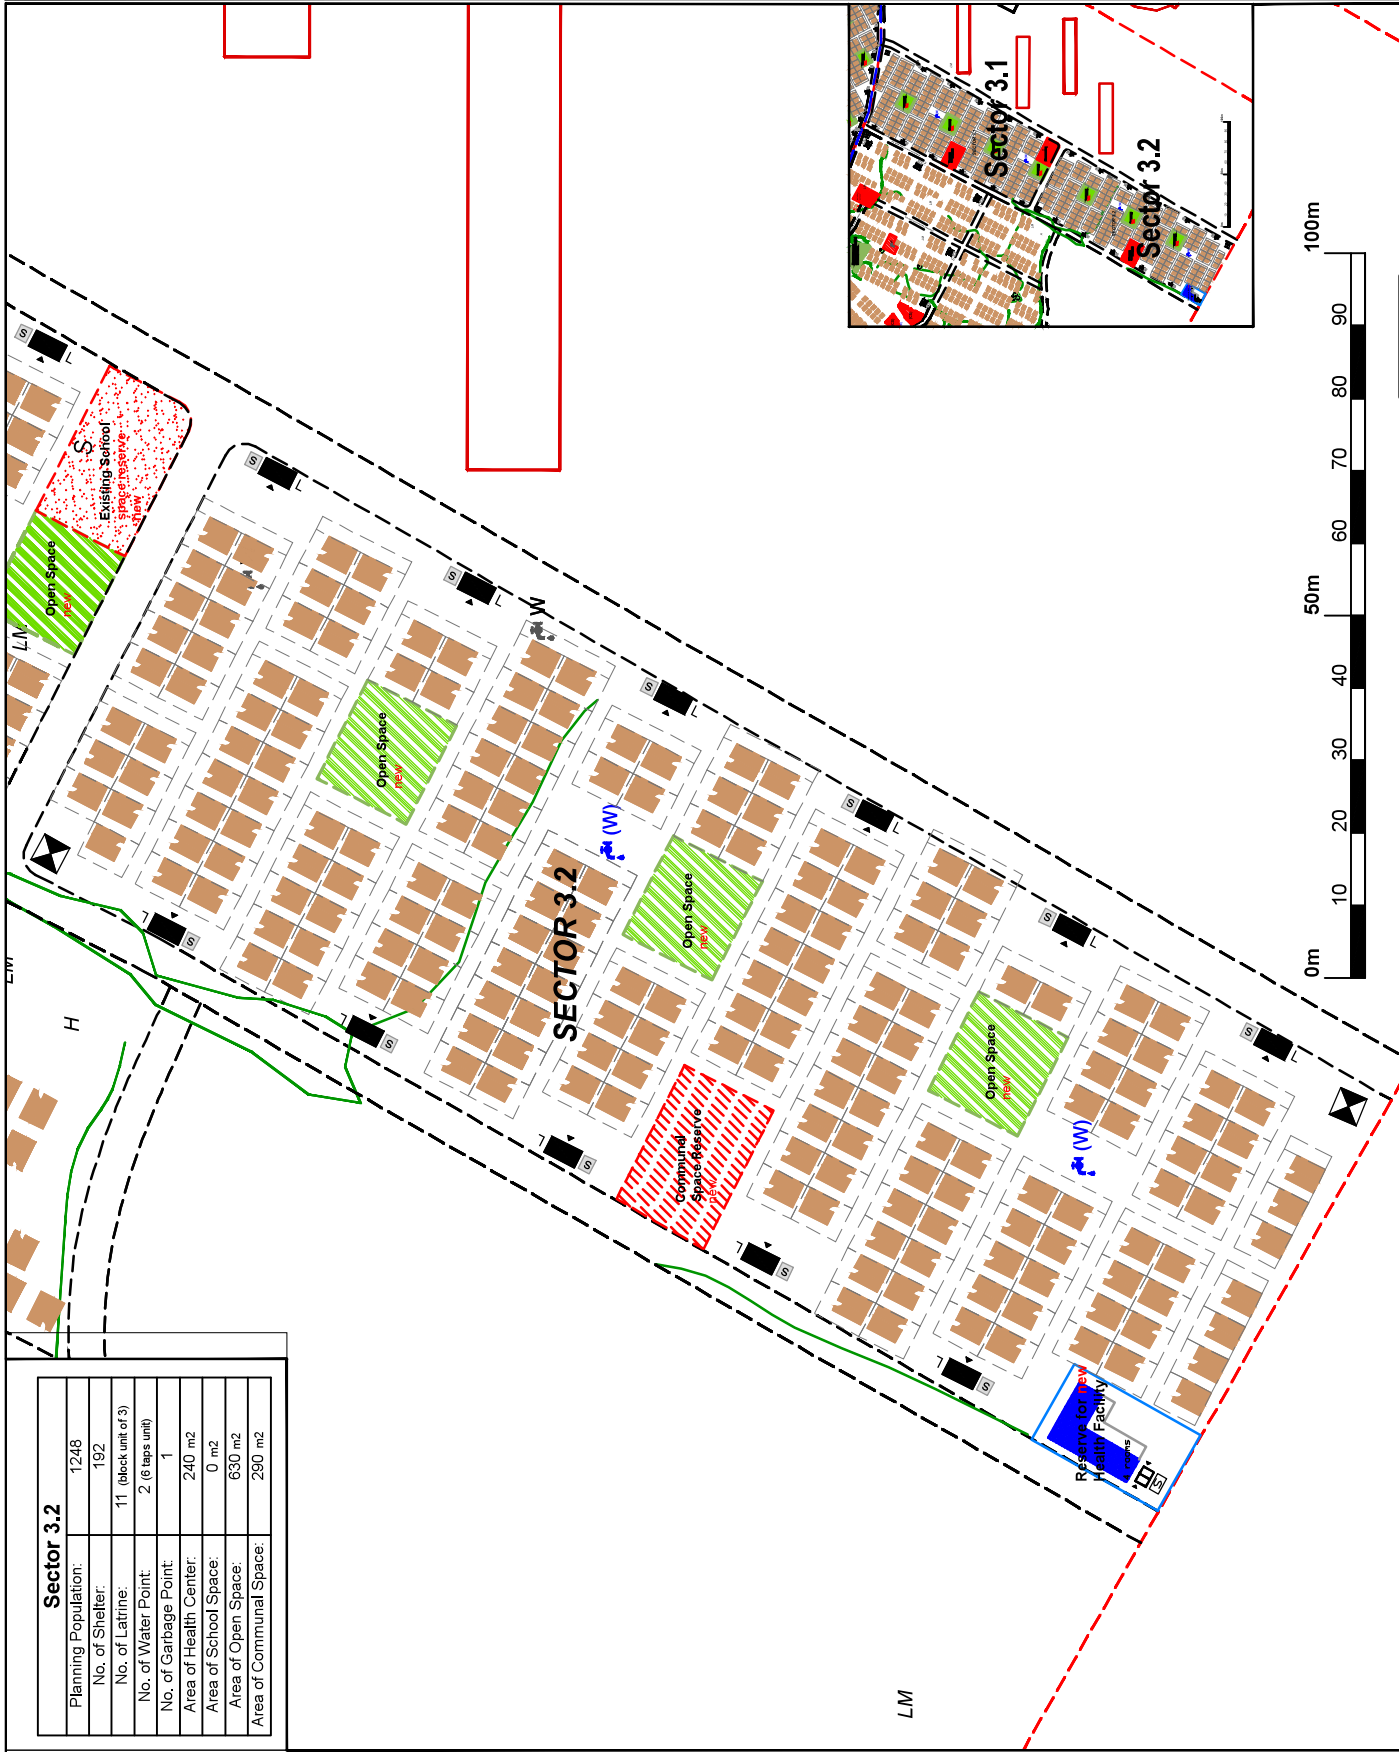
Sector 3.2	
Planning Population:	1248
No. of Shelter:	192
No. of Latrine:	11 (block unit of 3)
No. of Water Point:	2 (6 taps unit)
No. of Garbage Point:	1
Area of Health Center:	240 m <sup>2</sup>
Area of School Space:	0 m <sup>2</sup>
Area of Open Space:	630 m <sup>2</sup>
Area of Communal Space:	290 m <sup>2</sup>

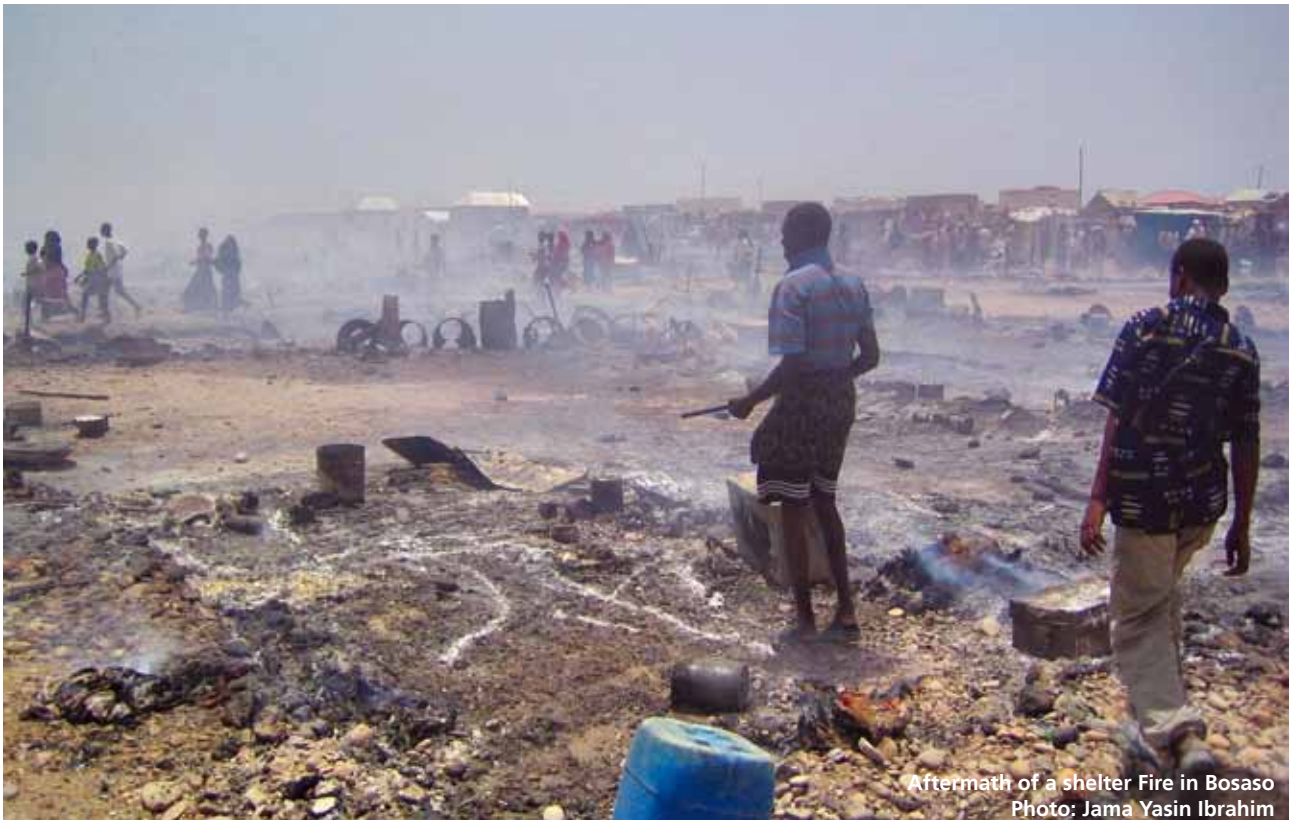
Aftermath of a shelter fire in Bosaso  
Photo: Jama Yasin Ibrahim

- ✗ Long term maintenance and support is required to ensure that fire breaks remain and sites remain clear of flammable debris.
- ✗ Solutions and activities in displacement sites remain temporary fixes.
- ✗ Sanitation remained a significant concern after the programmes.
- Limited funding availability and challenging security made project implementation challenging.

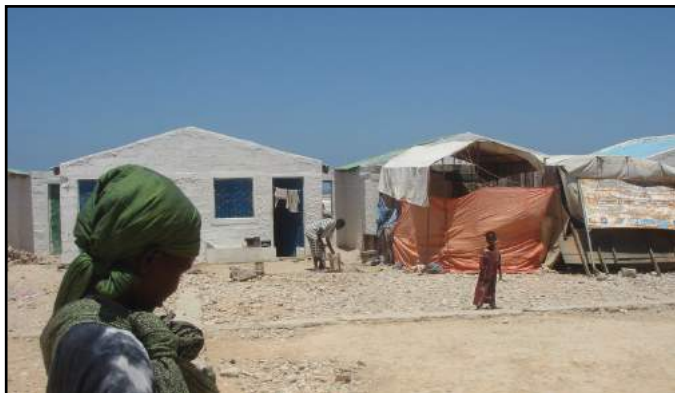
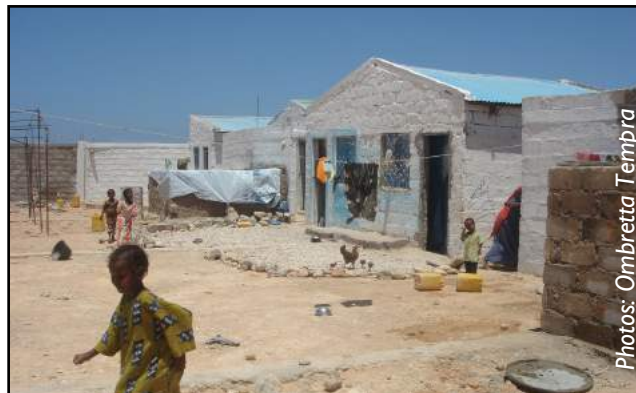
*Sites and services: the project focused on negotiating land and providing access, secure compound walls, water and sanitation.*

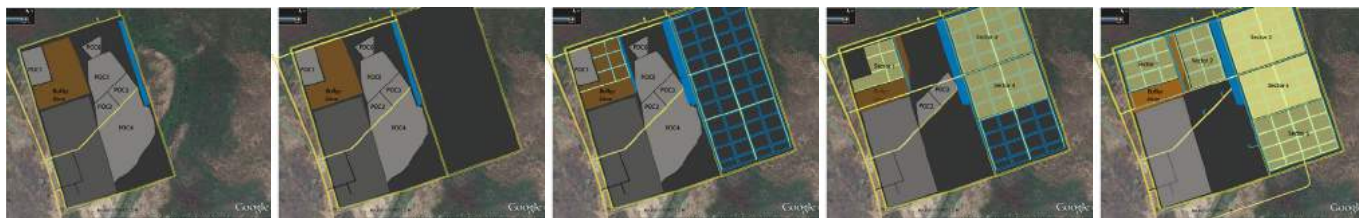
Phase 0: survey and de-mining. Phase 1: Access to site works and perimeter. Phase 2: Internal access and drainage. Phase 3: block development and relocations. Phase 4: block development, relocation and completion.

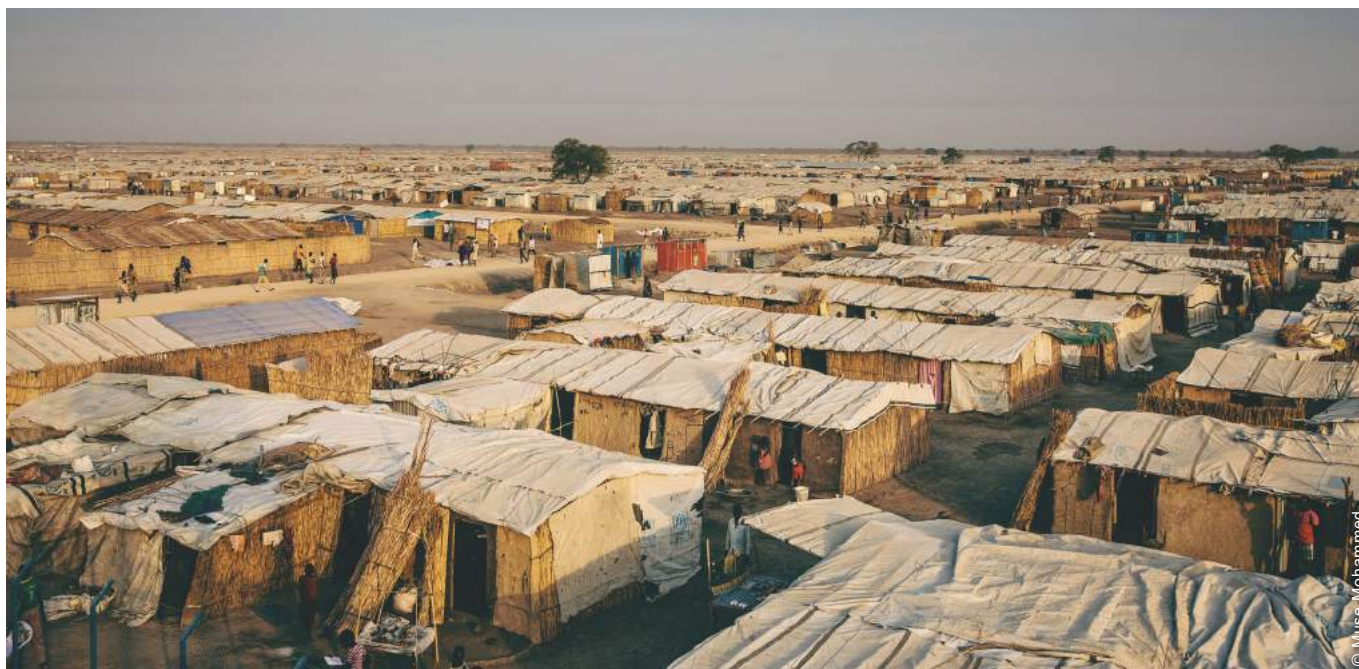
The shelter project built communal shelters due to lack of land and nationally limited resources. These shelters allowed to maximize the use of limited space and impacted shelter strategies throughout the country.

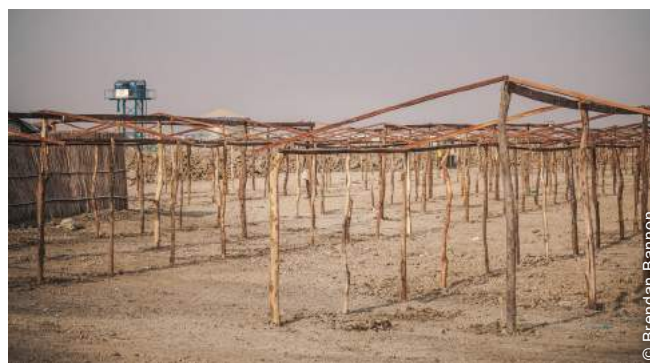
Shelter frames were built by contractors.

To protect from water coming in, it was initially planned to use sand to raise the floors of the shelters, but this proved impossible to procure. Households were therefore encouraged to use white soil to raise their floors instead.

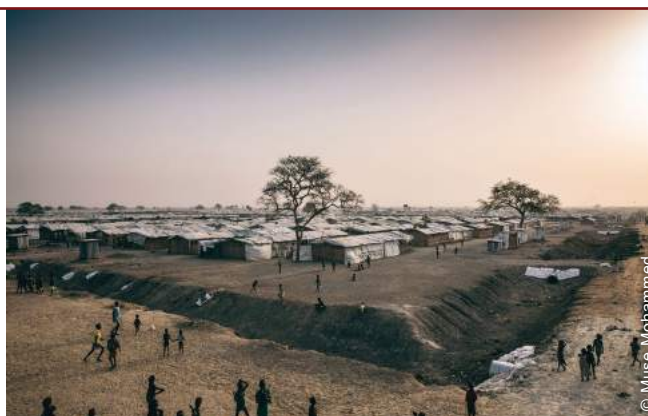
The site works were based on a Dutch "polder" system. They included 28m<sup>2</sup> section drainage ditches, berms, water retention basins, and large volume pumps to evacuate water.

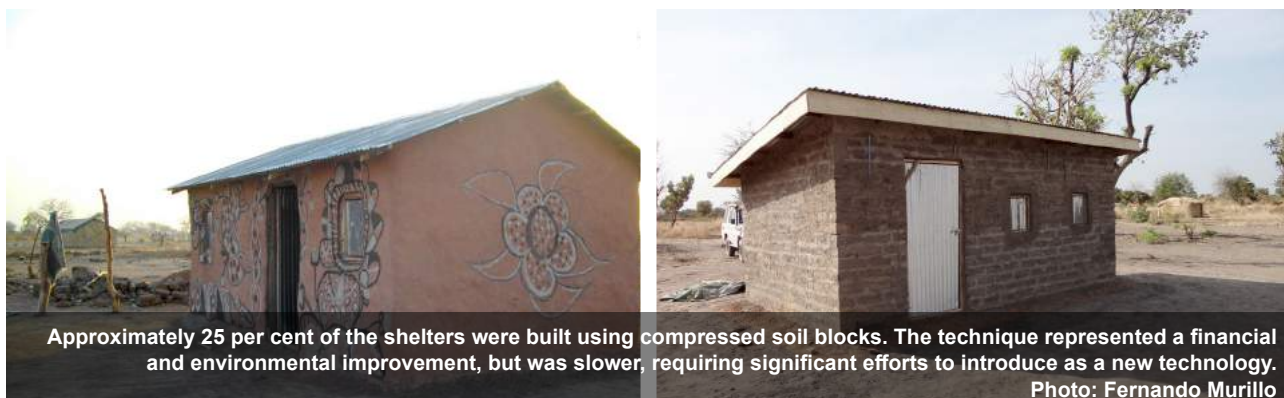
Approximately 25 per cent of the shelters were built using compressed soil blocks. The technique represented a financial and environmental improvement, but was slower, requiring significant efforts to introduce as a new technology.

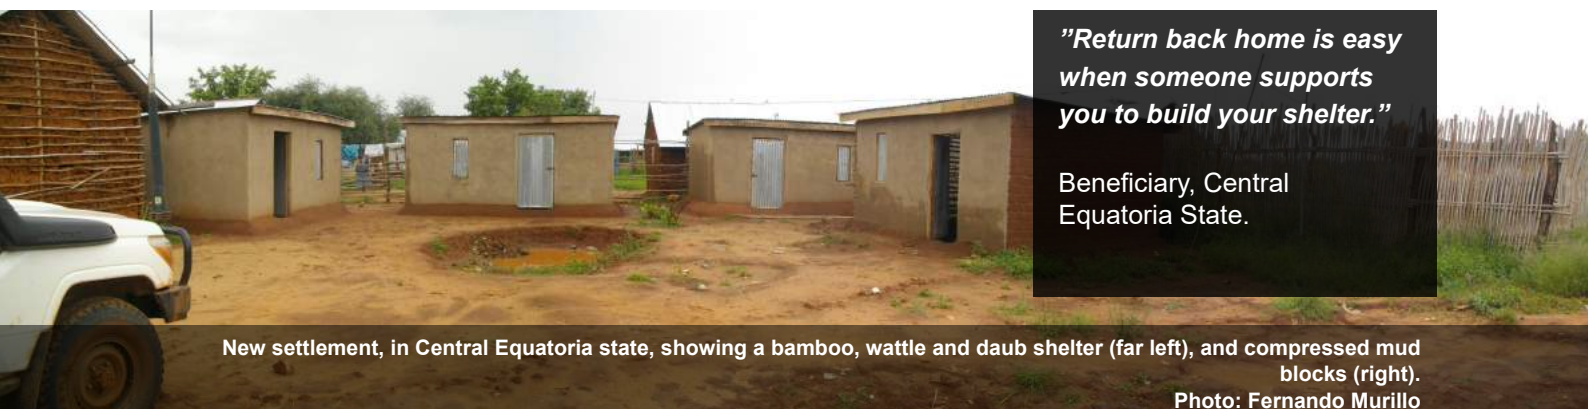
New settlement, in Central Equatoria state, showing a bamboo, wattle and daub shelter (far left), and compressed mud blocks (right).

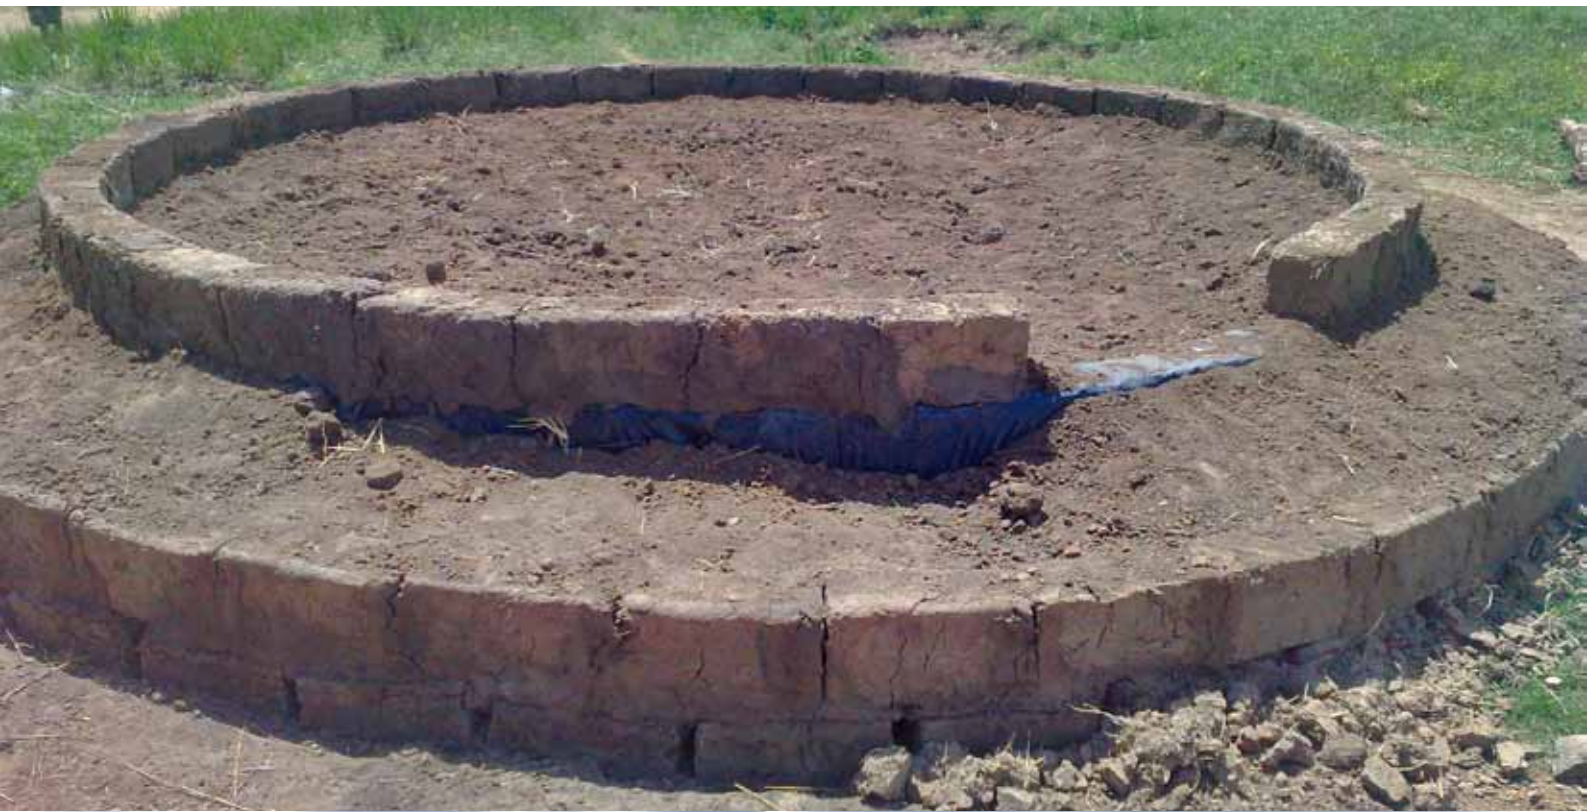
House under construction with improved plinth  
Photo: IFRC

- The house and foundations should be elevated.
- Foundations should be built with a large plinth beam of wattle and daub. This would need to be repaired by house owners after each small flood
- A water proof barrier should be put the foundations to protect the walls and floors which are made of adobe blocks.
- Walls made of sun dried mud blocks should be conical in shape
- Proper materials to build more resistant earth blocks should be identified. Examples are clay from termite hills, and using mud mixed with cow dung to protect against termites.
- Wood in direct contact with the earth should be treated to protect it from termites.

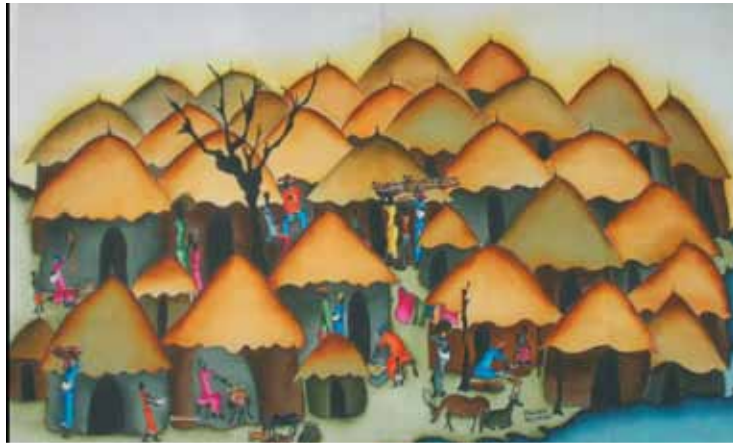
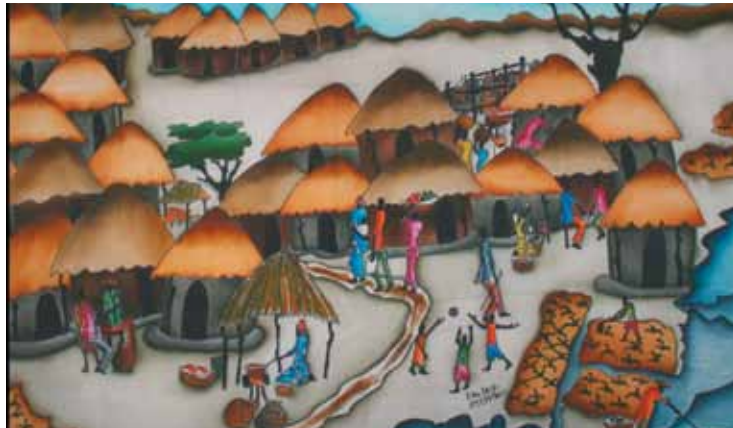
Public information images on proper site planning with space between buildings  
Image credit: IFRC

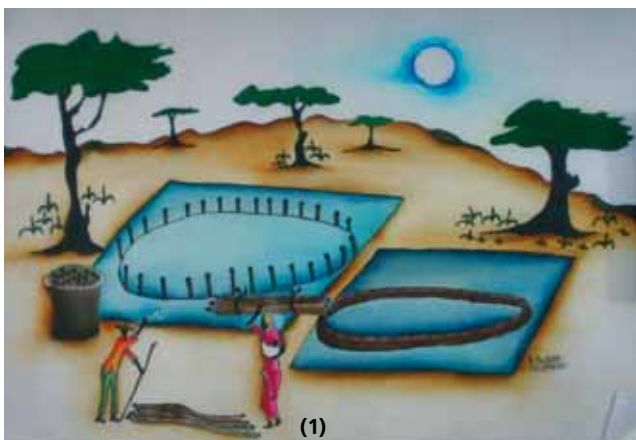
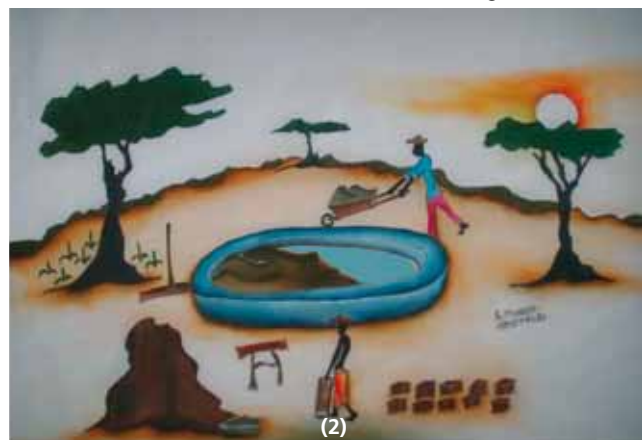
Images from public information posters on building a flood resistant structure: (1) elevate the plinth and put a plastic sheet under the floor (2) fold the plastic sheet over the ground level ring beam (3) build conical walls (4) thatch the roof, render the walls with mud and elevate the area around the house to protect it from flooding  
Image credit: IFRC
