SHELTER PROJECTS

ASEAN SHELTER EXAMPLES: 31 Case Studies

CASE STUDIES OF HUMANITARIAN SHELTER AND SETTLEMENT RESPONSES IN ASEAN MEMBER STATES

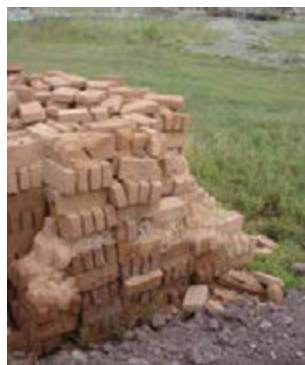
Obtaining good quality building materials remained problematic. These bricks decayed rapidly in the rain.

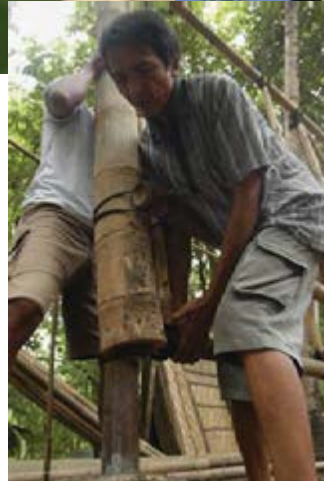
Connecting a vertical post to the foundation

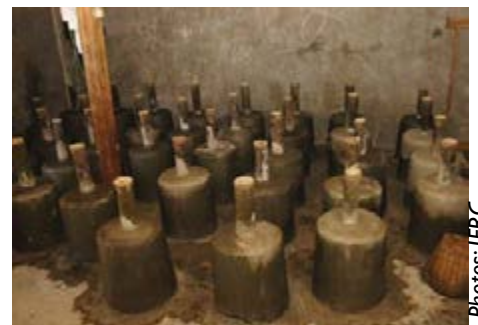
Foundation pads cast with bamboo to connect them to the frame

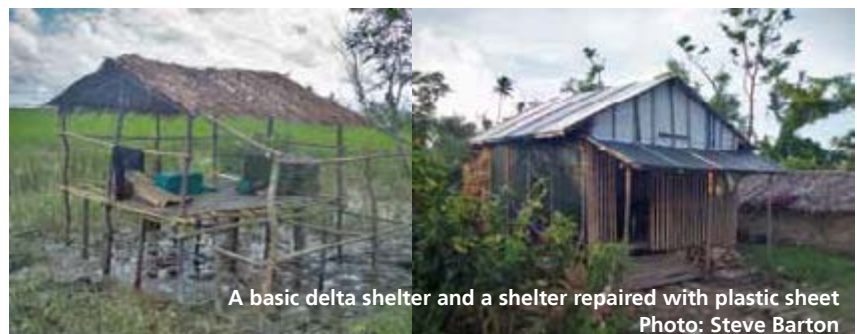
A basic delta shelter and a shelter repaired with plastic sheet
Photo: Steve Barton

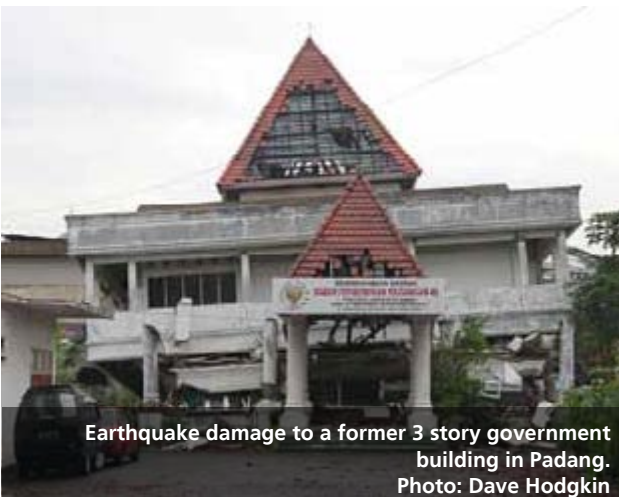
Earthquake damage to a former 3 story government building in Padang.
Photo: Dave Hodgkin

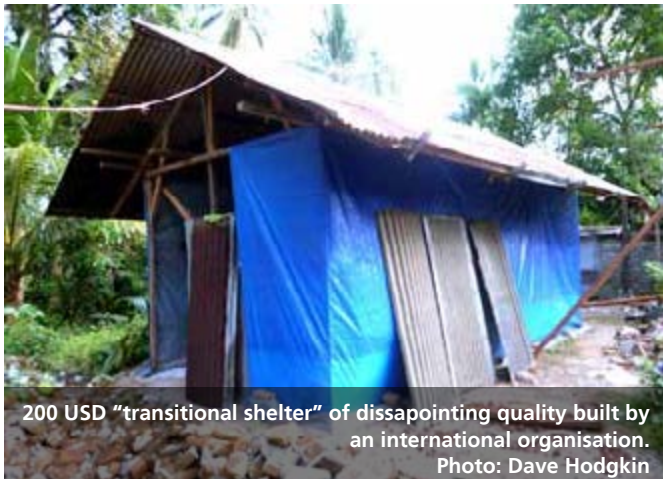
200 USD "transitional shelter" of disappointing quality built by an international organisation.
Photo: Dave Hodgkin

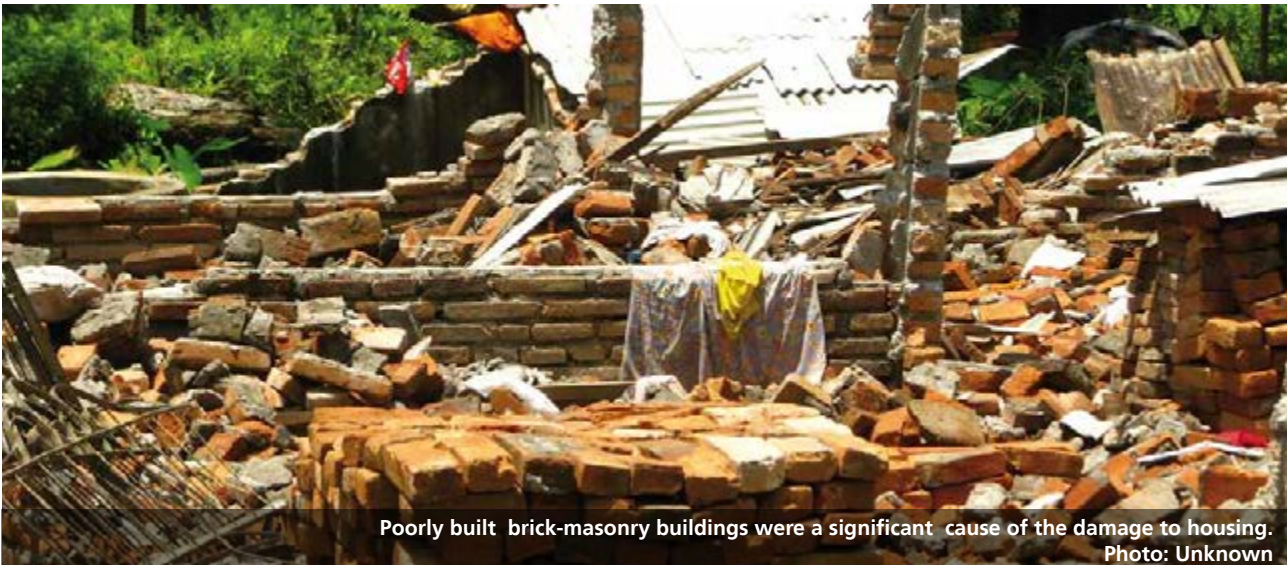
Poorly built brick-masonry buildings were a significant cause of the damage to housing. Photo: Unknown

The earthquake in September 2009 destroyed or damaged over 200,000 houses in West Sumatra. Poorly built brick based masonry caused many of these buildings to collapse.

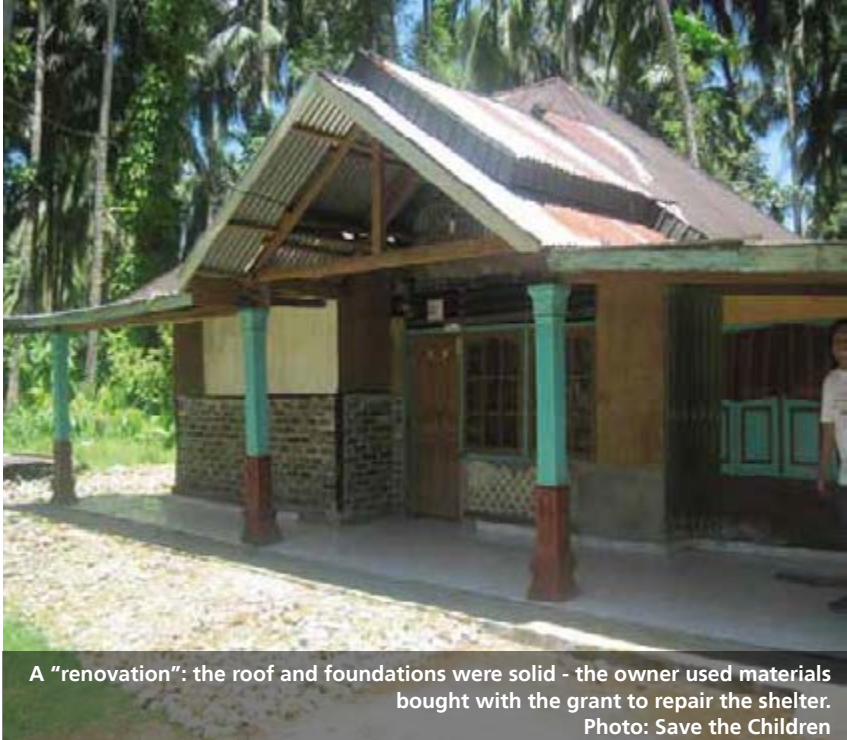
A “renovation”: the roof and foundations were solid - the owner used materials bought with the grant to repair the shelter. Photo: Save the Children

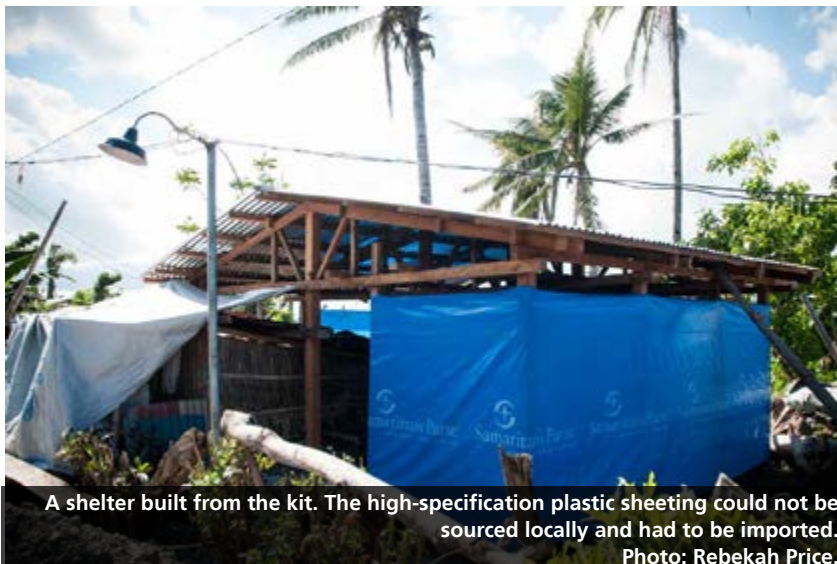
A shelter built from the kit. The high-specification plastic sheeting could not be sourced locally and had to be imported. Photo: Rebekah Price.

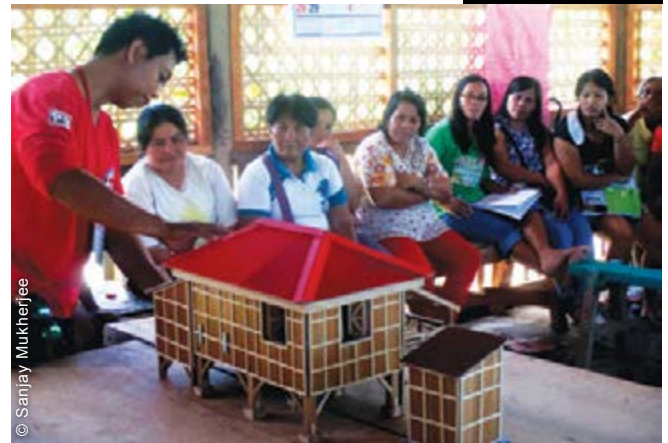
Core shelters and latrines were built to a set design, which was presented at community meetings to explain its features and receive feedback.

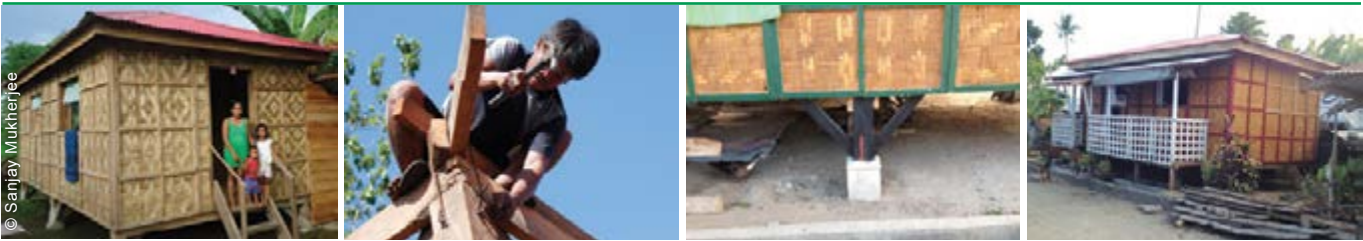
Safer building practices were promoted, such as strapping of roof structures, bracing and proper detailing of the foundations (raised and made of reinforced concrete).
