SHELTER PROJECTS

Haiti 16 Case Studies

CASE STUDIES OF HUMANITARIAN SHELTER AND SETTLEMENT RESPONSES IN HAITI

Shelter Projects - Haiti: 16 Case Studies

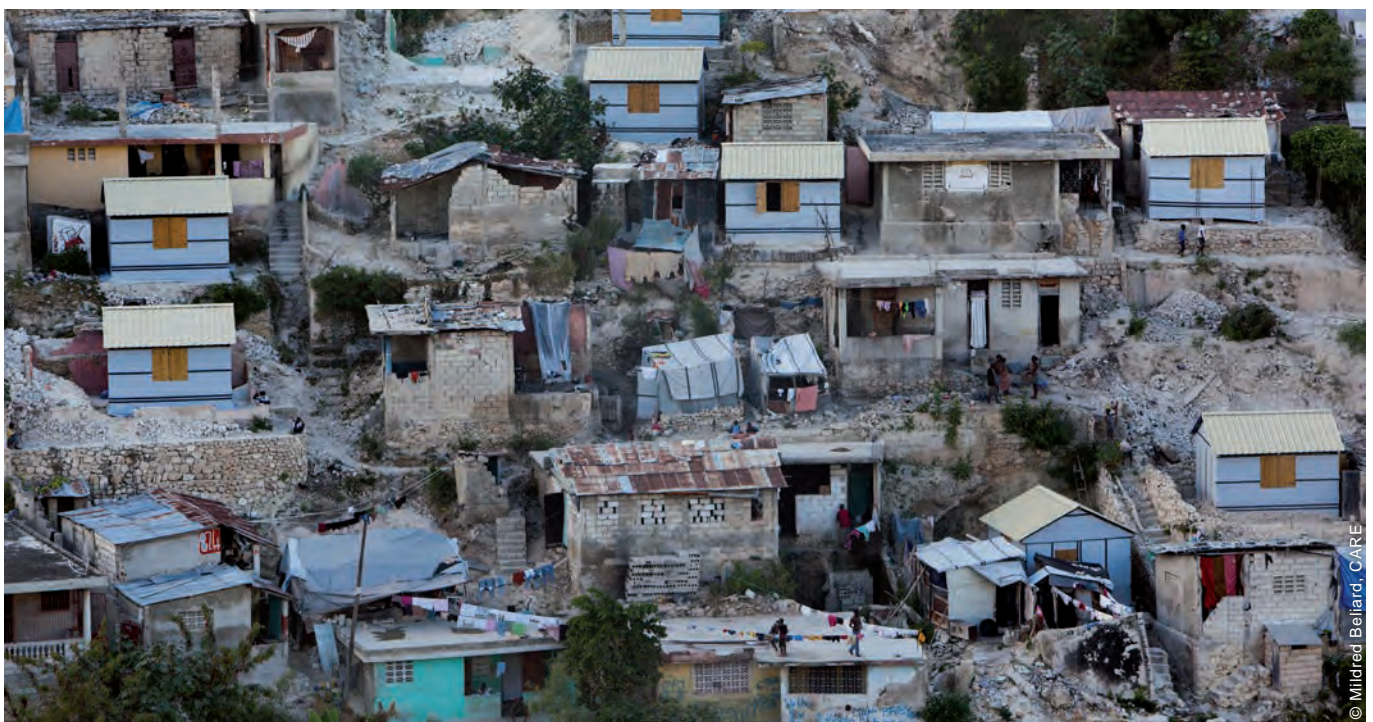
Hillside showing transitional shelters built on small plots of land.

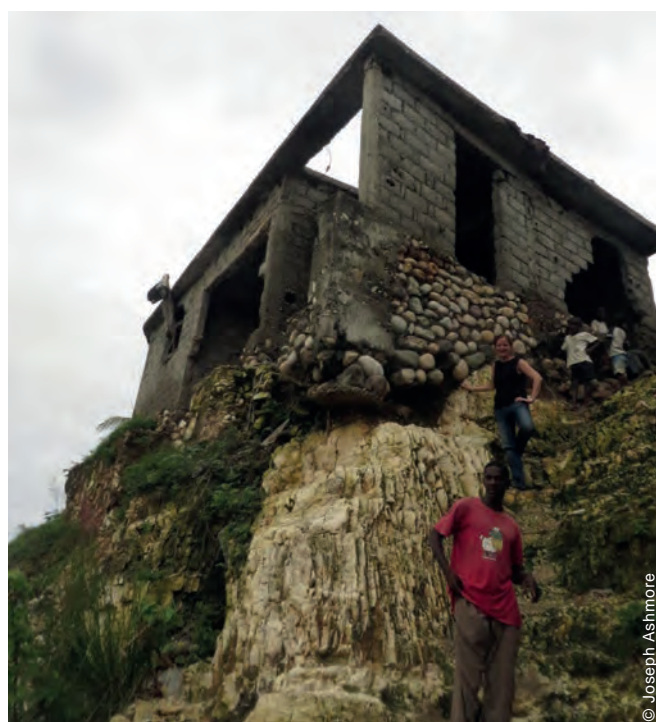
Houses in informal settlements are often vulnerable due to poor locations (marginal sites), poor materials (here we have river stones for foundations) and poor construction.

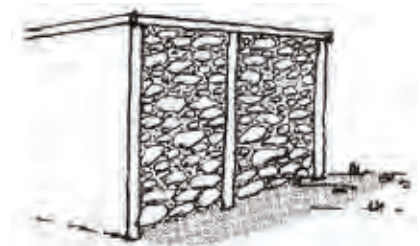
Kay Mur (stone nog): Small stones are cemented between a wooden frame. This was the most popular type of housing found in the south of Haiti.

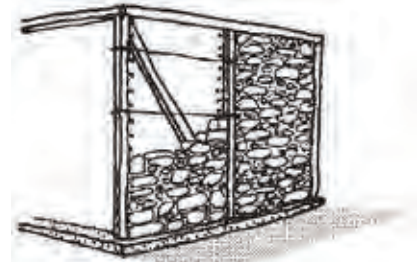
Kay Melange (spanish wall): Similar to Kay Mur, (above) but stones are smaller and a board is used as a guide during construction. Illustrated here with a suggested improvement of cross bracing

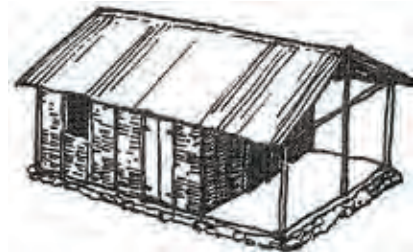
Kay an Planch (wood house): Wooden houses made of locally available timber or wood salvaged from urban construction sites. Deforestation had made wood scarce, so more houses were using palm wood.

The document noted that wooden houses tend to be more heavily damaged by hurricanes than other types of construction. Many of them, including those built by development agencies were poorly anchored to the ground

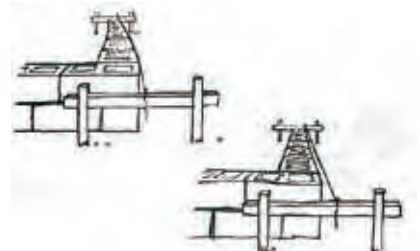
Kay an Bloc (block house) Houses made of cement block. These suffered from poor quality blocks and mortar as well as poor quality construction

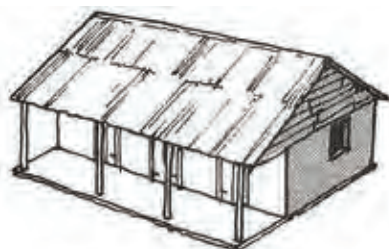
Safer designs are those where the veranda roofing sheets are separate to the main roof—damage to the veranda will not affect the main roof.

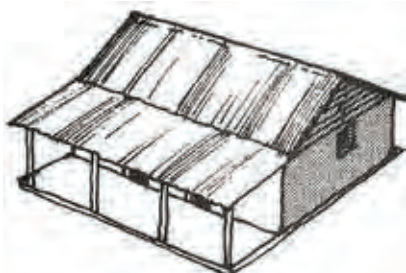
The arrangement below is preferable to the one above. If the verandah (above) was damaged by hurricanes the entire roof would be compromised, whilst in the verandah below damage to the verandah would not affect the rest of the roof

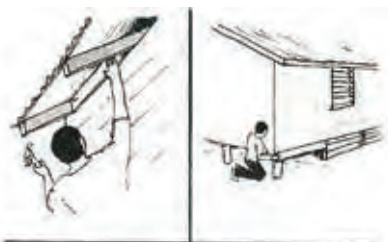
Hurricane preparedness: blocking gaps in the eaves and under shelters, securing walling and roofing sheets

- Place heavy objects on the roof to reduce suction.
- Seal areas below houses on blocks or piers with stones and mud to prevent air from entering underneath houses and lifting them off their foundations.
- Seal openings between roof and walls to prevent wind from entering the eaves.

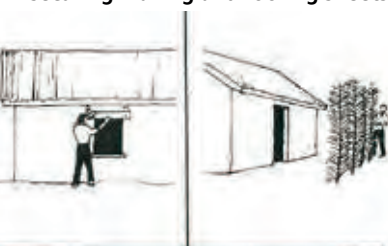
Hurricane preparedness: shuttering windows, building protective screens in front of openings and bracing corners of buildings

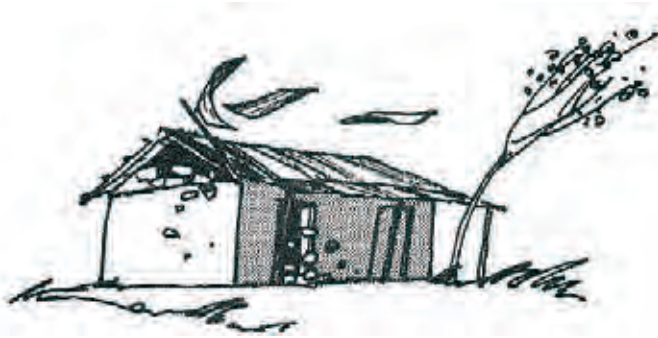
Risk of roof damage

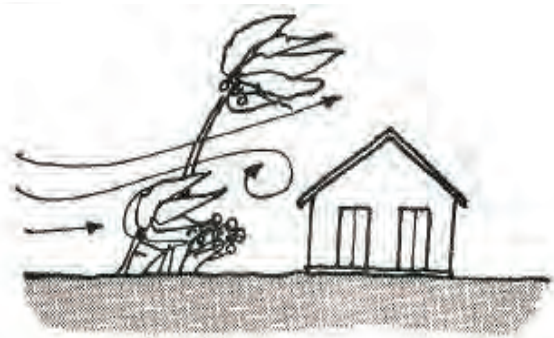
Trees can help protect houses from wind damage

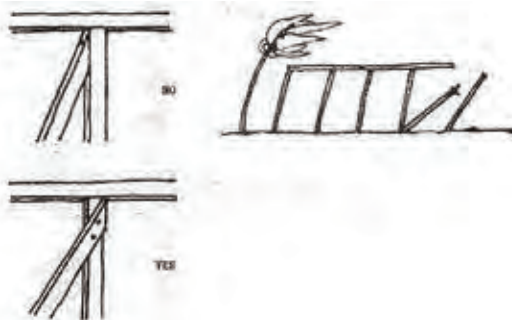
diagonal bracing can reinforce structures but should be correctly attached

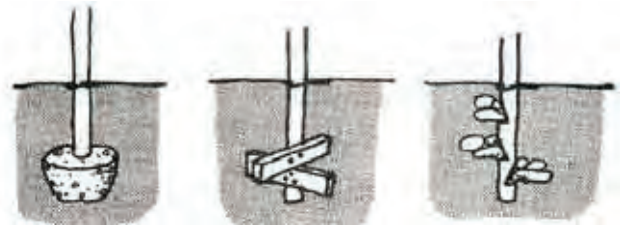
Different foundation details

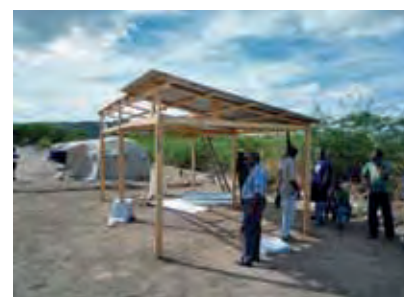
Prototype transitional shelter
Photo: Joseph Ashmore

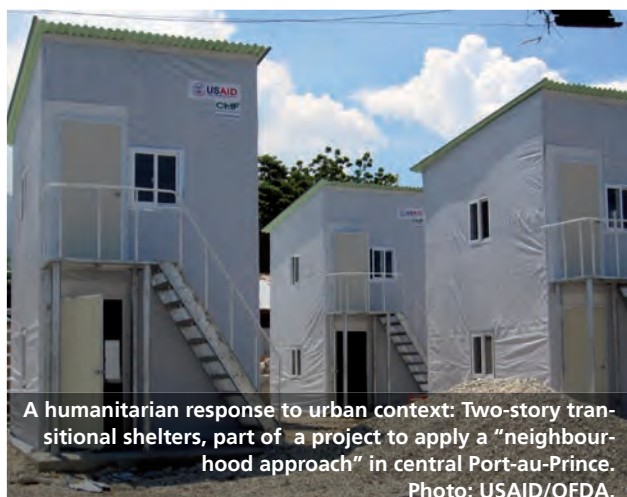
A humanitarian response to urban context: Two-story transitional shelters, part of a project to apply a “neighbourhood approach” in central Port-au-Prince. Photo: USAID/OFDA.

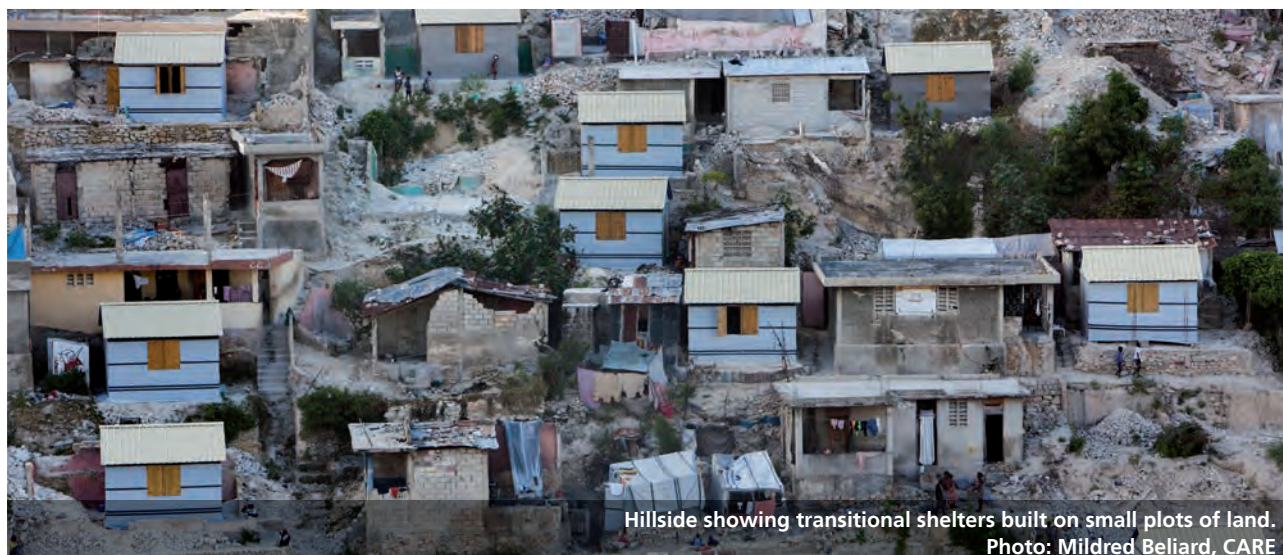
Hillside showing transitional shelters built on small plots of land.
Photo: Mildred Beliard, CARE

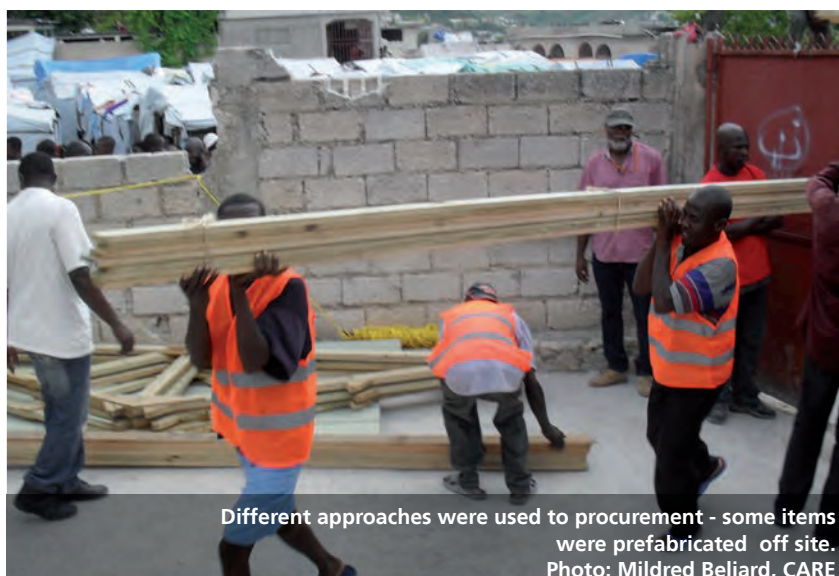
Different approaches were used to procurement - some items were prefabricated off site.
Photo: Mildred Beliard, CARE

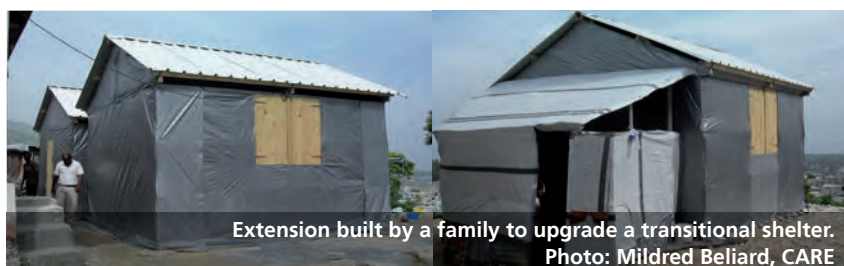
Extension built by a family to upgrade a transitional shelter.
Photo: Mildred Beliard, CARE

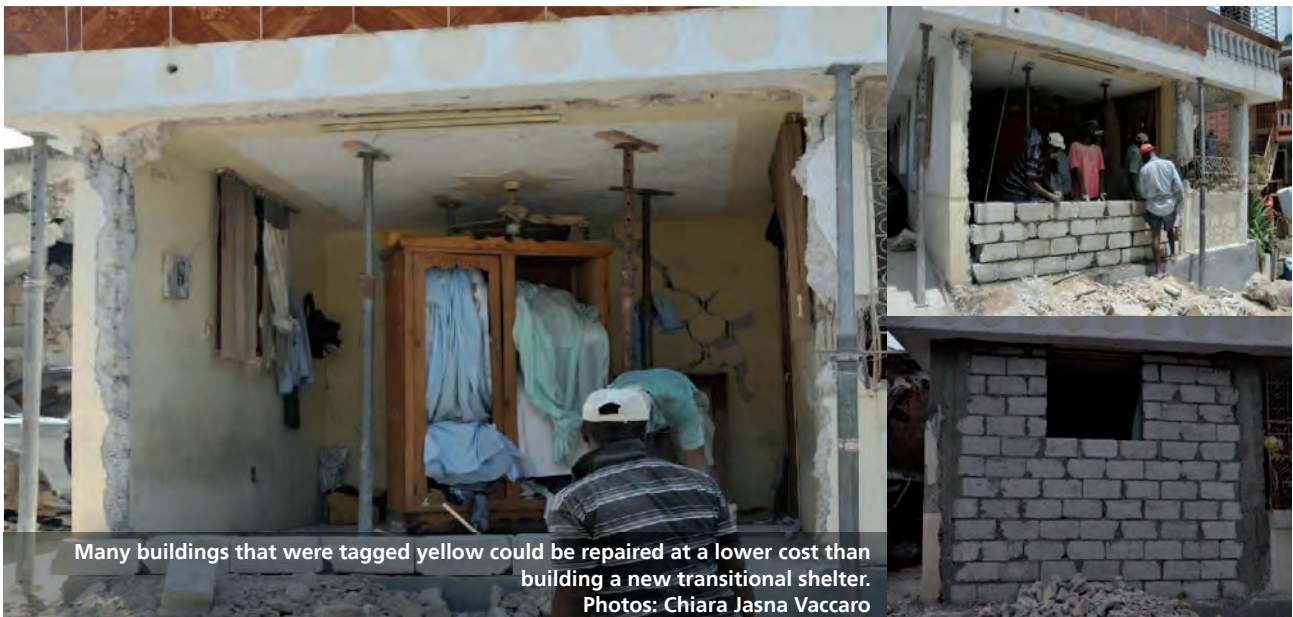
Many buildings that were tagged yellow could be repaired at a lower cost than building a new transitional shelter.
Photos: Chiara Jasna Vaccaro

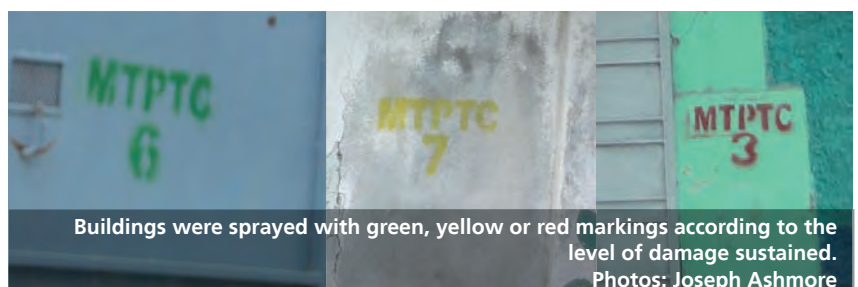
Buildings were sprayed with green, yellow or red markings according to the level of damage sustained.
Photos: Joseph Ashmore

During the assessment, over 400,000 structures were tagged; this was nearly every building in the Port-au-Prince metropolitan area that was impacted by the earthquake.

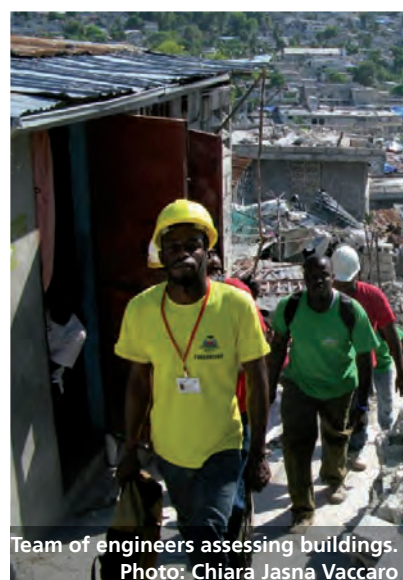
Different repair specifications were developed for walls with and without windows, cracked ring beams, walls that had separated from the roof, and for minor cracking in walls and columns.

- High quality materials: rather than allowing the masons to make their own blocks using river sand, stronger blocks were made in factories. They were made with clean materials and were vibrated after casting. Masons were required to use clean sand for the mortar.
- A thinner layer of stronger mortar: the masons used a 3:1 sand : cement ratio rather than the traditional 6:1 ratio. The masons were instructed to use only a thin layer of this mortar. This helps to compensate for the higher cost of the mortar.
- Steel reinforcement bars in the wall: the masons were instructed to add two steel bars between every four courses of blocks and vertically every three blocks. The horizontal steel bars are tied into the vertical columns and the vertical bars are tied into the ring beam.

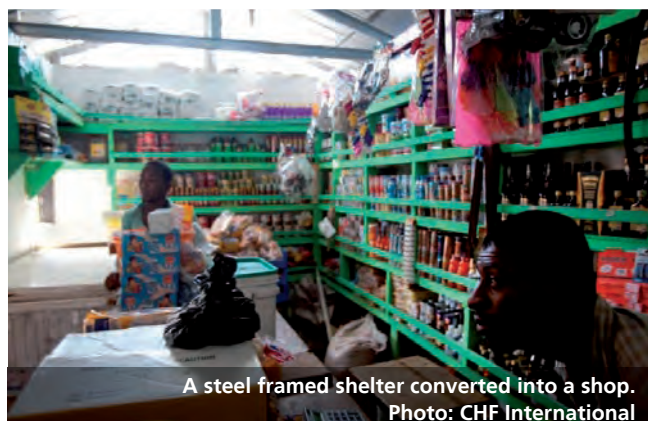
A steel framed shelter converted into a shop.
Photo: CHF International

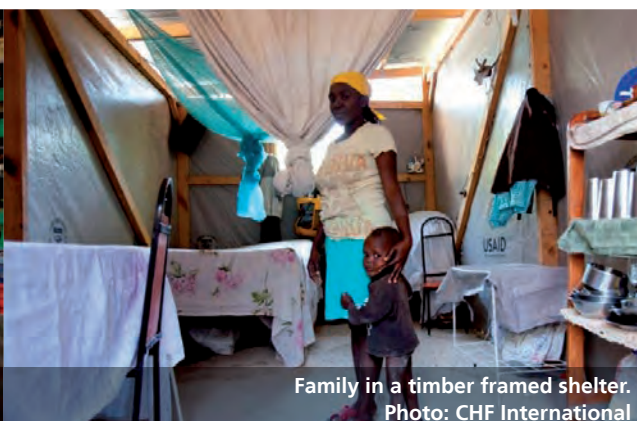
Family in a timber framed shelter.
Photo: CHF International

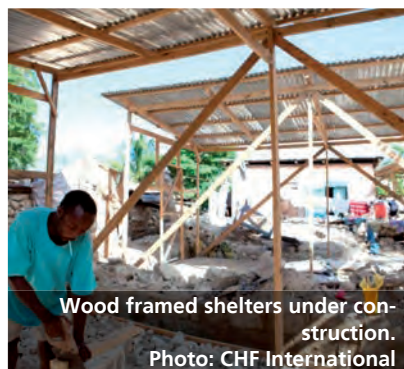
Wood framed shelters under construction. Photo: CHF International

Local teams were responsible for managing and tracking shelter components from the assembly facilities. In many cases, steel frame shelter components were transported to individual building sites by groups of labourers.

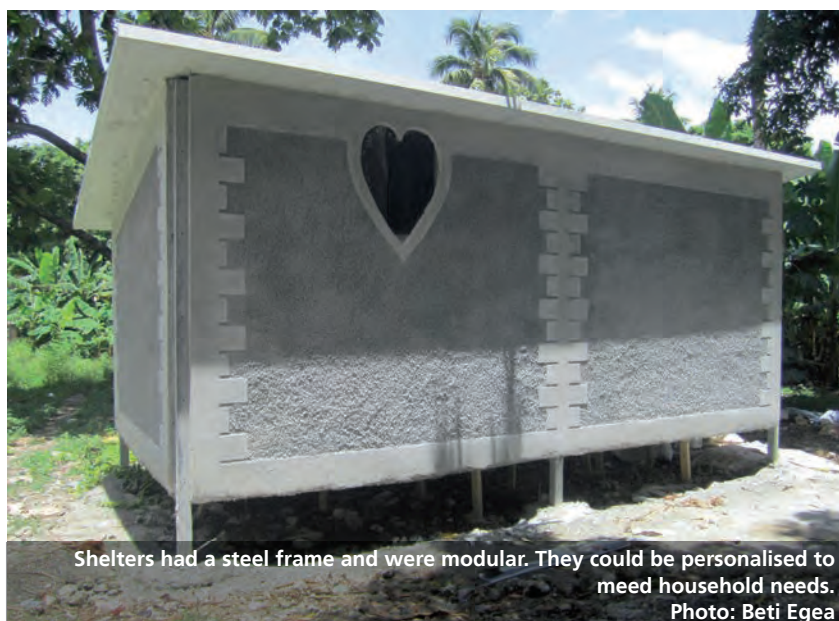
Shelters had a steel frame and were modular. They could be personalised to meet household needs.
Photo: Beti Egea

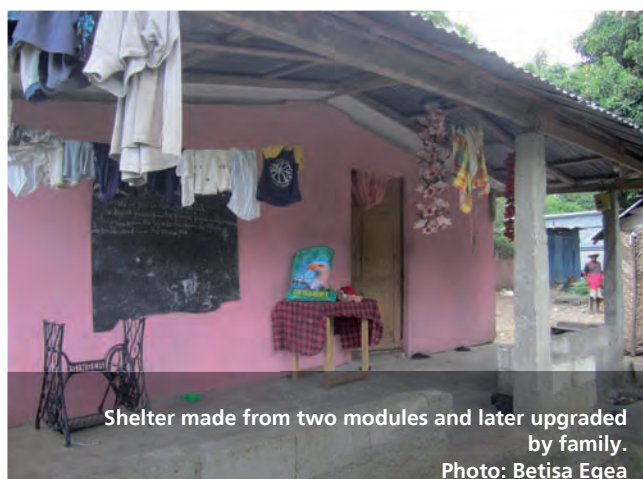
Shelter made from two modules and later upgraded by family.
Photo: Betisa Egea

The shelter had a galvanised steel frame with a mono-pitch roof and a raised floor. The shelter was 3 x 6m on plan and had 6 columns spaced on a 3m grid, fixed to rectangular reinforced concrete foundations using a base plate and four ordinary bolts per base. The shelter could be demounted and foundation bolts cut to reuse the frame.

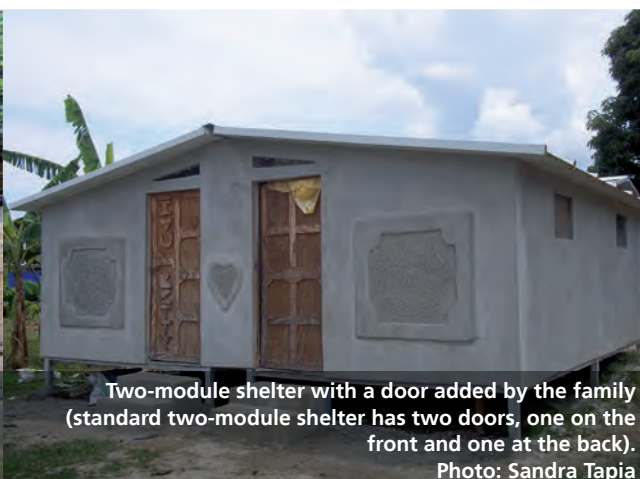
Two-module shelter with a door added by the family (standard two-module shelter has two doors, one on the front and one at the back).
Photo: Sandra Tapia

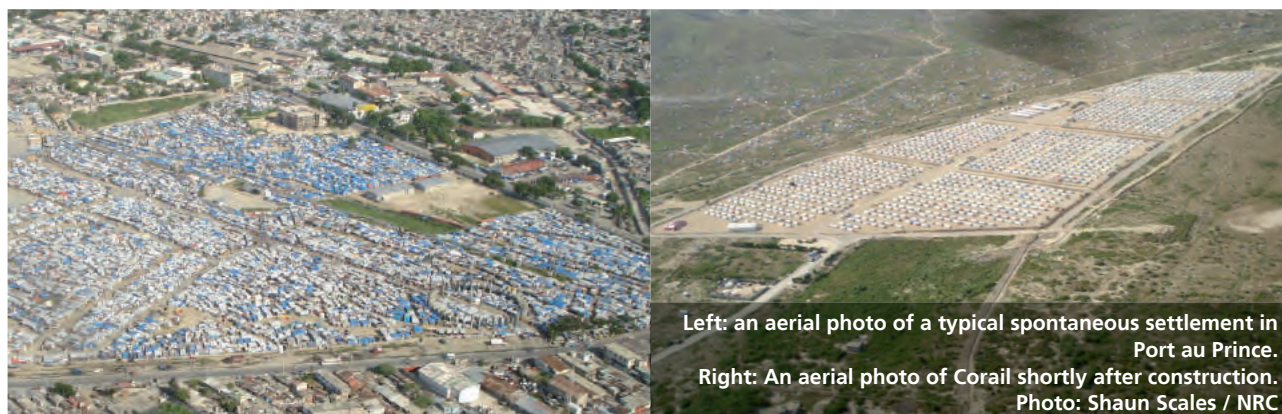
Left: an aerial photo of a typical spontaneous settlement in Port au Prince.
Right: An aerial photo of Corail shortly after construction.
Photo: Shaun Scales / NRC

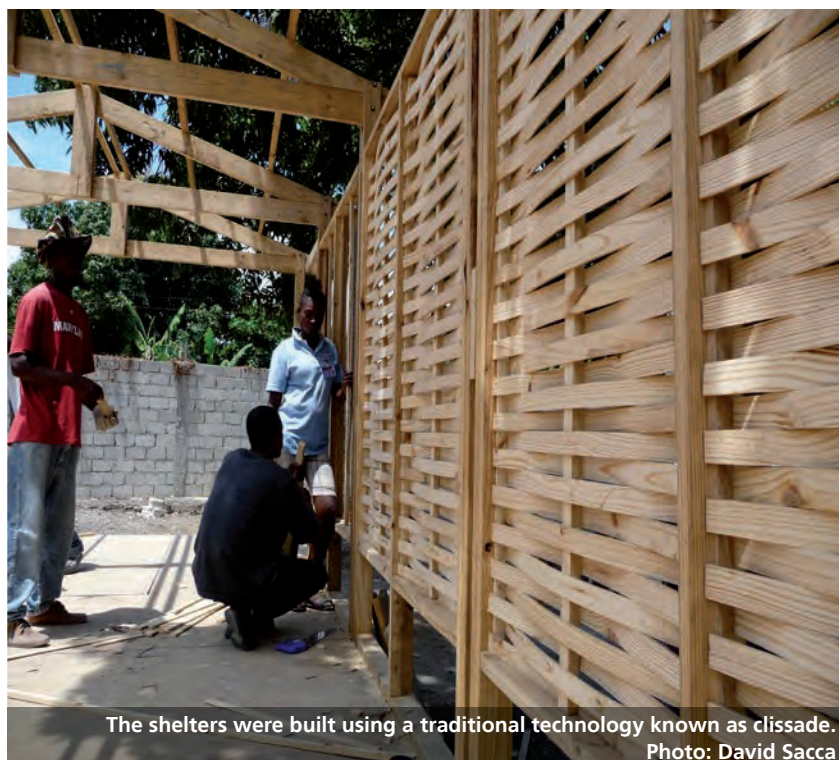
The shelters were built using a traditional technology known as *clissade*.
Photo: David Sacca

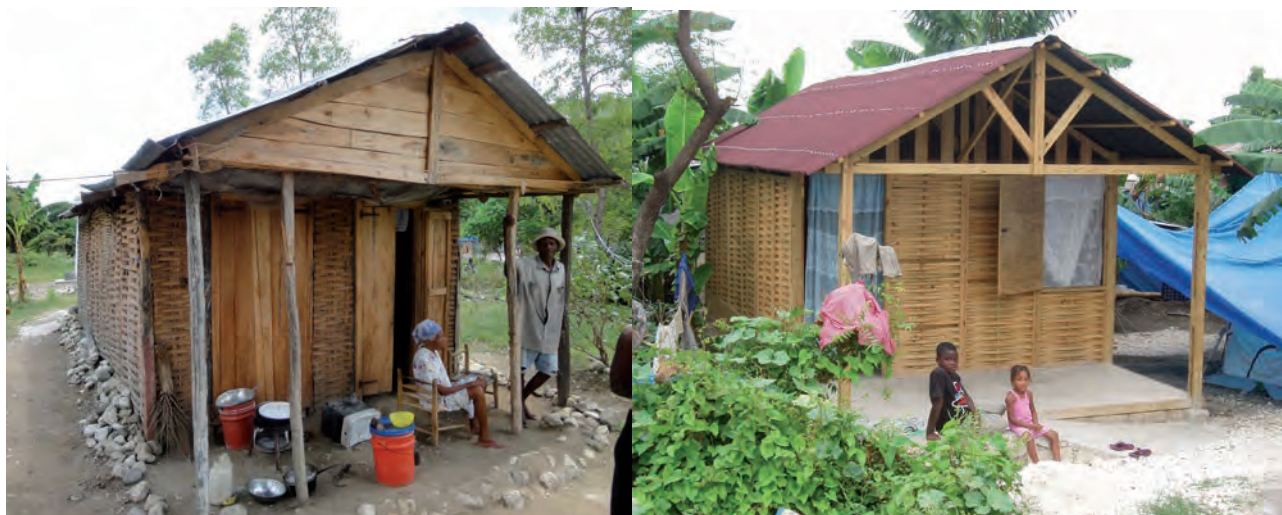
A traditional shelter that survived the earthquake.
Photo: Joseph Ashmore

In general, the *clissade* houses resisted the earthquake much better than the concrete houses. Where they were damaged in the earthquake, the injuries to the occupants were not as severe as those caused by collapsing concrete houses.

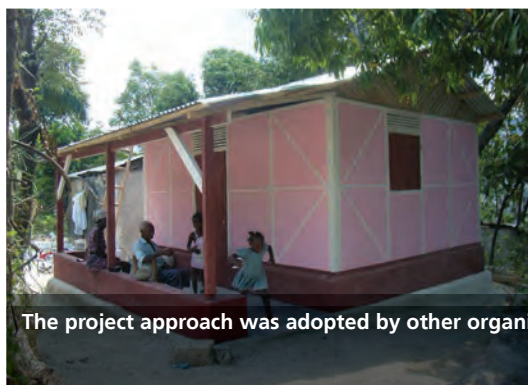
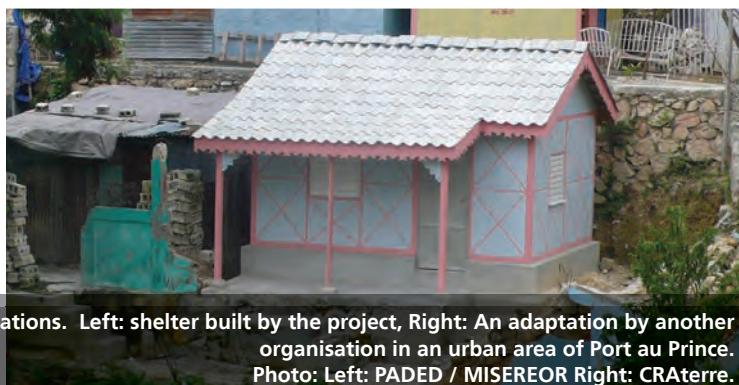
The project approach was adopted by other organisations. Left: shelter built by the project, Right: An adaptation by another organisation in an urban area of Port au Prince. Photo: Left: PADED / MISEREOR Right: CRAterre.

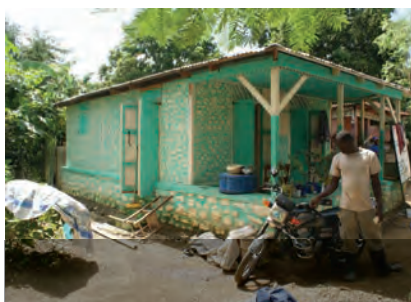
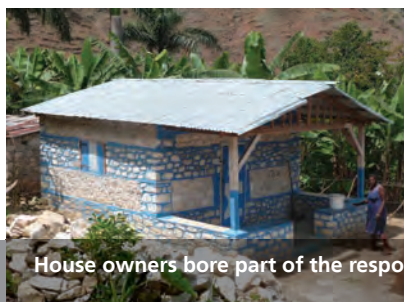
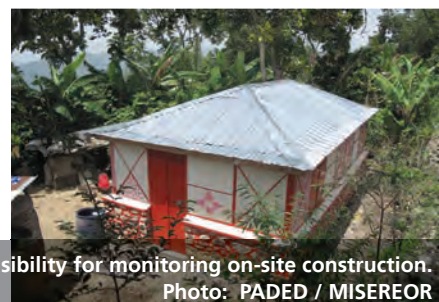
House owners bore part of the responsibility for monitoring on-site construction. Photo: PADED / MISEREOR

During the house repairs, the inhabitants were given a guided tour of a damaged house to point out defects and reasons for failure. With this new knowledge, people were able to take on part of the responsibility for the quality of construction and repairs to their own houses.

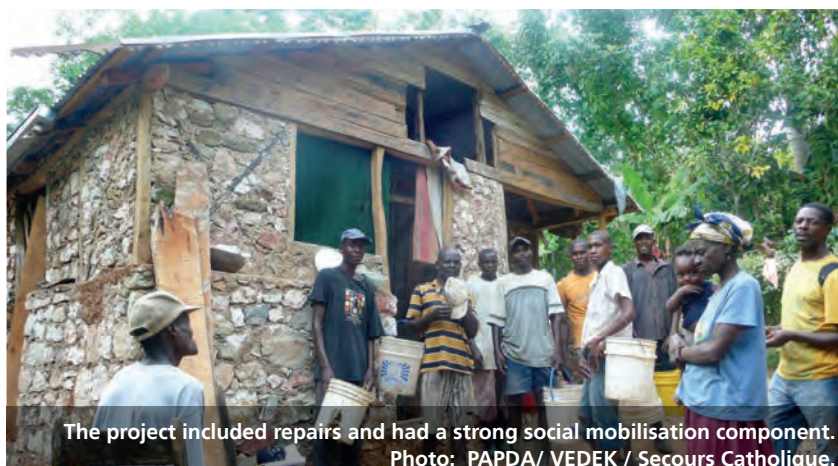
The project included repairs and had a strong social mobilisation component. Photo: PAPDA/ VEDEK / Secours Catholique.

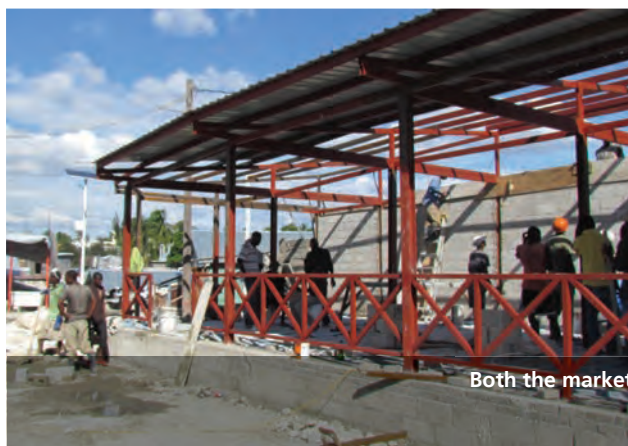
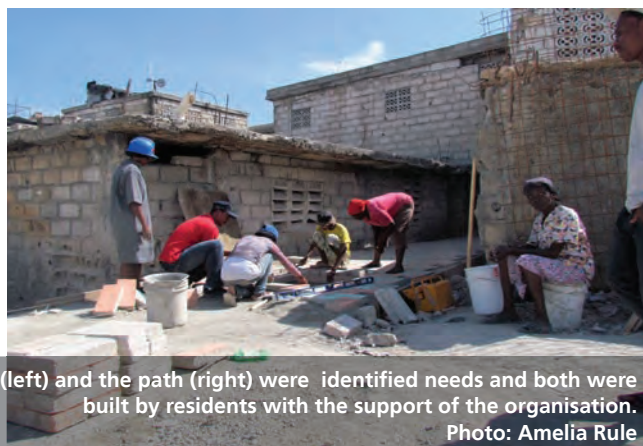
Both the market (left) and the path (right) were identified needs and both were built by residents with the support of the organisation.

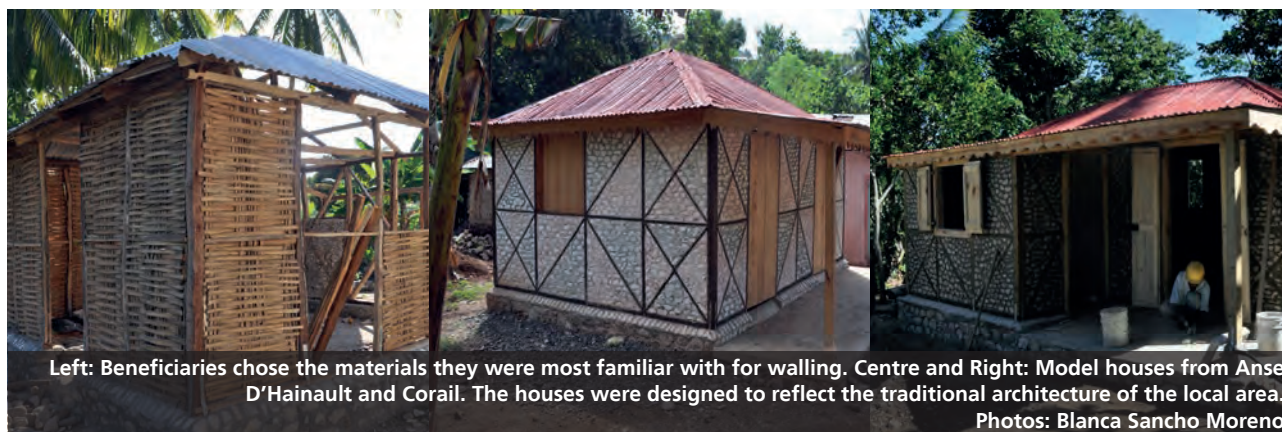
Left: Beneficiaries chose the materials they were most familiar with for walling. Centre and Right: Model houses from Anse D'Hainault and Corail. The houses were designed to reflect the traditional architecture of the local area.
