SHELTER PROJECTS

SITE PLANNING: 16 Case Studies

CASE STUDIES OF HUMANITARIAN SHELTER AND SETTLEMENT RESPONSES WITH A SITE PLANNING COMPONENT

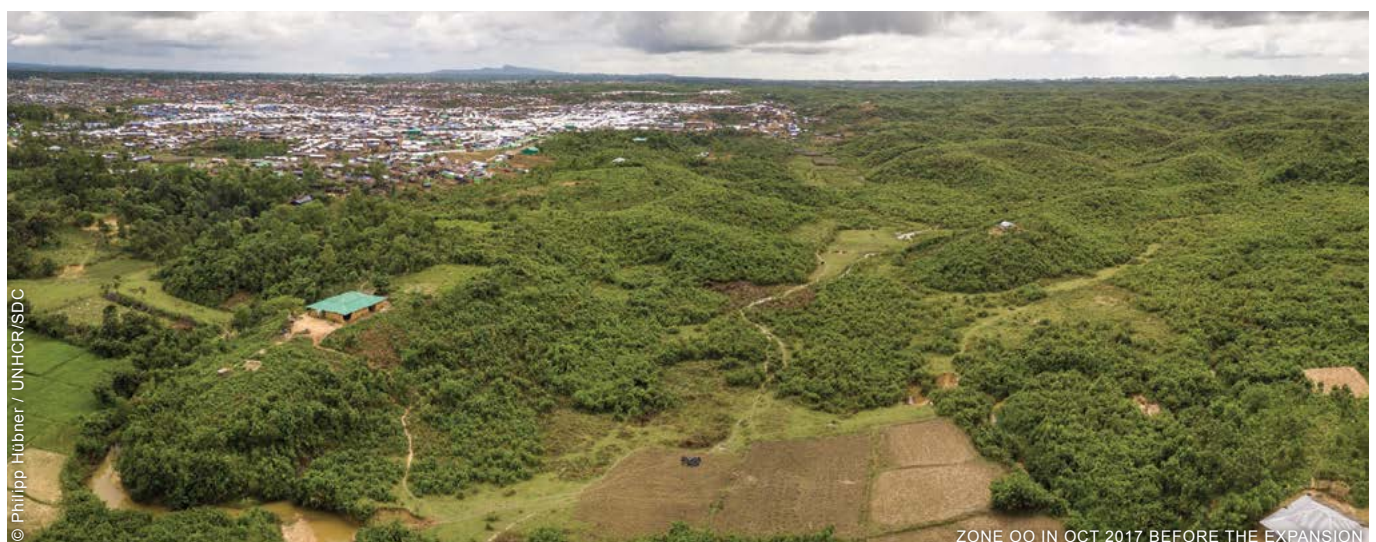
ZONE OO IN OCT 2017 BEFORE THE EXPANSION

Prior to the establishment of the transit centre, refugees self-settled on improvised plots using whatever material they could find, as agencies did not have time to plan in advance of people settling.

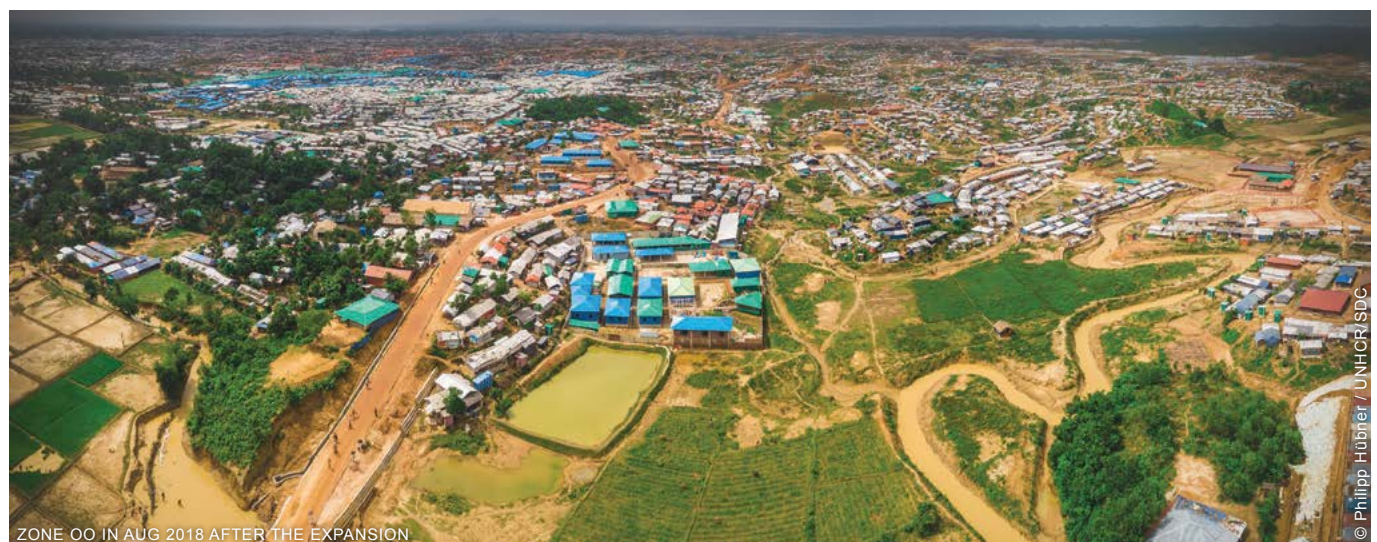
ZONE OO IN AUG 2018 AFTER THE EXPANSION

Access to the site was challenging and agencies fenced the west side of the zone to prevent uncontrolled expansion towards the natural reserve area.

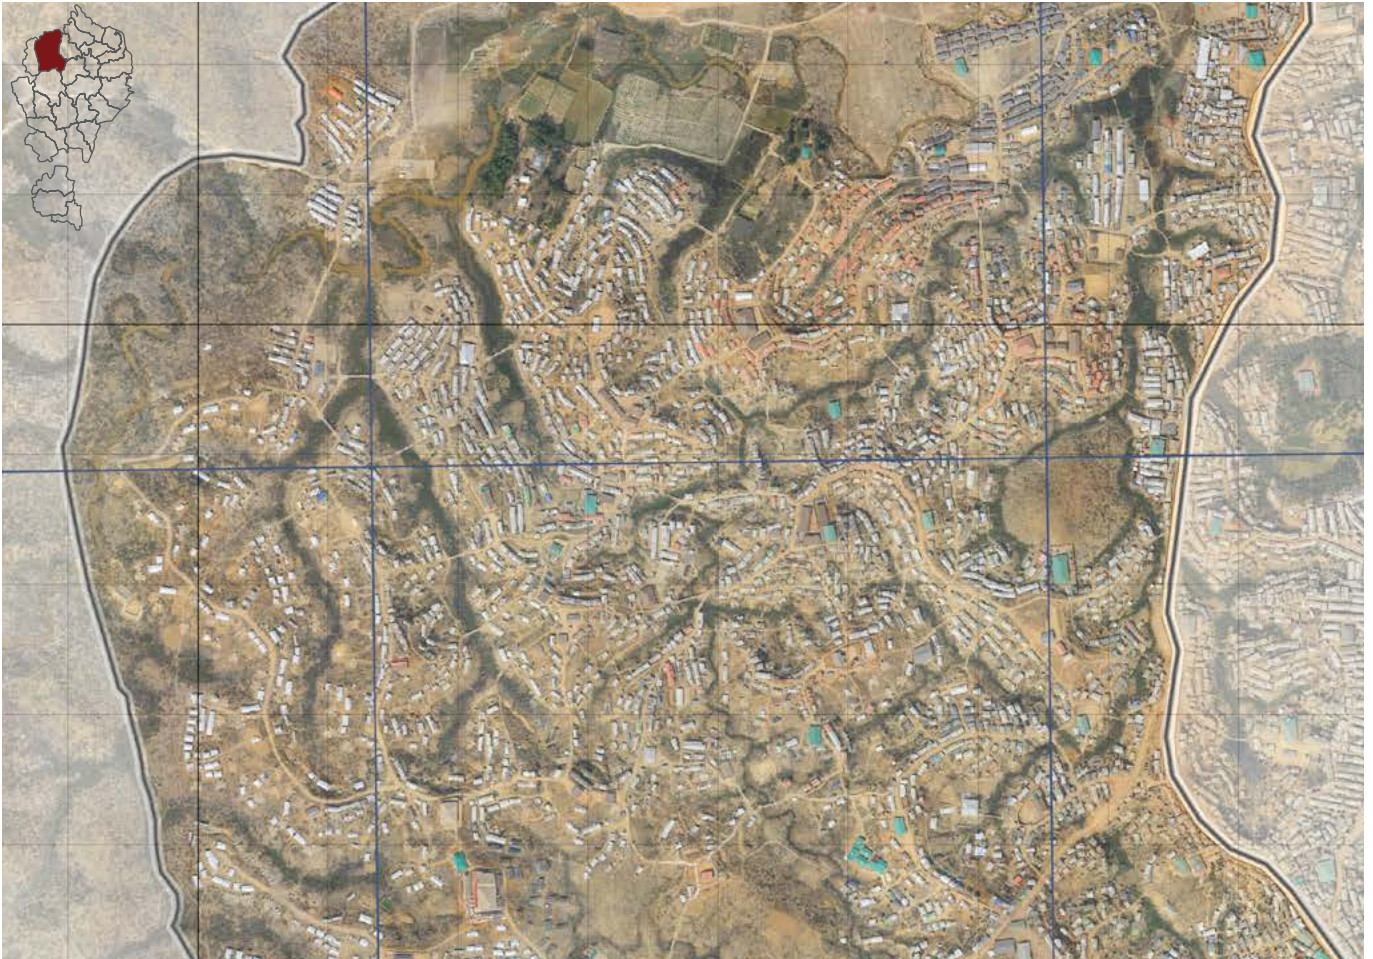
Drone image of zone OO after refugees settled, in February 2018. Densities were lower here than in other parts of the site, and services were relatively well distributed. However, this also meant that assistance was not evenly spread throughout the site, as other areas remained very dense and lacked services (Source: NPM, 14 Feb 2018).

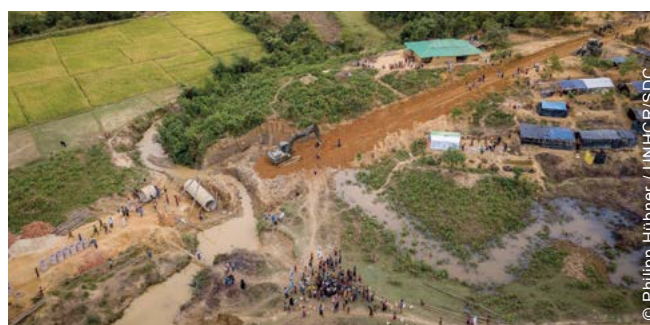
Major infrastructure (such as the Army road and culverts) was needed to convert a forest land into a liveable settlement.

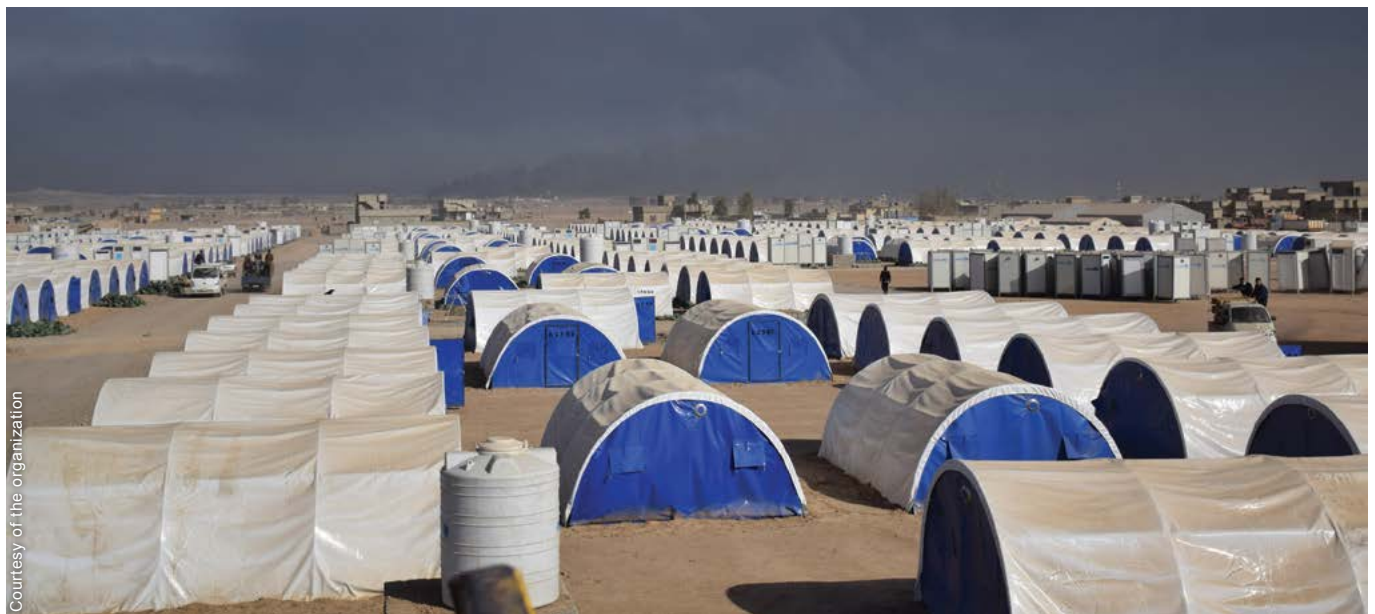
Government standard tents of 6x4m were installed in clustered blocks of 20 each. Space for extensions was minimal but, after families had moved in, upgrades were conducted to the floor and electricity was installed. Partners could then build service facilities in specific blocks pre-allocated in the site plan.

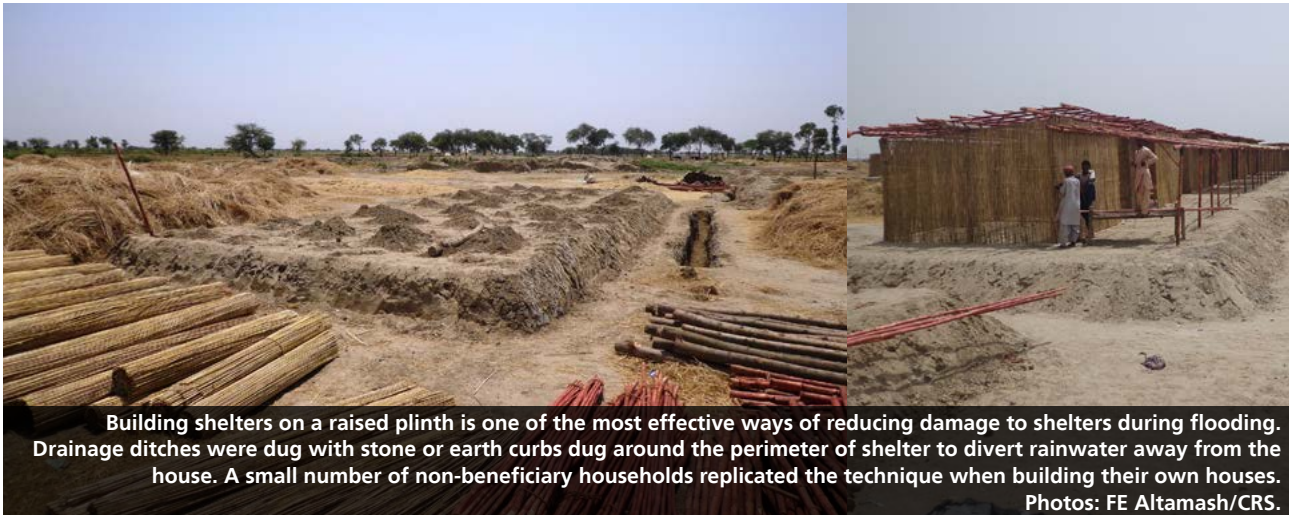
Building shelters on a raised plinth is one of the most effective ways of reducing damage to shelters during flooding. Drainage ditches were dug with stone or earth curbs dug around the perimeter of shelter to divert rainwater away from the house. A small number of non-beneficiary households replicated the technique when building their own houses. Photos: FE Altamash/CRS.

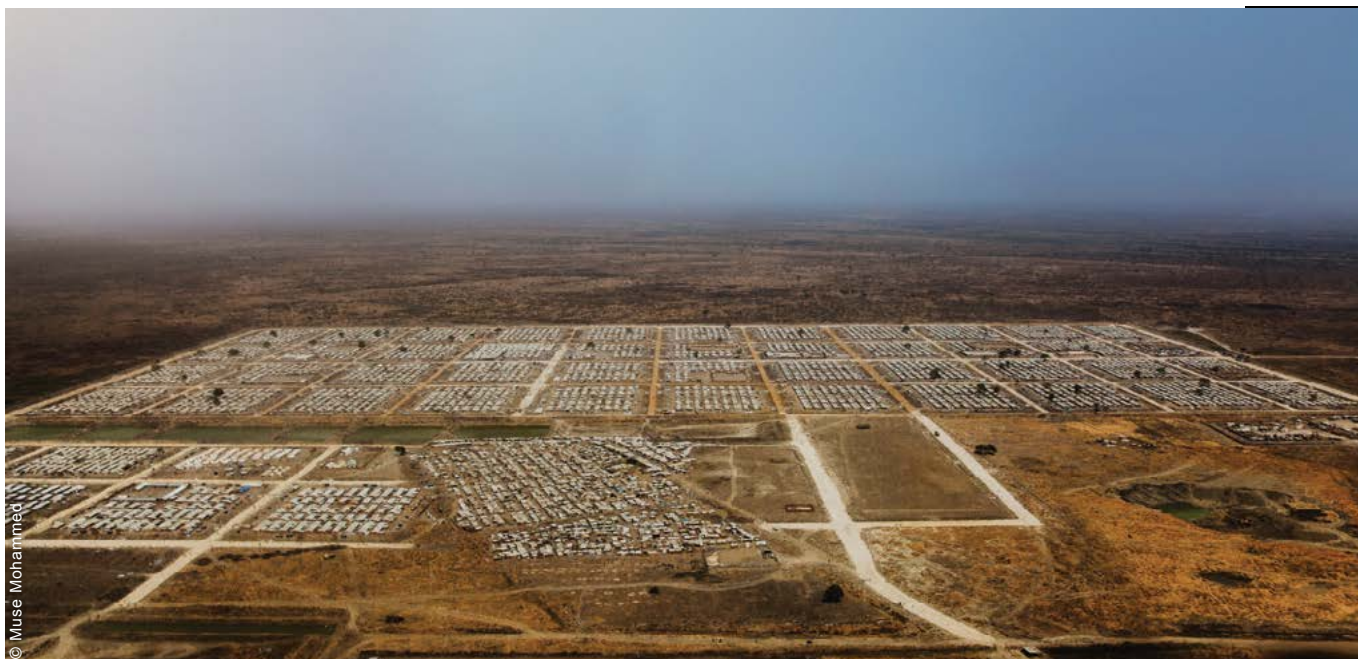
The expansion plan included land that was already spontaneously occupied by camp residents. Careful phasing of major upgrading works was required, as the whole site needed to be upgraded.

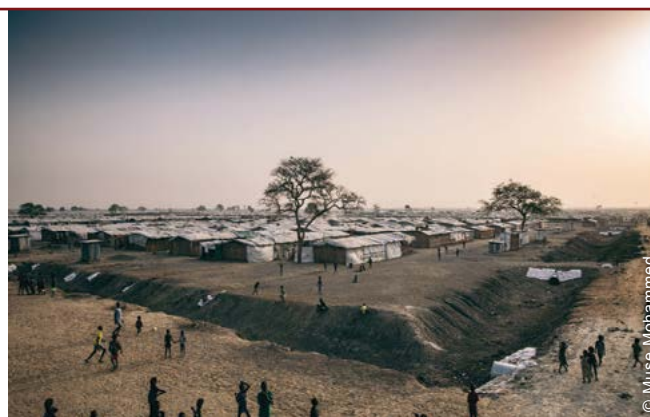
The site works were based on a Dutch “polder” system. They included 28m² section drainage ditches, berms, water retention basins, and large volume pumps to evacuate water.

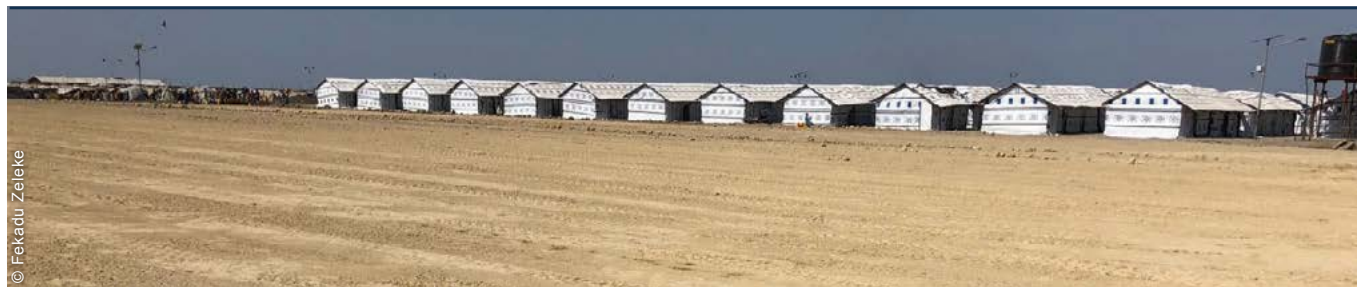
Priority activities in the rehabilitation included backfilling, ground levelling, reconstruction of drainage and rehabilitation of secondary roads, as well as reorganization of the space to improve access to services.

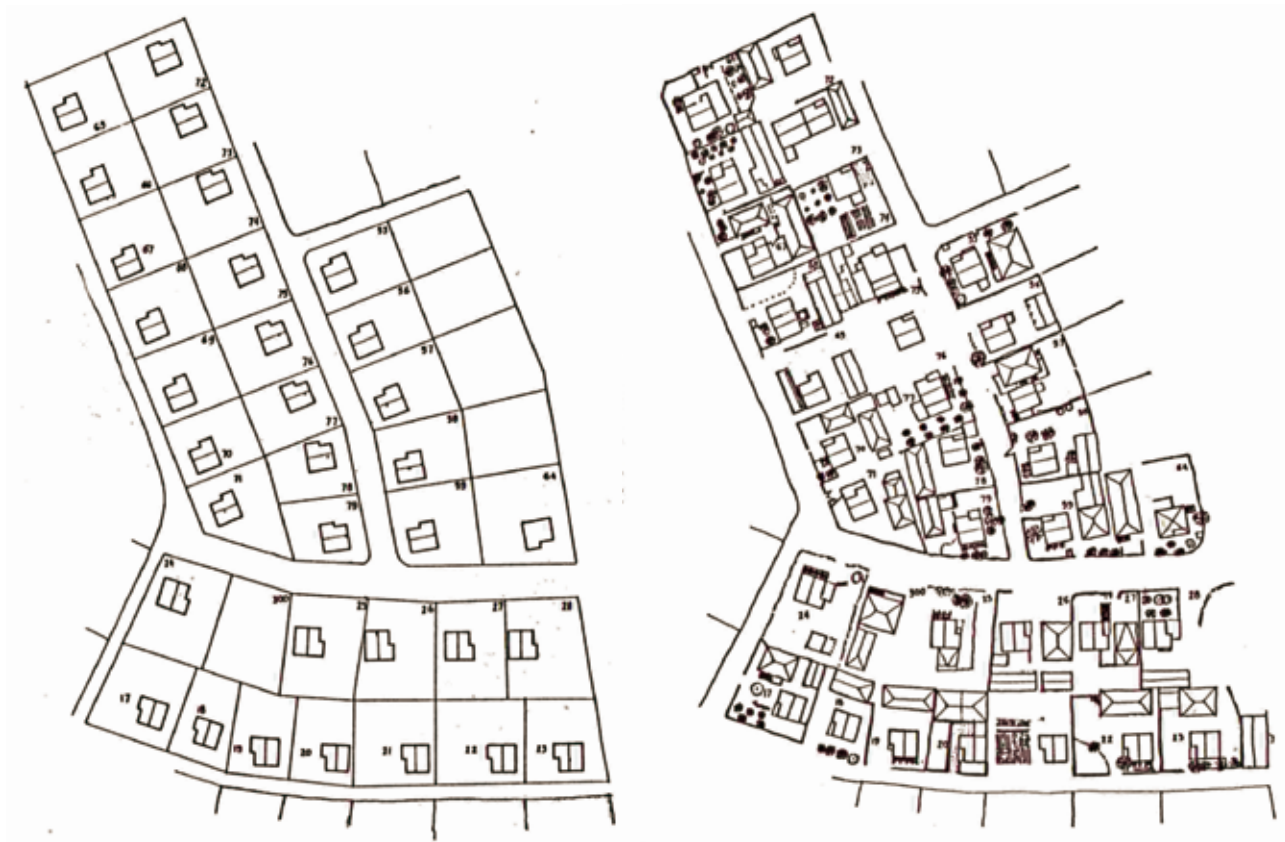
Maps of a neighbourhood of the resettlement village of new Muhipler drawn 13 years apart. Left 1971, Right 1984
 Illustration: Housing and Culture after Earthquakes / Yasemin Aysan / Paul Oliver / Ian Davis

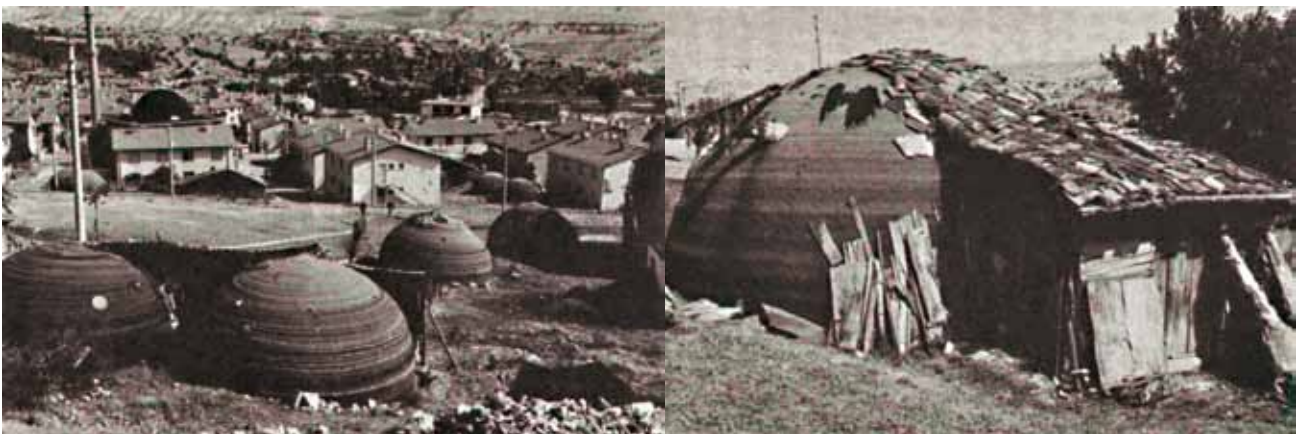
Polyurethane 'igloos' were deployed. An experiment that was discontinued after the 1975 Lice earthquake
 Photos: Housing and Culture after Earthquakes / Yasemin Aysan / Paul Oliver
