SHELTER IN URBAN CONTEXTS: 12 Relevant Case Studies

CASE STUDIES OF HUMANITARIAN SHELTER AND SETTLEMENT RESPONSES IN URBAN SETTINGS

U.I / B.2 Azerbaijan - 1992 - Conflict - People displaced

Case study: Upgrade of collective centres

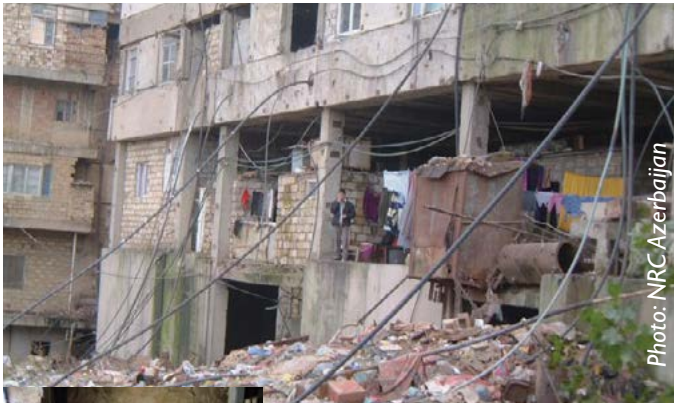
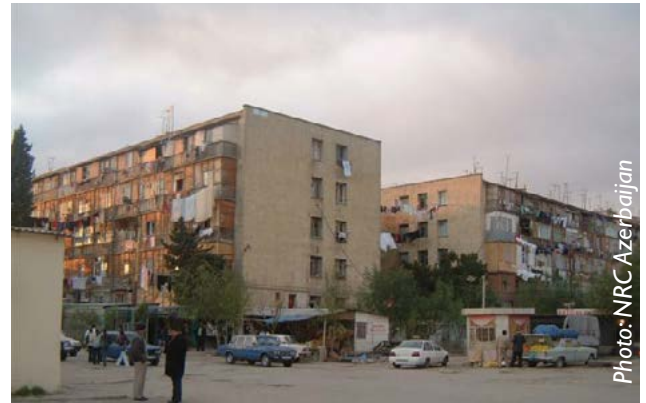
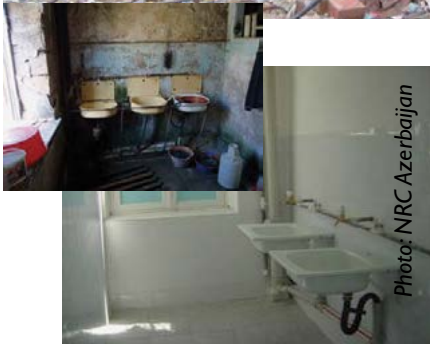
Bathrooms before and after upgrade

Inhabitants saw broken sewerage as the greatest problem in the buildings. Other common problems included shortage of water, leaking roofs and dampness. As a result, plastering, floors and ceilings in toilets and bathrooms were damaged in most buildings.

- rehabilitation of the shared areas - toilets, bathrooms, washing rooms, kitchens and corridors;
- infrastructure repairs - electricity, sewerage, water and sewerage pipes;
- repair of roofs;
- installation of new water heaters, sinks, stoves, faucets, showers, light bulbs, circuit breakers, switchboards, windows and doors;
- installation of electricity transformers (this was not costly but served a large number of IDPs).

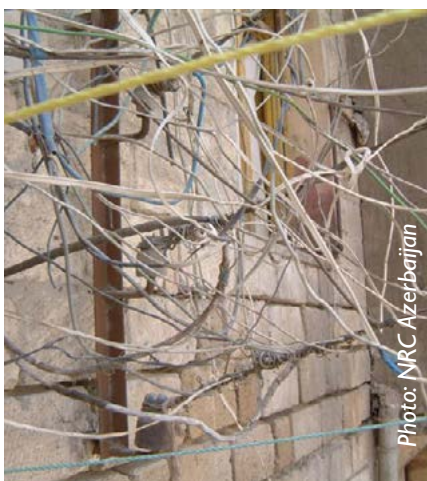
Wiring before upgrade

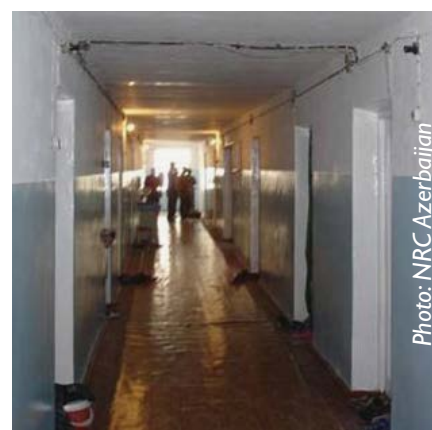
Corridors before and after upgrade

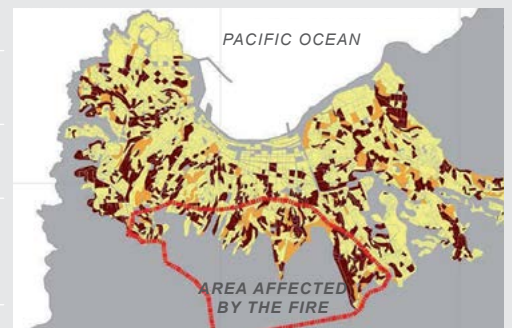
Map highlighting the area affected by the fire and the density of the dwellings, from high (red) to low (yellow). Source: Salinas-Silva 2015.

The fire affected especially the poorest areas, as they were informally constructed without any urban planning, leading to a high density of structures, proximity to the forests, and poor accessibility. During the emergency, fire-trucks could not reach the affected areas, worsening the situation further. The density of construction, mainly due to extended families building large complexes on the same plot of land to live in close proximity, contributed significantly to the fire spreading faster and more devastatingly. **Some neighbourhoods were hence burnt down completely.**

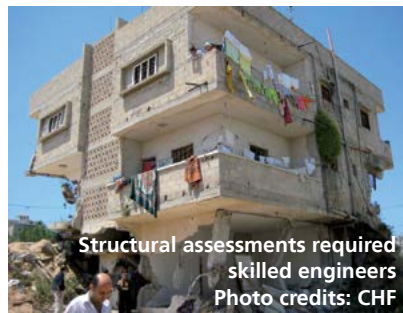
Structural assessments required skilled engineers
Photo credits: CHF

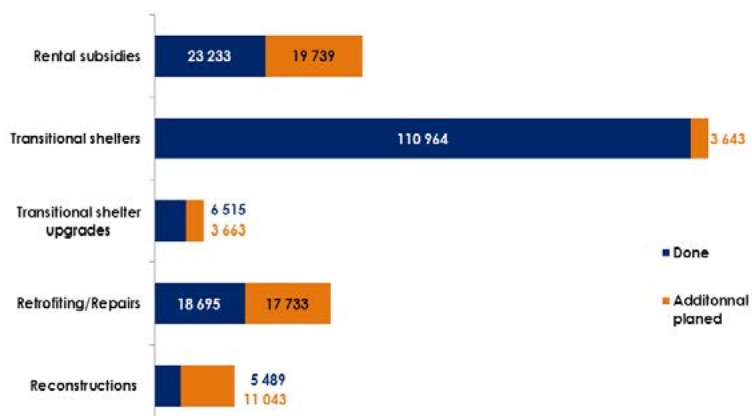
Graph to show completed and planned housing solutions, November 2012
Source : E-Shelter and CCCM Cluster

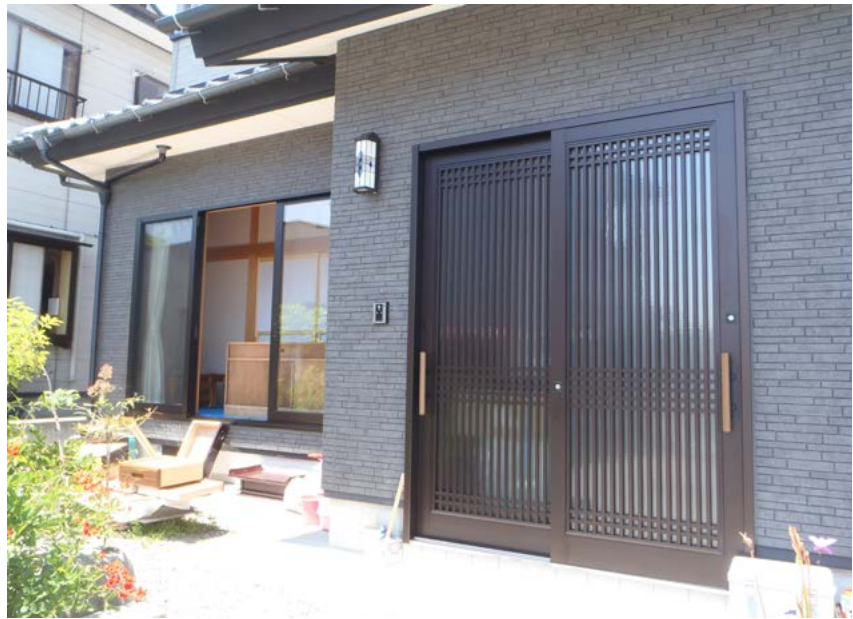
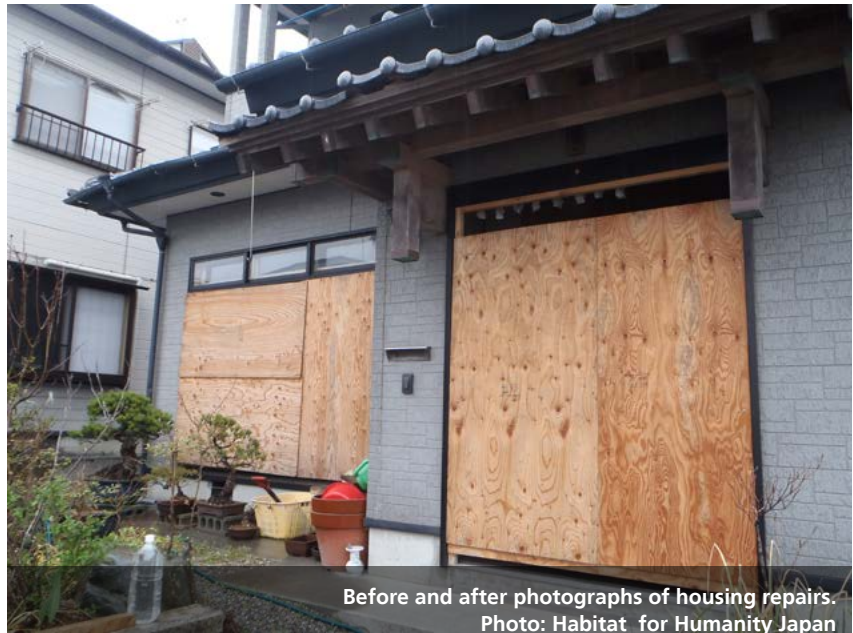
Before and after photographs of housing repairs.
Photo: Habitat for Humanity Japan

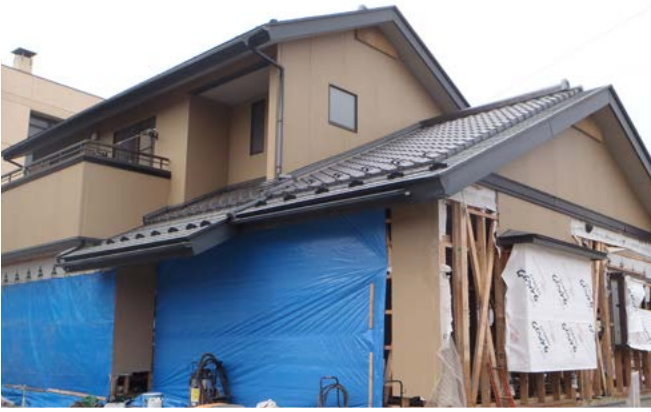
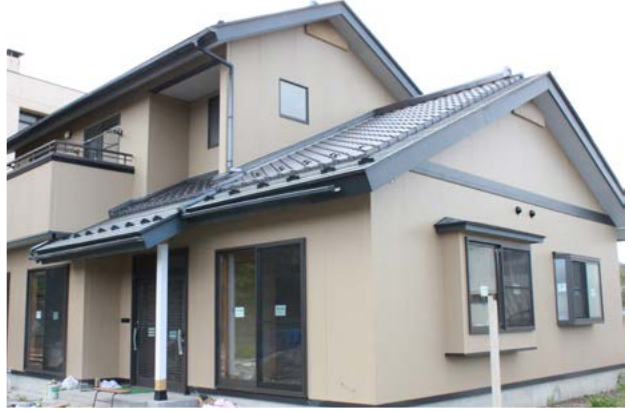
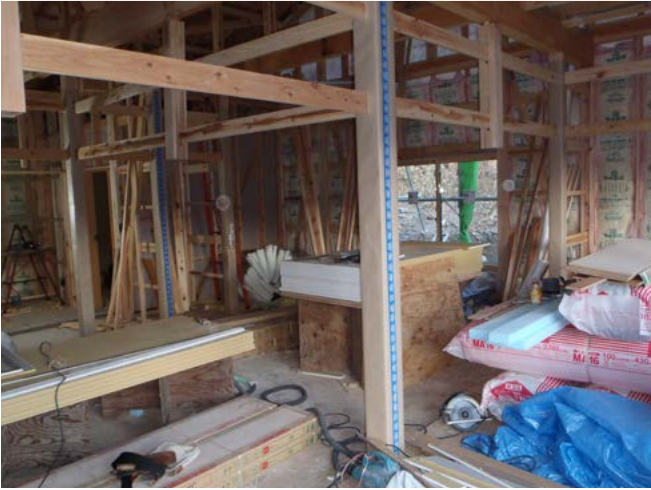
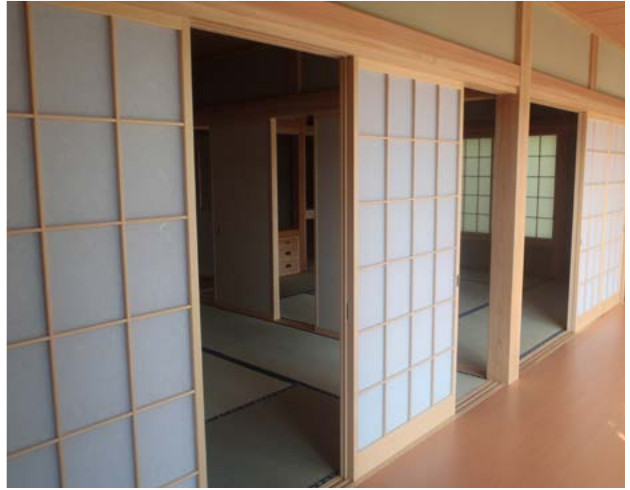
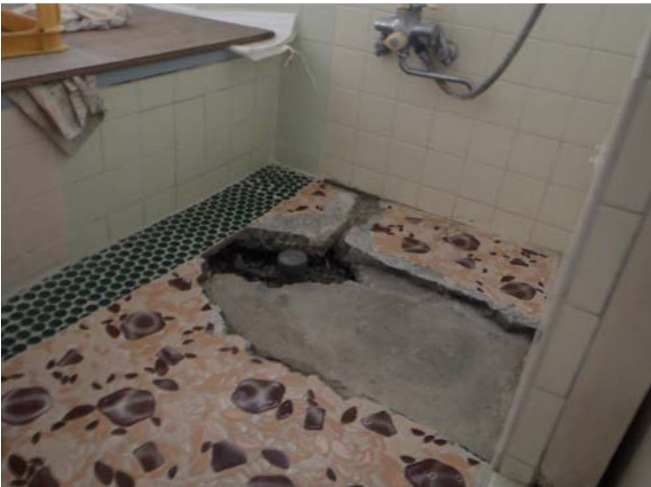
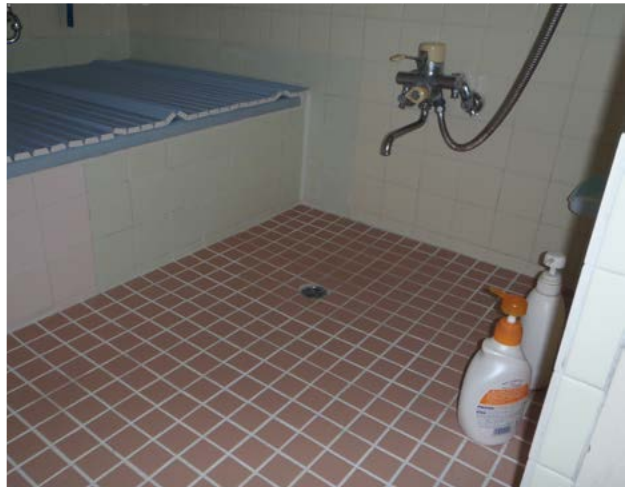
Before and after photographs of housing repairs. Photo: Habitat for Humanity Japan

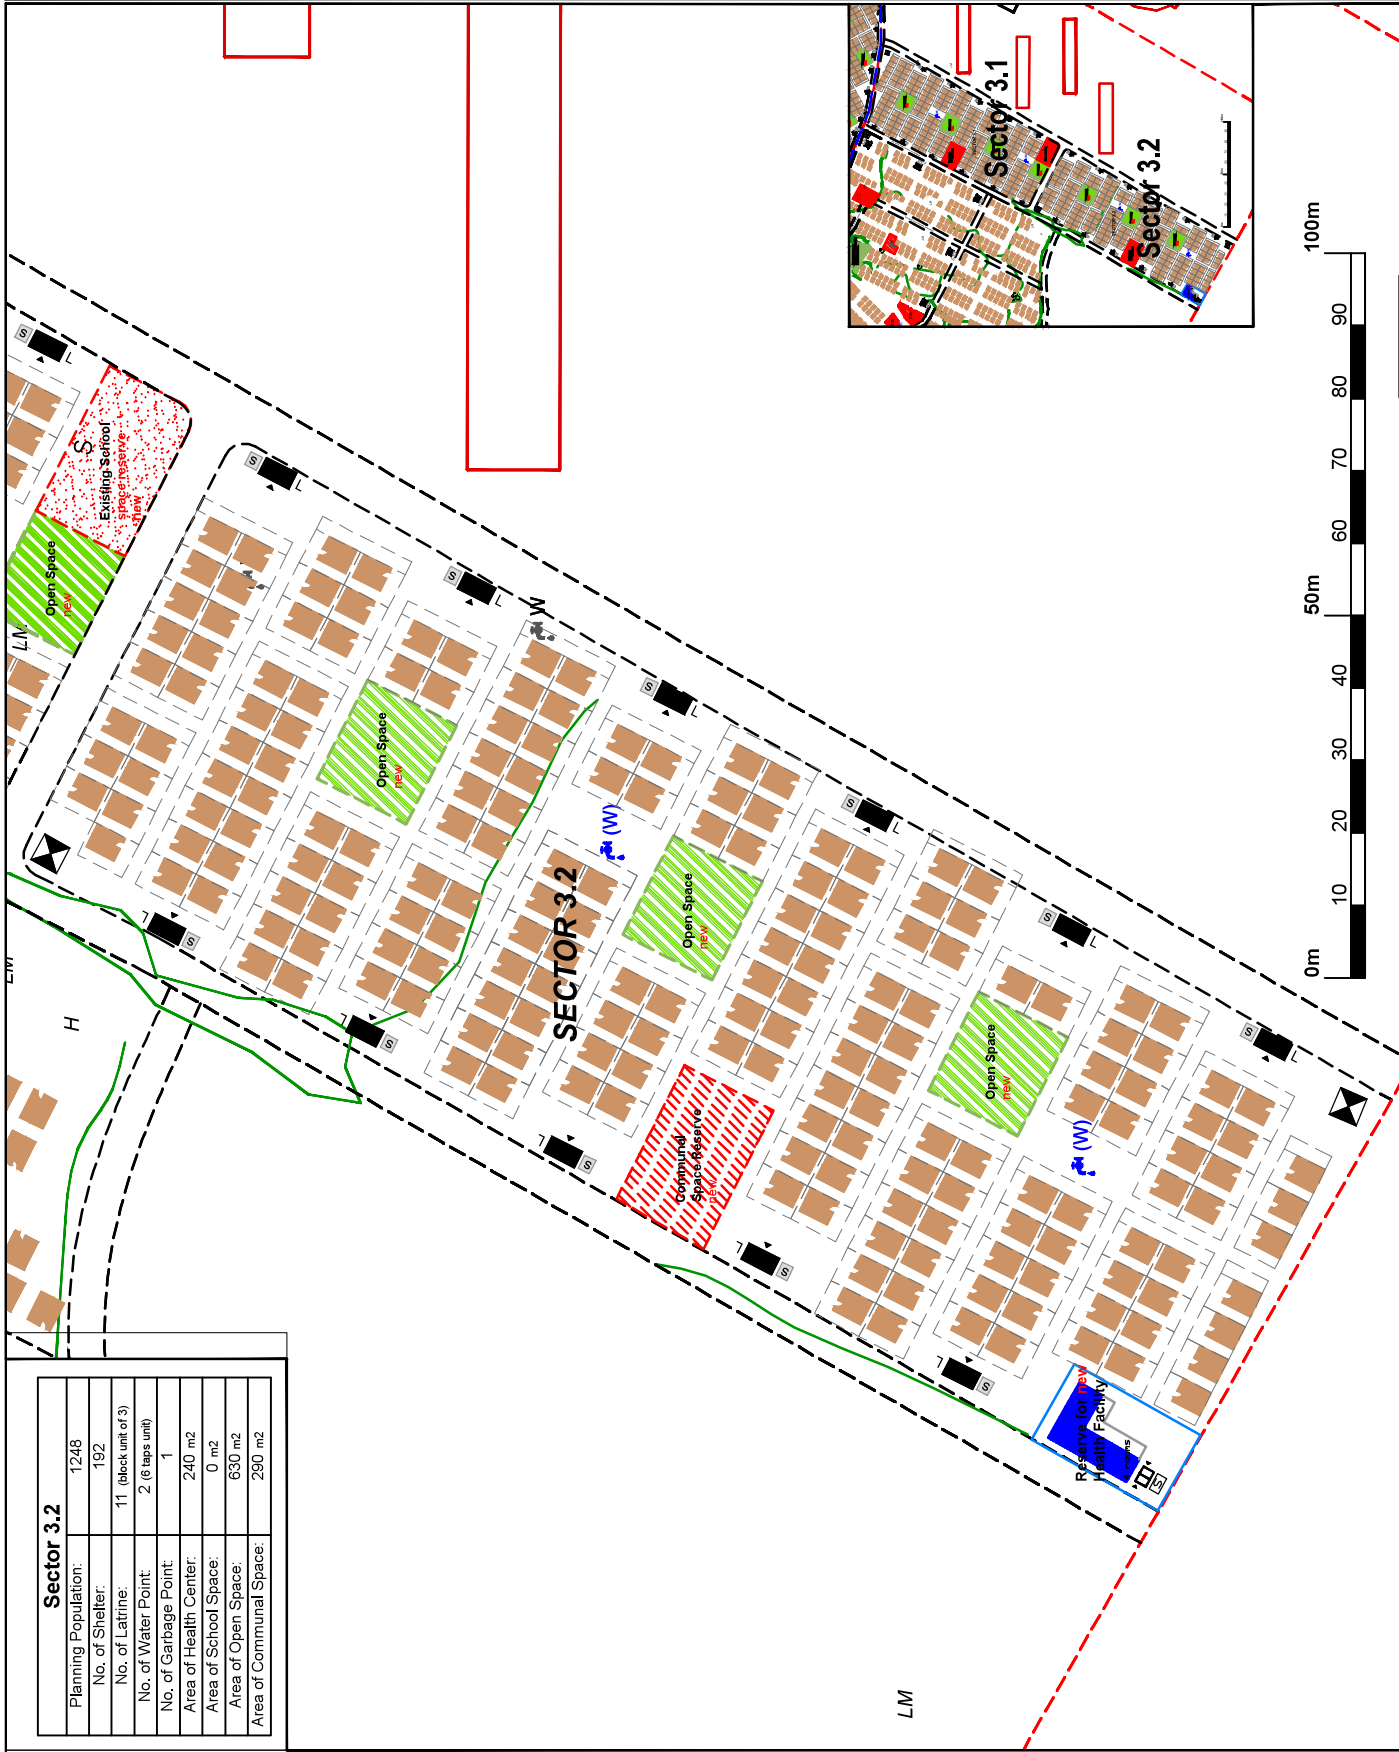
Sector 3.2	
Planning Population:	1248
No. of Shelter:	192
No. of Latrine:	11 (block unit of 3)
No. of Water Point:	2 (6 taps unit)
No. of Garbage Point:	1
Area of Health Center:	240 m ²
Area of School Space:	0 m ²
Area of Open Space:	630 m ²
Area of Communal Space:	290 m ²
