C.I Honduras - 1998 - Hurricane Mitch

Case study: Transitional shelter

Transitional shelter construction

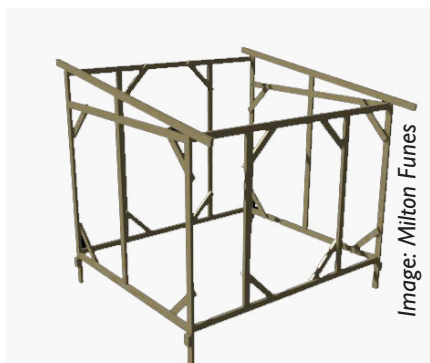
Computer model of the timber frame of the shelter

The shelter model adopted was a timber-framed structure.

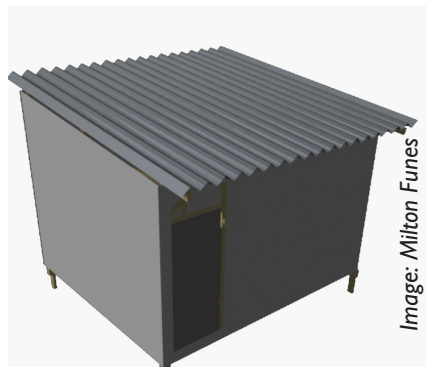
Computer model of the shelter with a corrugated iron roof and plastic sheeting walls

The programme provided materials and technical assistance for construction of a 3.05m x 3.65m wood-framed shelter in central and southern Honduras for victims of Hurricane Mitch. The roof was made of galvanized roof sheets that were reused when the families rebuilt their houses with more durable materials. The sides were made of reinforced good quality woven plastic sheeting. The shelter included a door and two windows with nets to provide both privacy and ventilation.

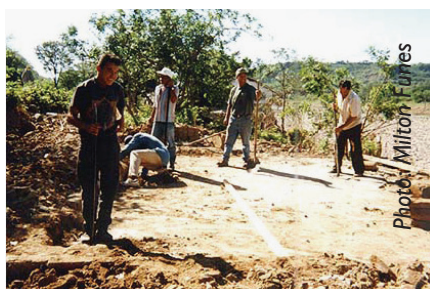
Marking out the site for a shelter

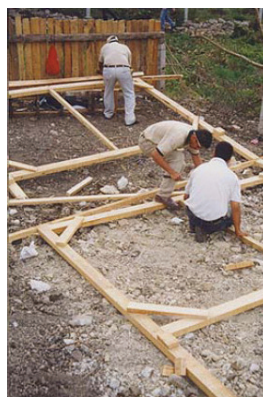
Prefabricating walls

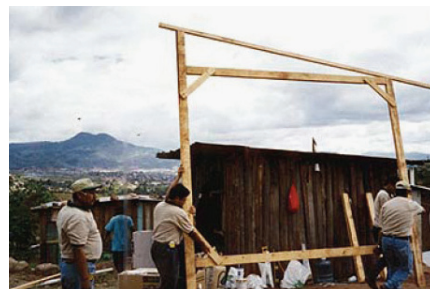
Shelter assembly using prefabricated walls

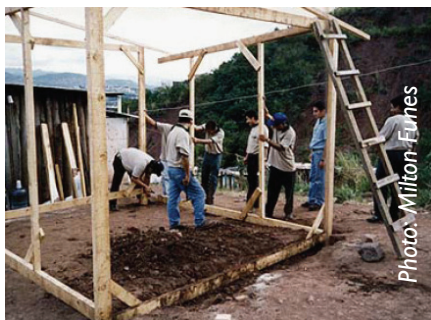
Completing the frame

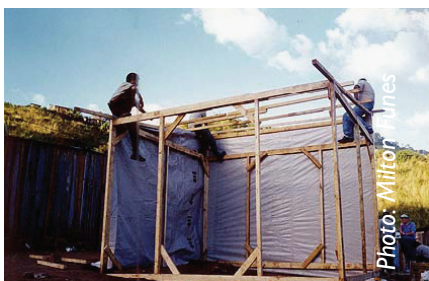
Covering the frame
