SHELTER PROJECTS 2009

Shelter Projects 2009

Published 2010

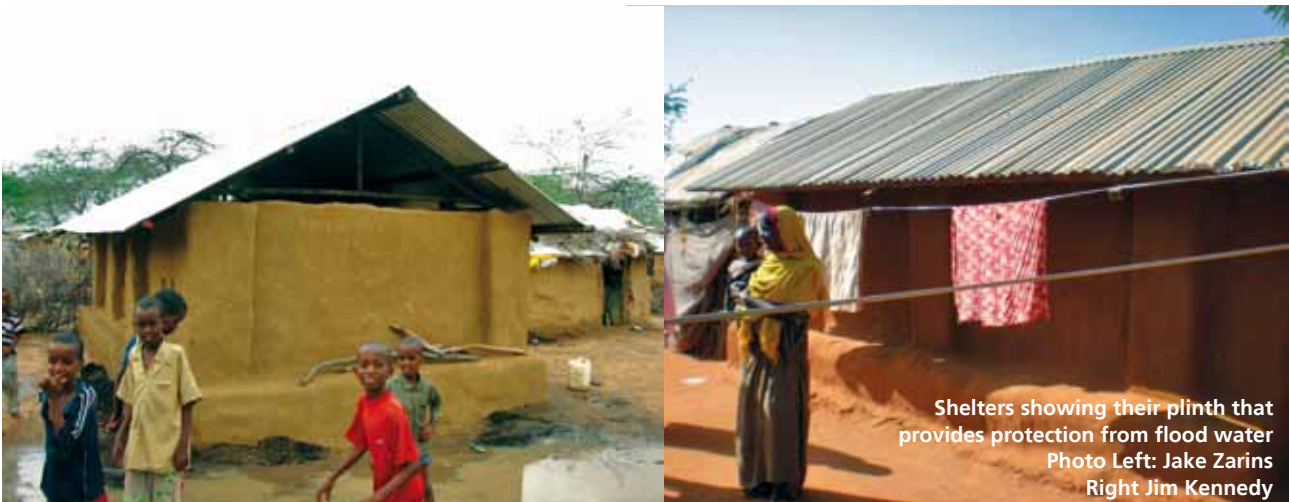
Shelters showing their plinth that provides protection from flood water
 Photo Left: Jake Zarins
 Right Jim Kennedy

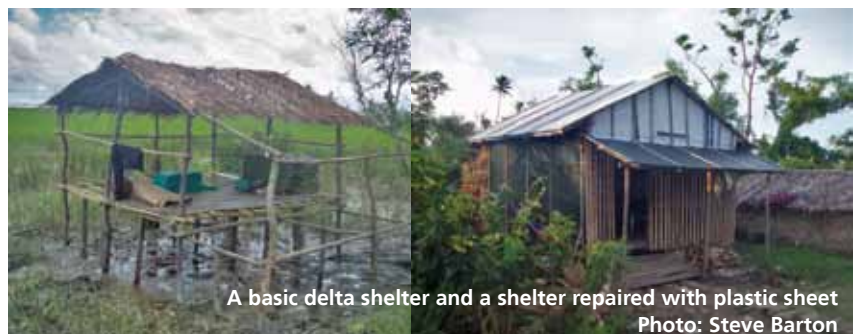
A basic delta shelter and a shelter repaired with plastic sheet
Photo: Steve Barton

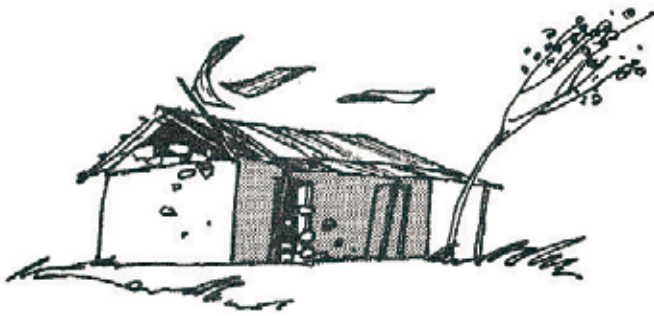
Risk of roof damage

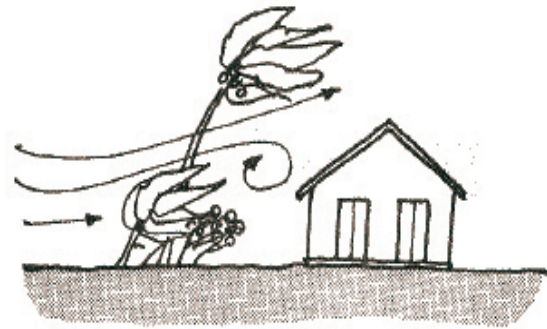
Trees can help protect houses from wind damage

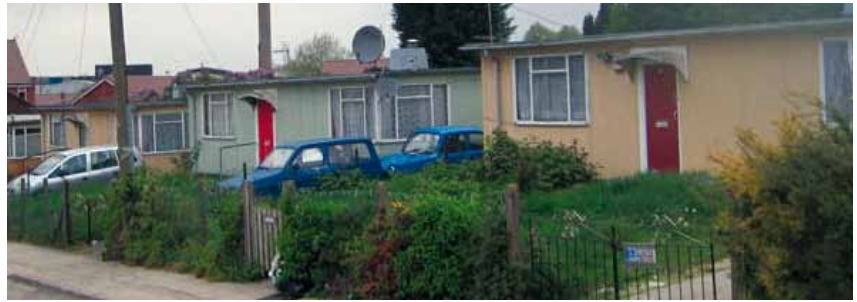
The first prototype developed in secrecy was a prefabricated single-storey house with two layer steel walls. There was an aluminium foil lining between interior and exterior walls. The houses were built on a concrete slab and had fitted steel furniture.

In cold weather, the steel prototype suffered severely from condensation. Boiling a kettle would cause condensation to run down the walls. In low temperatures, the condensation would freeze inside the walls. It also caused mould to form on items stored inside the kitchen furniture.

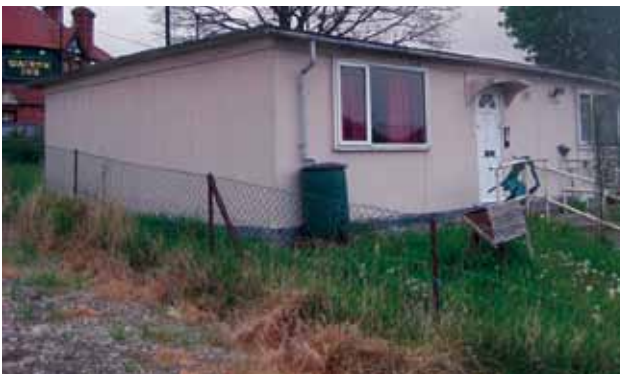
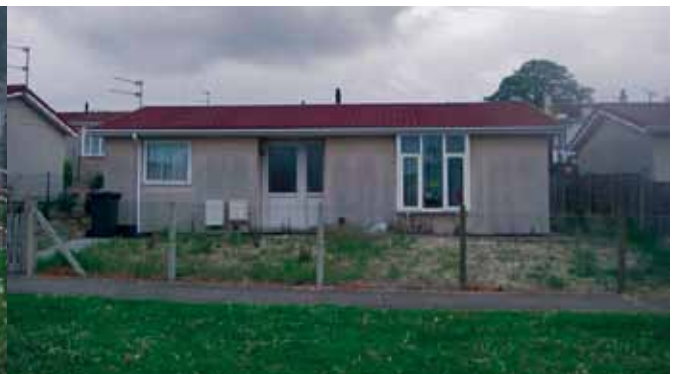
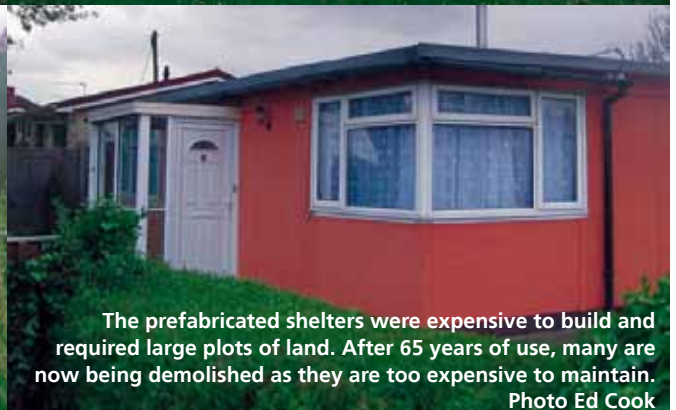
The prefabricated shelters were expensive to build and required large plots of land. After 65 years of use, many are now being demolished as they are too expensive to maintain.
Photo Ed Cook
