C.13 Nicaragua - 1972 - Earthquake

Planned camp

7.5 magnitude earthquake
Managua, Nicaragua

Shelters in community-
grouped camp in Coyotepe,
Masaya

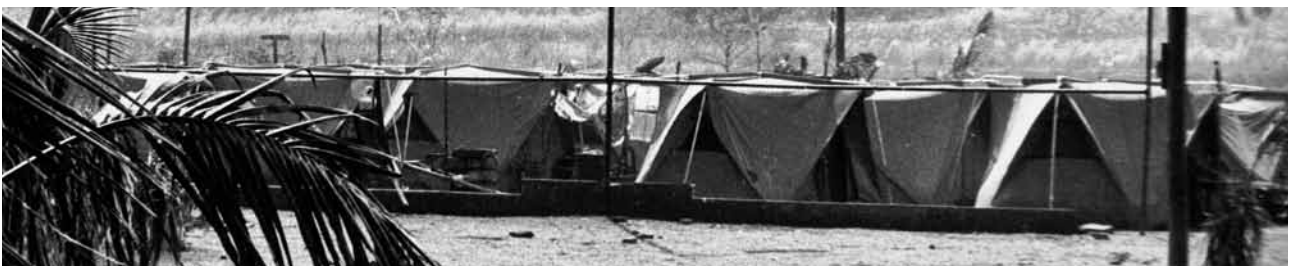
Planned camp for earthquake affectees
Photo: Ian Davis

The camp was laid out using square 'clusters' of 16 shelters, with a central space for administrative buildings and social or recreation areas. The clusters were placed so that the camp could be expanded after the initial construction phase. This would allow the camp to have capacity for up to 3,500 people (700 shelters). The layout was designed to accommodate either community or individual cooking and washing facilities. The latrines were placed outside of all of the shelter clusters along the side of the camp.
