C.21 Turkey, Gediz - 1970 - Earthquake

Case study credit:
UNDRO 1982

7.2 magnitude earthquake
Gediz Turkey

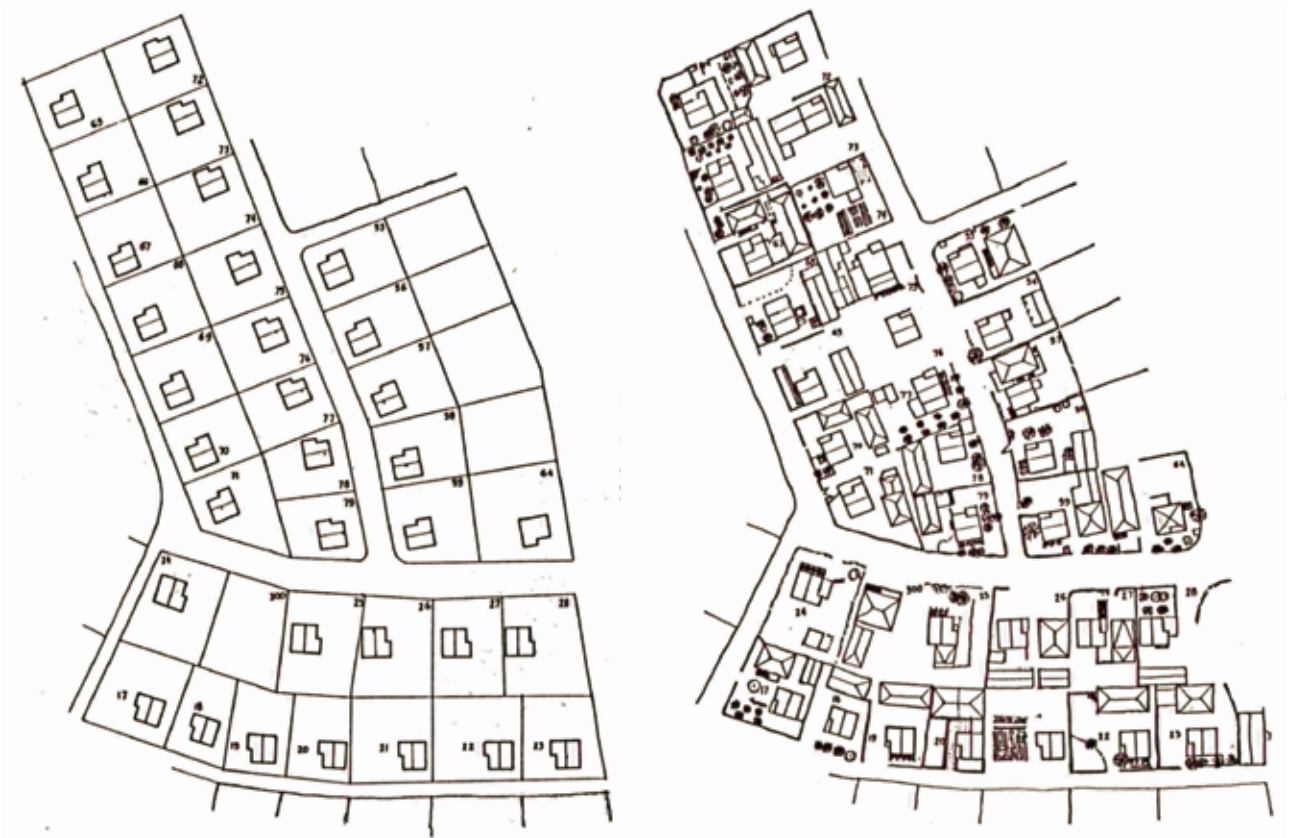
Maps of a neighbourhood of the resettlement village of new Muhipler drawn 13 years apart. Left 1971, Right 1984
Illustration: Housing and Culture after Earthquakes / Yasemin Aysan / Paul Oliver / Ian Davis

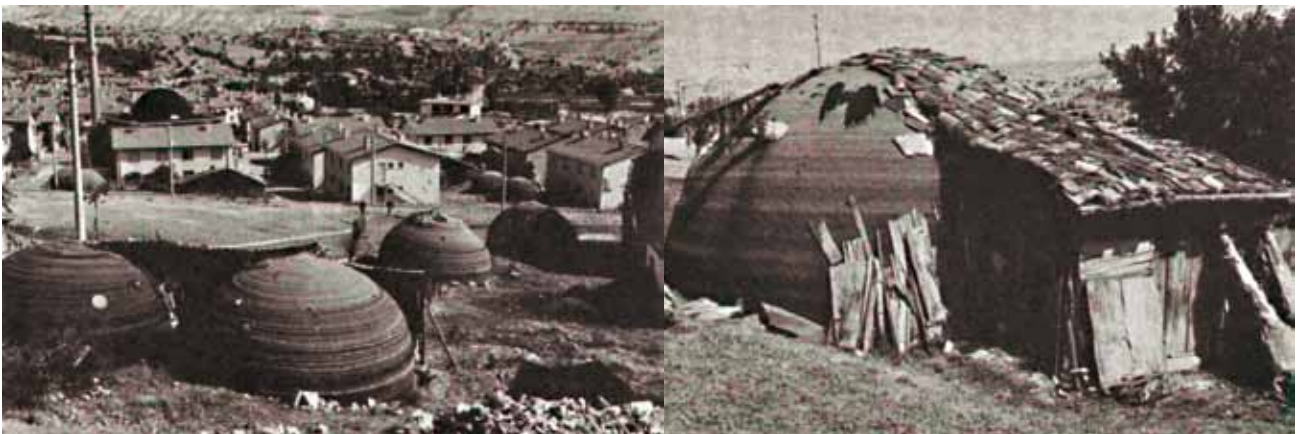
Polyurethane 'igloos' were deployed. An experiment that was discontinued after the 1975 Lice earthquake
Photos: Housing and Culture after Earthquakes / Yasemin Aysan / Paul Oliver

In Gediz temporary shelter was used only for a very short period. In Ackaalan 400 polyurethane domes were built and occupied. Imported labour was used for the clearing rubble.
