## A.4 Haiti - 2010 - Earthquake - Overview

### Sheltering in Haiti:

#### Looking forward while looking back

## A.4 Haiti - 2010 - Earthquake - Overview continued

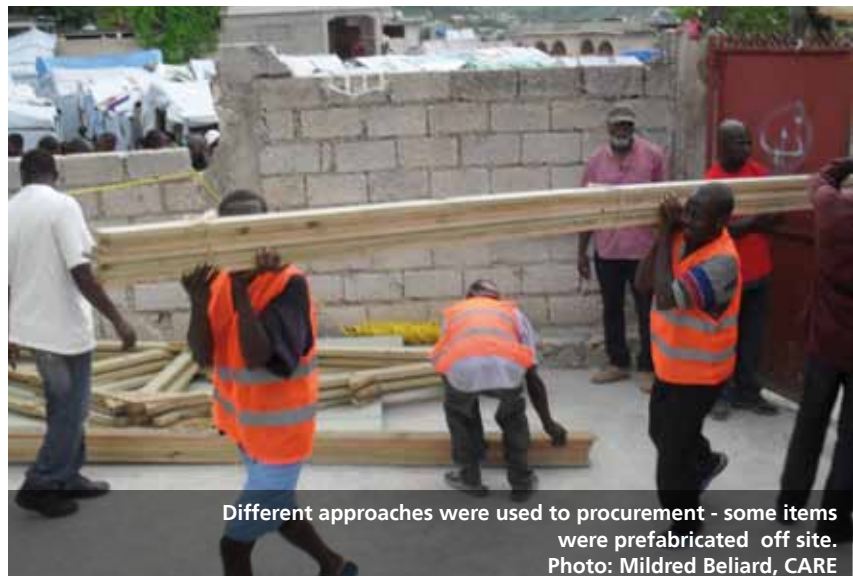
Different approaches were used to procurement - some items were prefabricated off site. Photo: Mildred Beliard, CARE

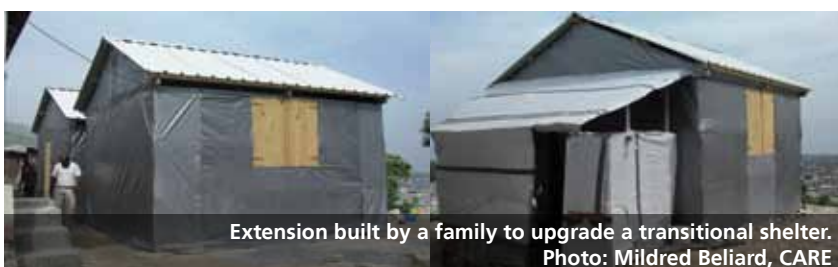
Extension built by a family to upgrade a transitional shelter. Photo: Mildred Beliard, CARE

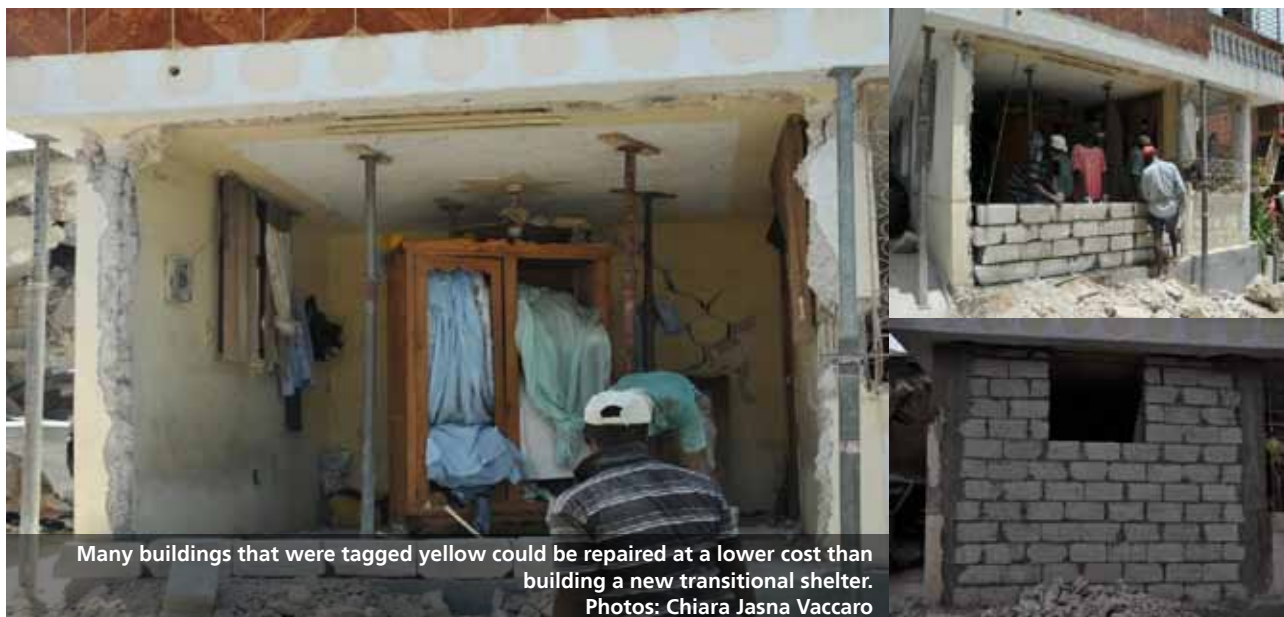
Many buildings that were tagged yellow could be repaired at a lower cost than building a new transitional shelter.  
Photos: Chiara Jasna Vaccaro

Once a house had been assessed, the next challenge was to repair it. The cost of rebuilding yellow tagged buildings was relatively inexpensive compared to the cost of new construction or comparable transitional shelters. However, it was also clear that the reason that most buildings had collapsed was that they were poorly built.

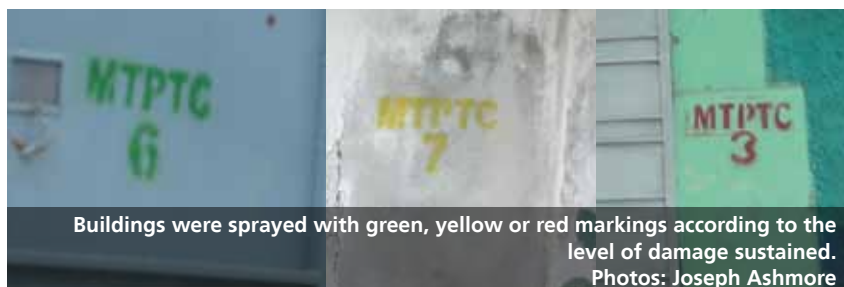
Buildings were sprayed with green, yellow or red markings according to the level of damage sustained.  
Photos: Joseph Ashmore

The assessment tagged buildings according to the damage using the following "traffic light" system:

- green - safe for use,
- yellow - damaged, but stable (needing minor repairs to be made useable),
- red - unstable, either major repairs or demolition and rebuilding required.

The assessment highlighted how widespread the damage was. Rather than having a core area of red tagged houses surrounded by rings of yellow tagged and then green tagged houses, nearly every neighbourhood is a mixture of green, yellow, and red tagged buildings.

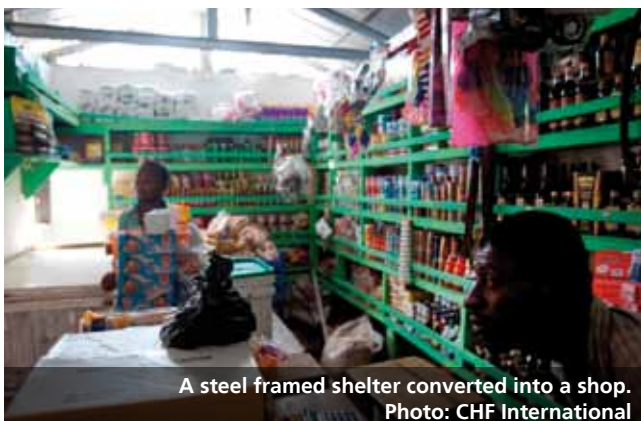
A steel framed shelter converted into a shop.  
Photo: CHF International

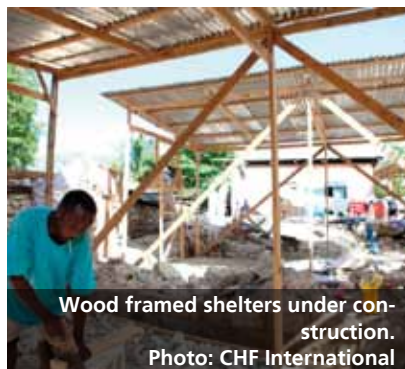
Wood framed shelters under construction. Photo: CHF International

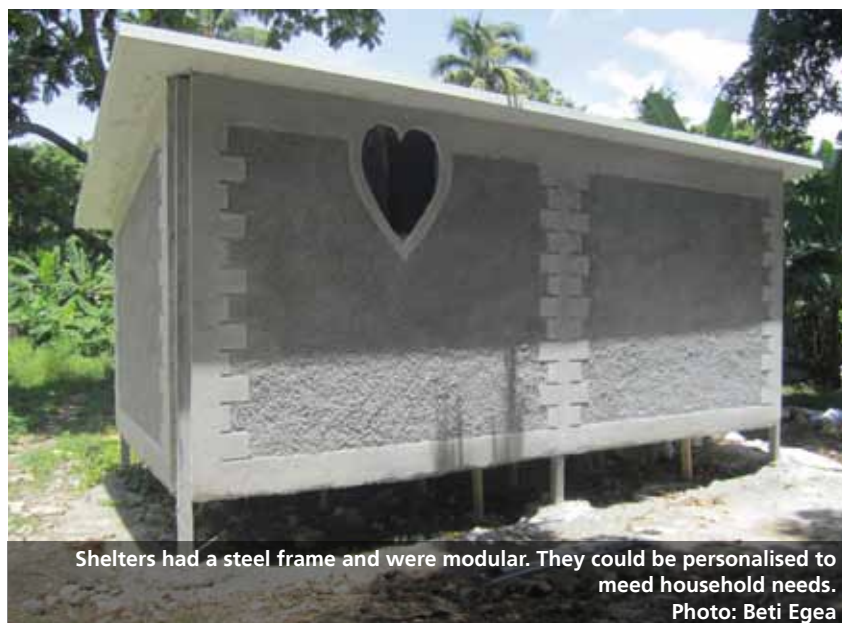
Shelters had a steel frame and were modular. They could be personalised to meet household needs.  
Photo: Beti Egea

The shelter had a galvanised steel frame with a mono-pitch roof and a raised floor. The shelter was 3 x 6m on plan and had 6 columns spaced on a 3m grid, fixed to rectangular reinforced concrete foundations using a base plate and four ordinary bolts per base. The shelter could be demounted and foundation bolts cut to reuse the frame.

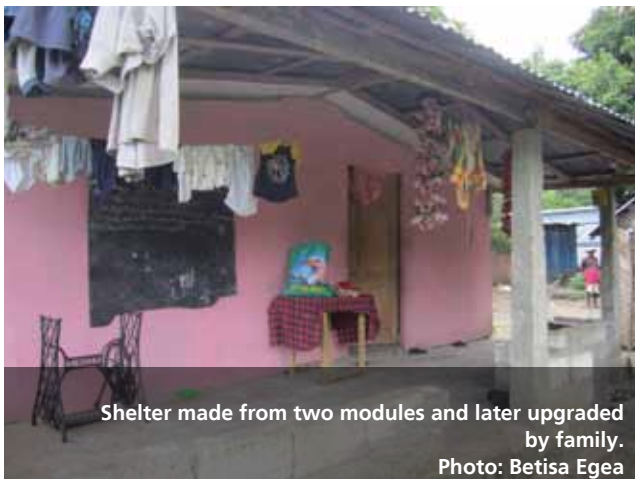
Shelter made from two modules and later upgraded by family.  
Photo: Betisia Egea

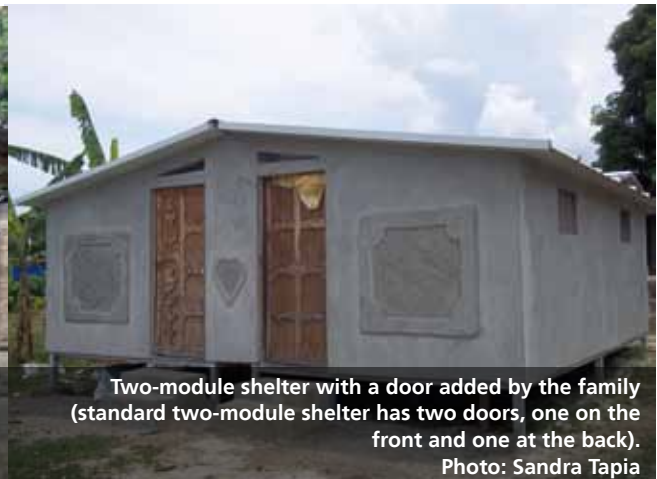
Two-module shelter with a door added by the family (standard two-module shelter has two doors, one on the front and one at the back).  
Photo: Sandra Tapia

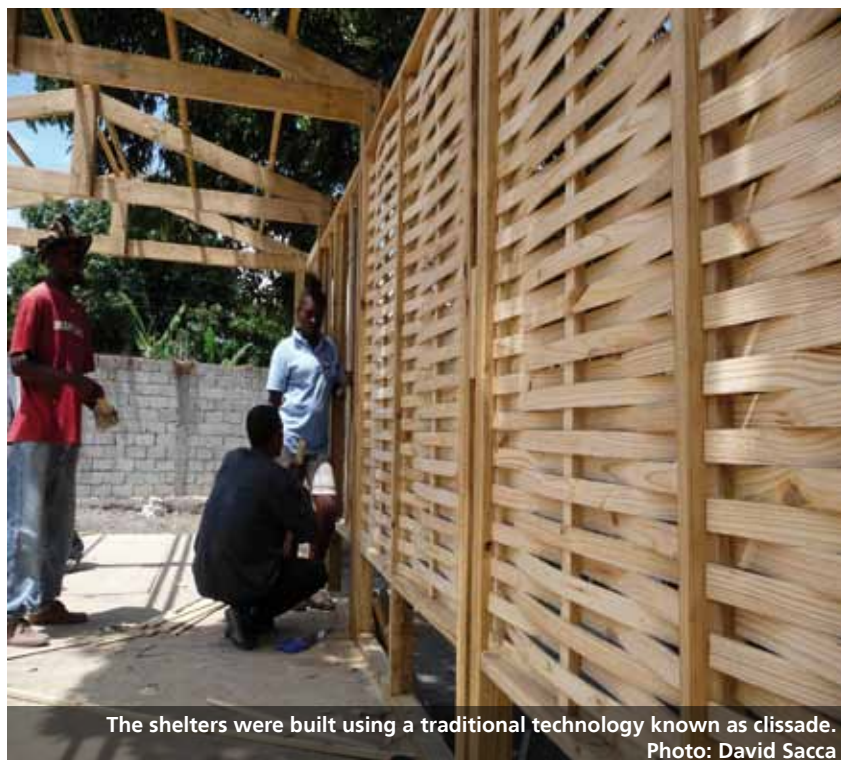
The shelters were built using a traditional technology known as *clissade*.  
Photo: David Sacca

In general, the *clissade* houses resisted the earthquake much better than the concrete houses. Where they were damaged in the earthquake, the injuries to the occupants were not as severe as those caused by collapsing concrete houses.

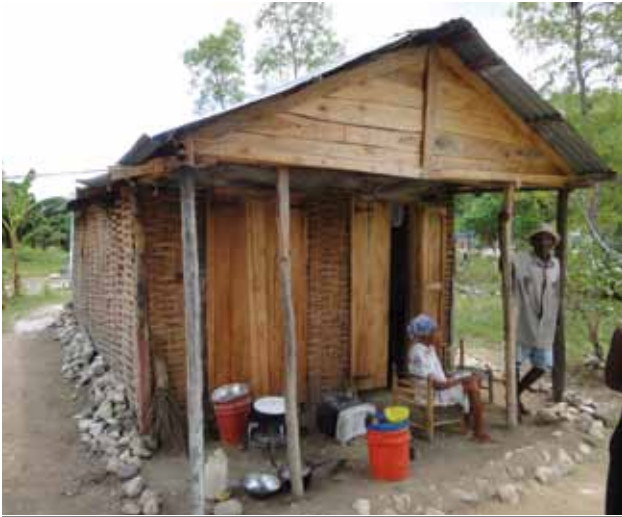
A traditional shelter that survived the earthquake.  
Photo: Joseph Ashmore
