SHELTER PROJECTS

2011-2012

Shelter Projects 2011–2012

Published 2013

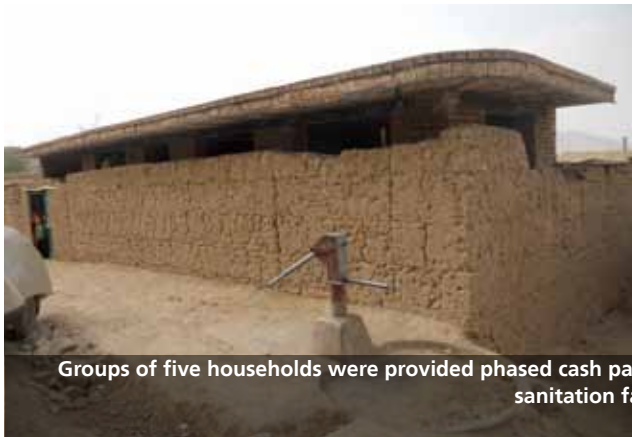
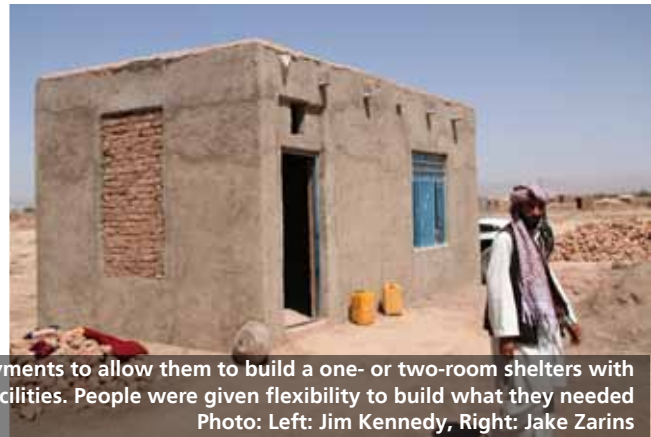
Groups of five households were provided phased cash payments to allow them to build a one- or two-room shelters with sanitation facilities. People were given flexibility to build what they needed
Photo: Left: Jim Kennedy, Right: Jake Zarins

During the shelter construction, households received support from the project technical staff. This included advice on the plot layout, ground clearing and foundation digging, stone masonry, brick masonry, seismic risk reduction measures and roofing design.

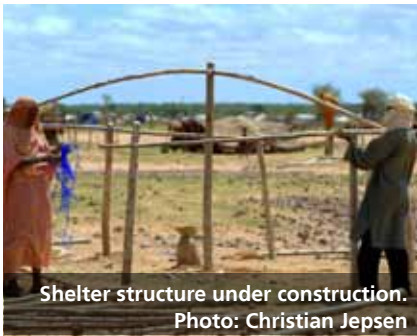
Shelter structure under construction.
Photo: Christian Jepsen

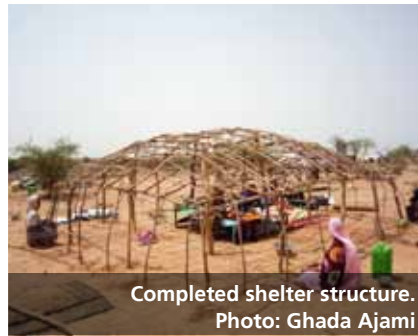
Completed shelter structure.
Photo: Ghada Ajami

Tuareg tents are suited to the environmental conditions: high wind loads, high temperatures and sand storms. The shelter contained no concrete so did not worsen water scarcity. The sides of the shelter were made from mats which could be re-positioned in order to change the location of the doors depending on the direction of the wind.

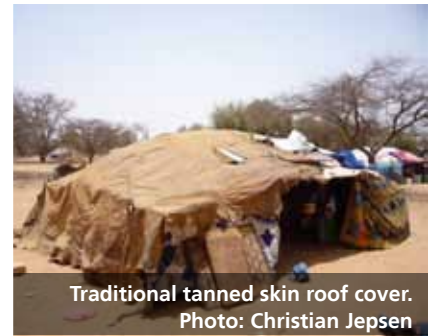
Traditional tanned skin roof cover.
Photo: Christian Jepsen

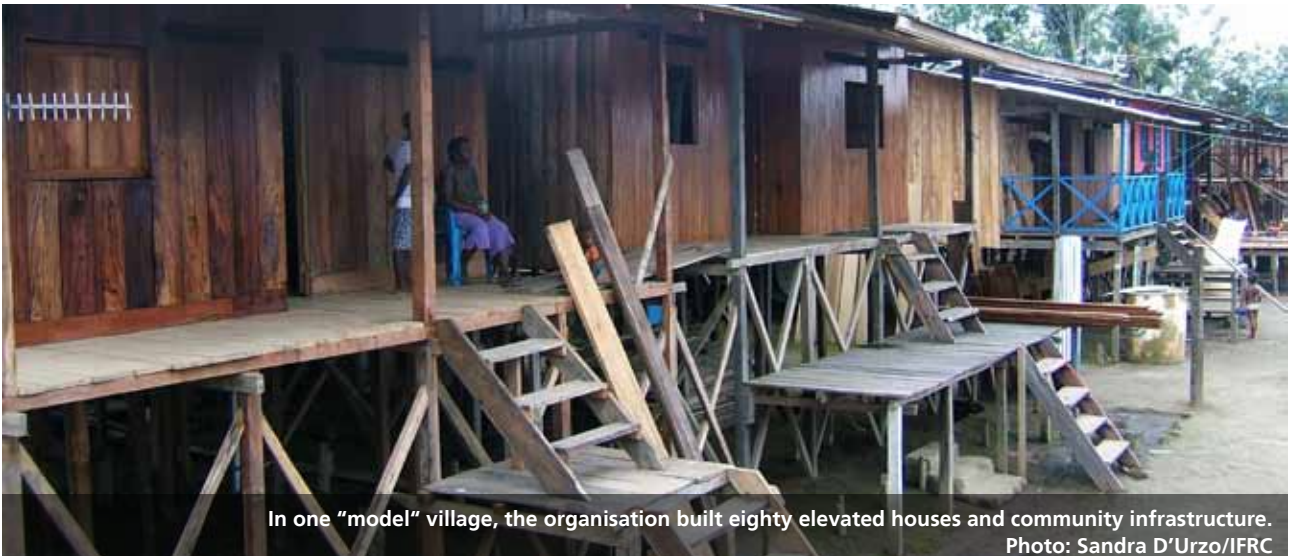
In one “model” village, the organisation built eighty elevated houses and community infrastructure.
Photo: Sandra D’Urzo/IFRC

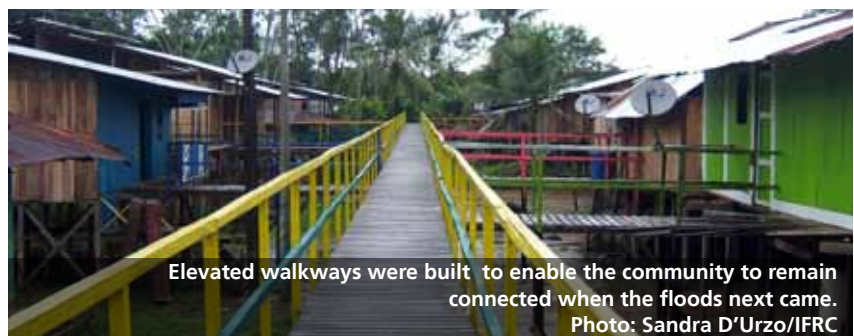
Elevated walkways were built to enable the community to remain connected when the floods next came.
Photo: Sandra D’Urzo/IFRC

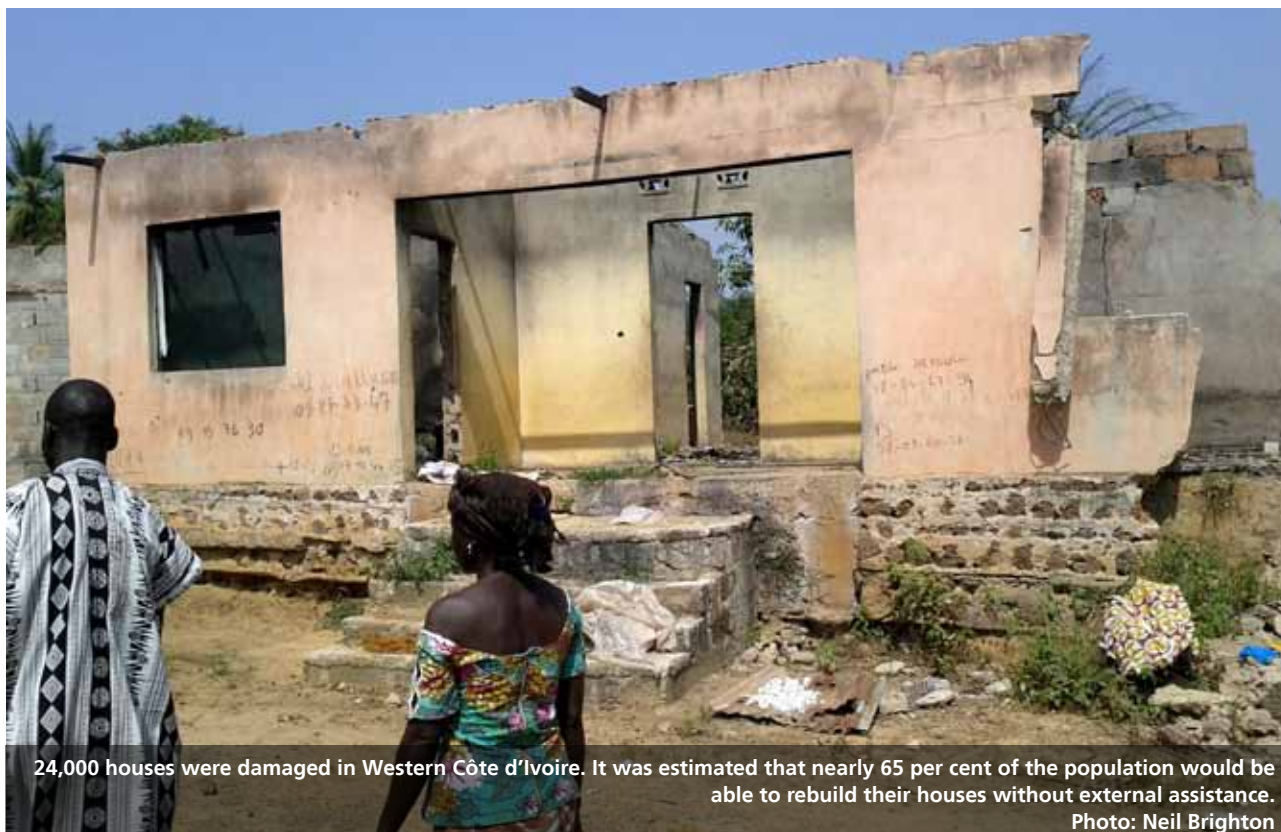
24,000 houses were damaged in Western Côte d'Ivoire. It was estimated that nearly 65 per cent of the population would be able to rebuild their houses without external assistance.

In Western Côte d'Ivoire, the vast majority of households lived in houses that are built with materials found locally and were either constructed from mud-bricks or wattle and daub. The roofs were thatched or covered in corrugated iron. Though the house walls were prone to erosion from rain and wind, and were relatively weak, they were built by the households themselves and contributed to a high self-recovery rate.

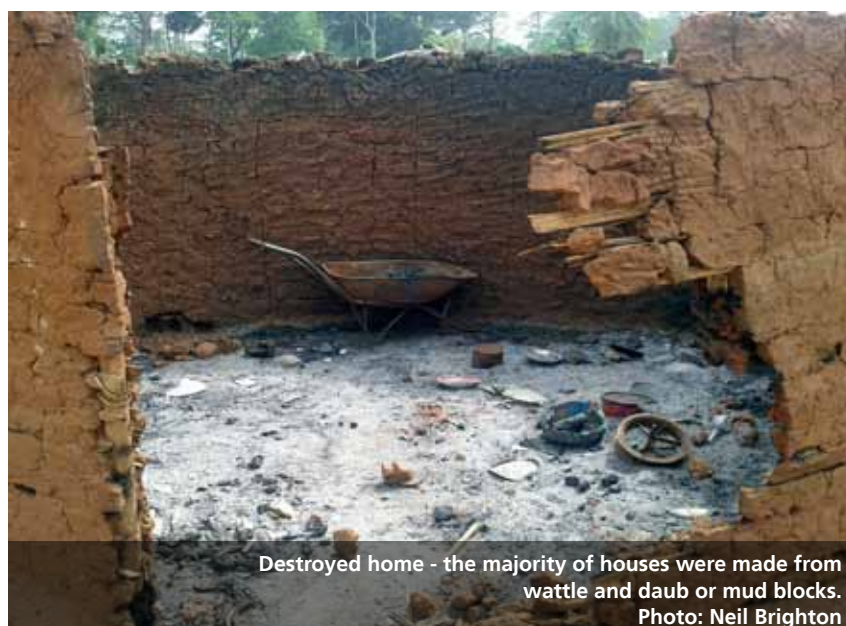
Destroyed home - the majority of houses were made from wattle and daub or mud blocks.

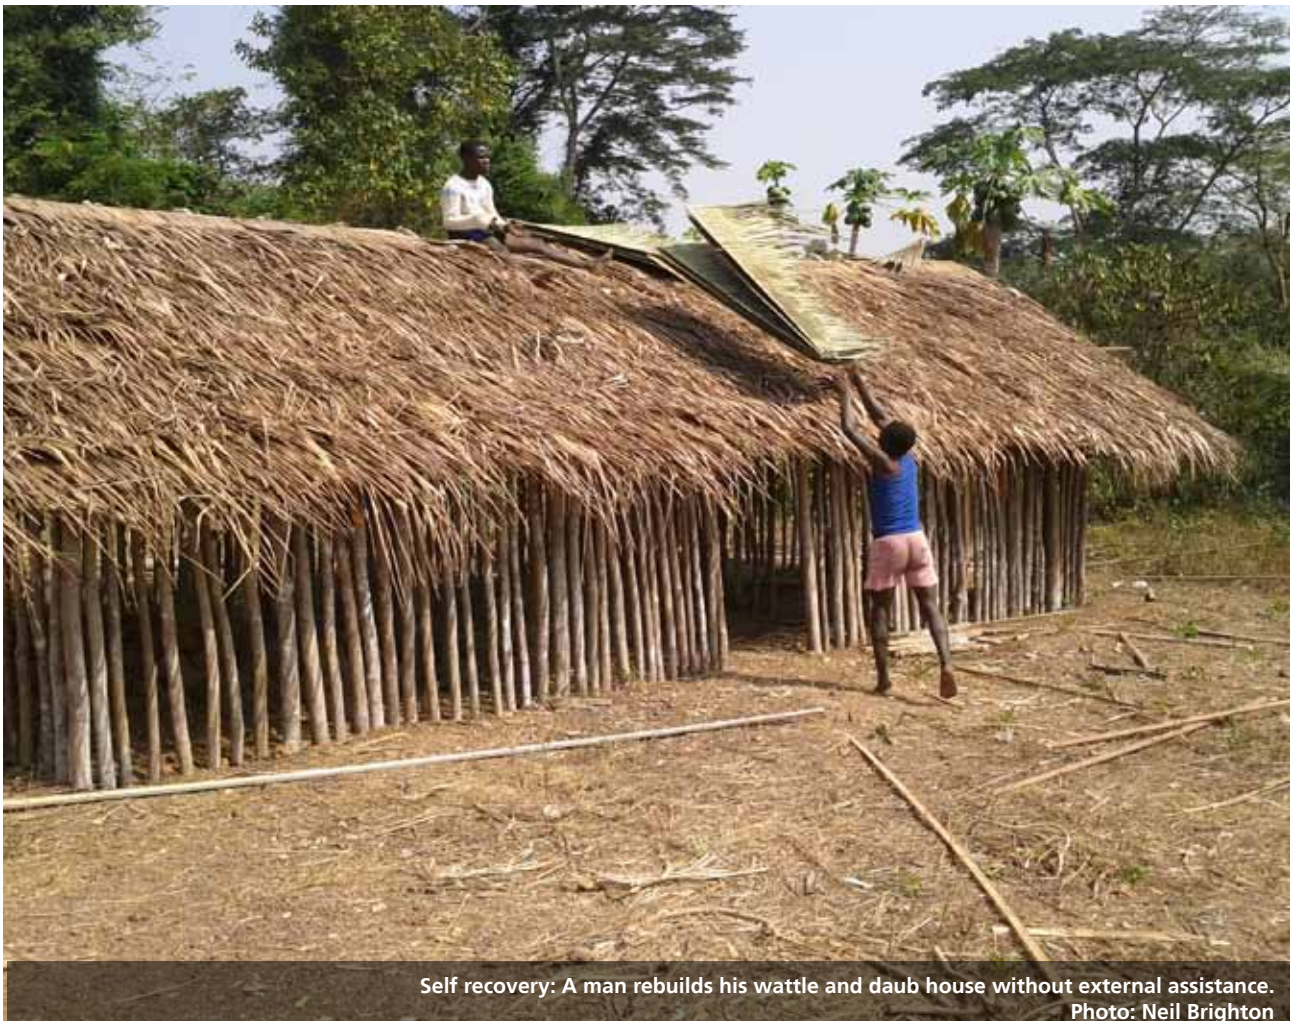
Self recovery: A man rebuilds his wattle and daub house without external assistance. Photo: Neil Brighton

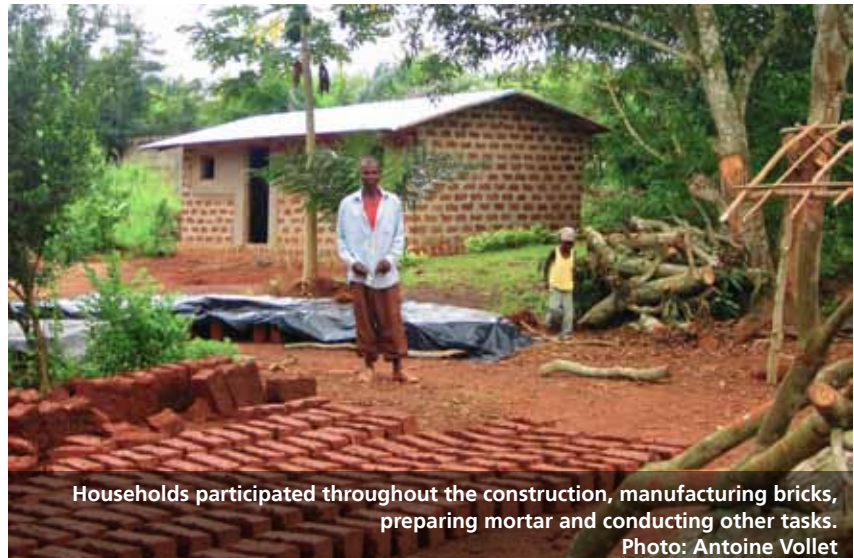
Households participated throughout the construction, manufacturing bricks, preparing mortar and conducting other tasks.
Photo: Antoine Vollet

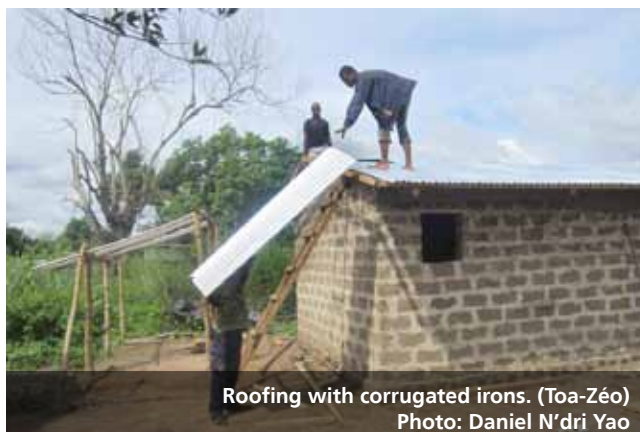
Roofing with corrugated irons. (Toa-Zéou)
Photo: Daniel N'dri Yao

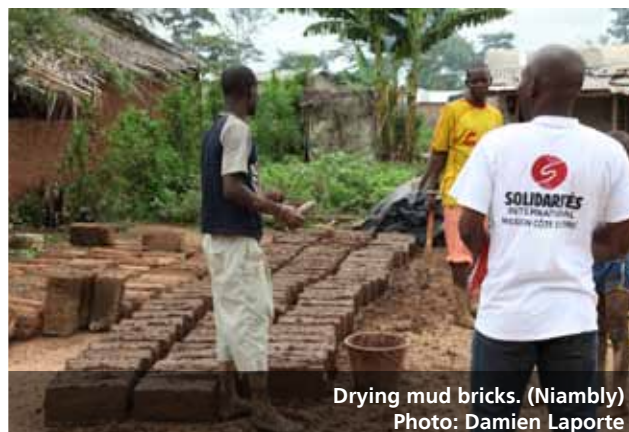
Drying mud bricks. (Niambly)
Photo: Damien Laporte

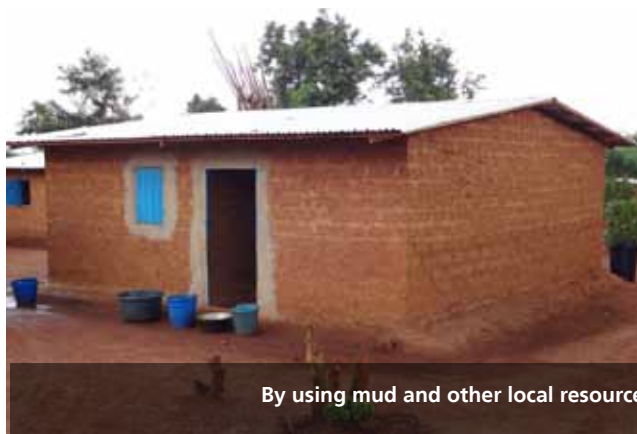
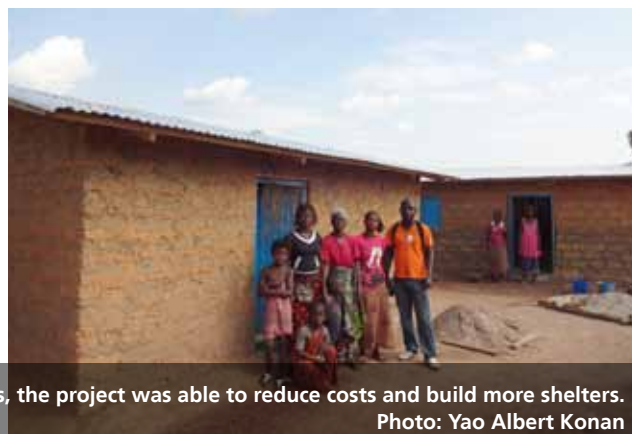
By using mud and other local resources, the project was able to reduce costs and build more shelters.

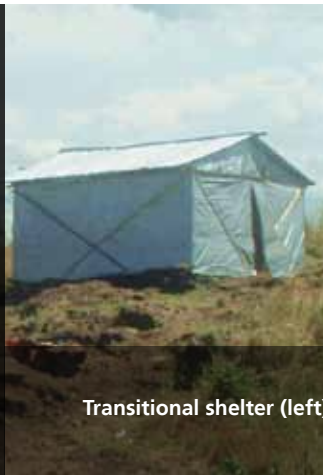
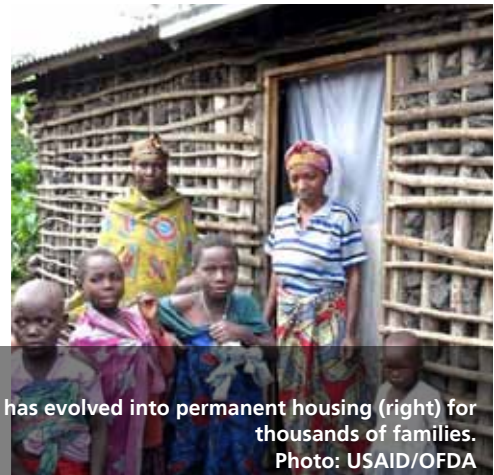
Transitional shelter (left) has evolved into permanent housing (right) for thousands of families. Photo: USAID/OFDA

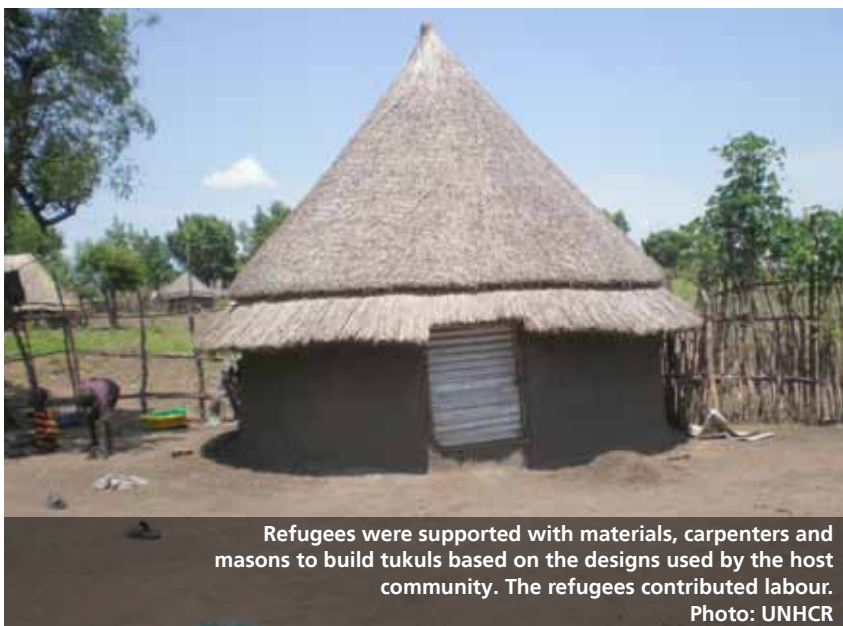
Refugees were supported with materials, carpenters and masons to build tukuls based on the designs used by the host community. The refugees contributed labour. Photo: UNHCR

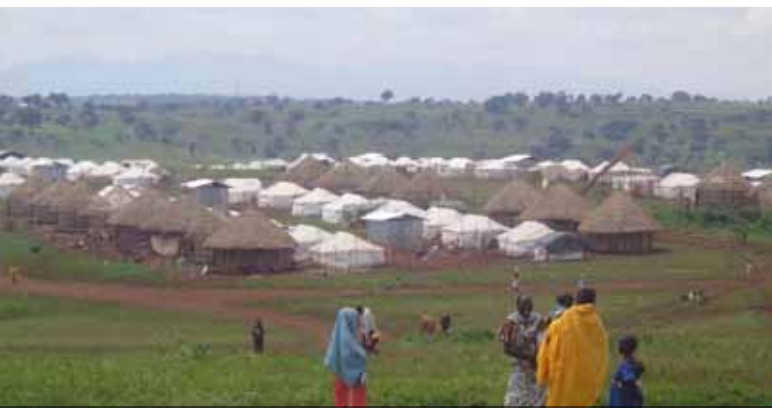
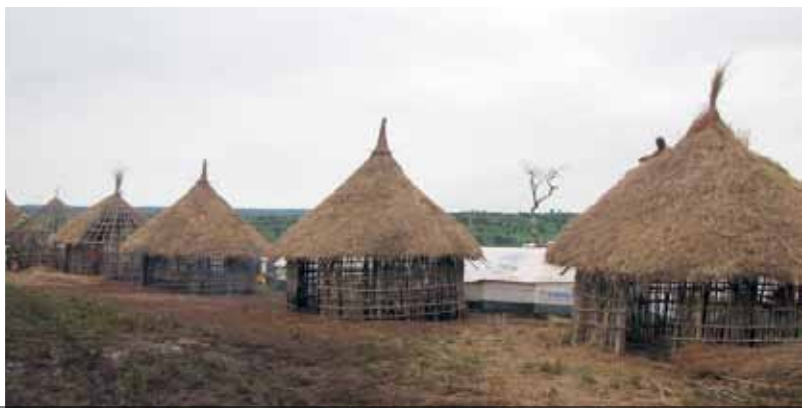
Timber and bamboo frames shelters were built with thatched roofs as a more durable shelter solution than tents. It proved challenging to source mud to plaster the walls as originally intended.
Photos: Left: UNHCR, Right: Demissew Bizuwerk / IOM Ethiopia.

In the project plans, a carpenter and a mason, working with families would be able to build ten shelters in fifteen days. In practice, only half the number of shelters could be built. This was due to an underestimation of the training required by those constructing the shelters, and an underestimation of the number of households who would require additional assistance.

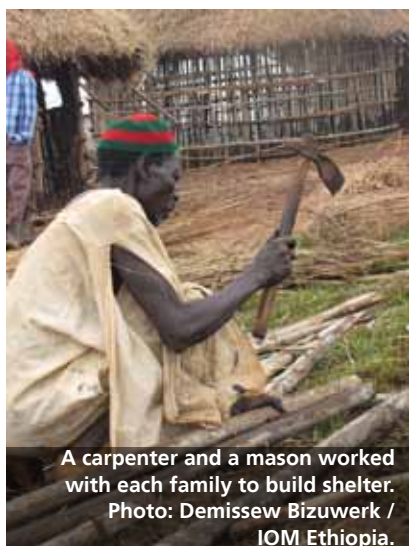
A carpenter and a mason worked with each family to build shelter.
Photo: Demissew Bizuwerk / IOM Ethiopia.

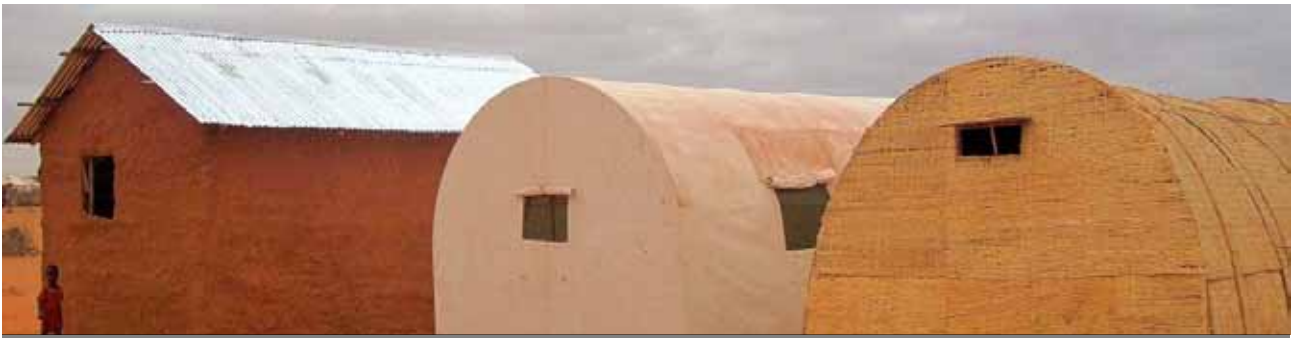
Three different prototype shelters were built and a group of refugee representatives, the government and the key organisations agreed on a common design
Image: NRC

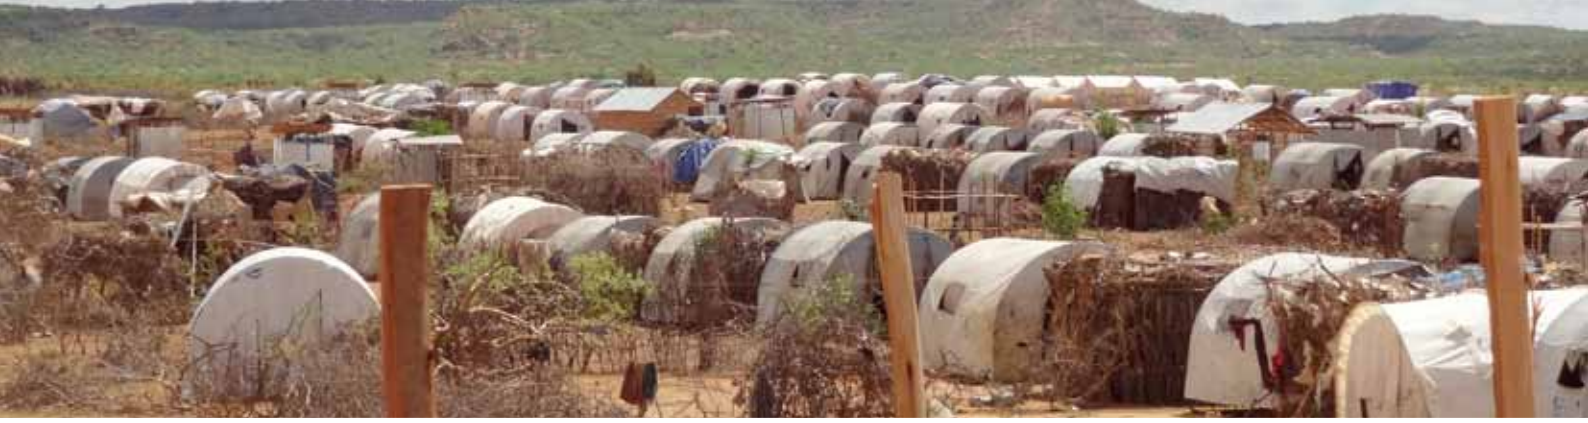
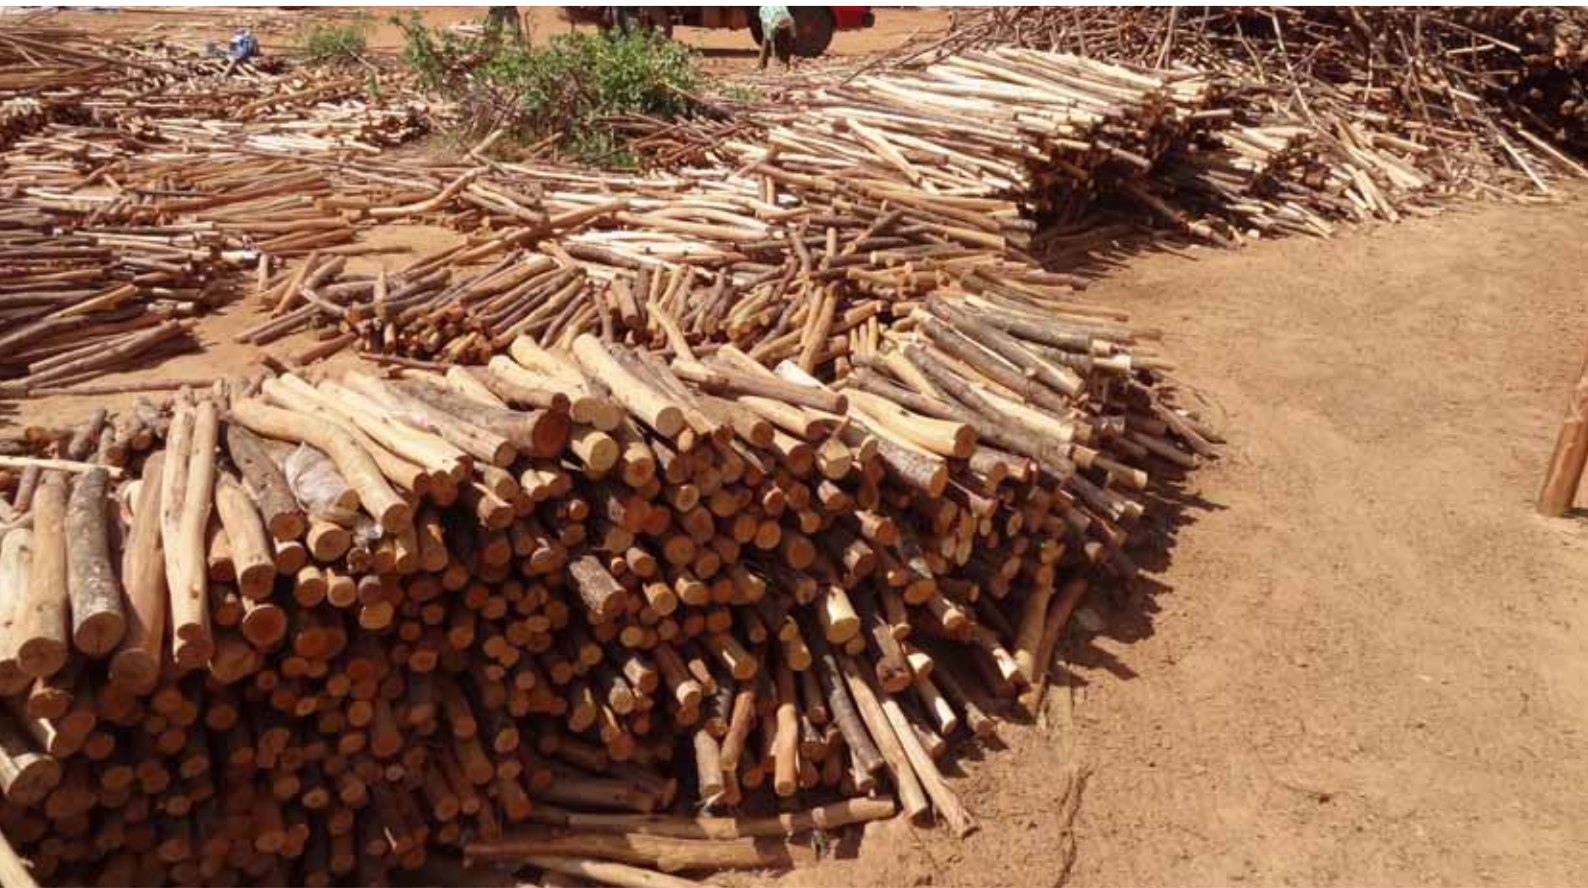
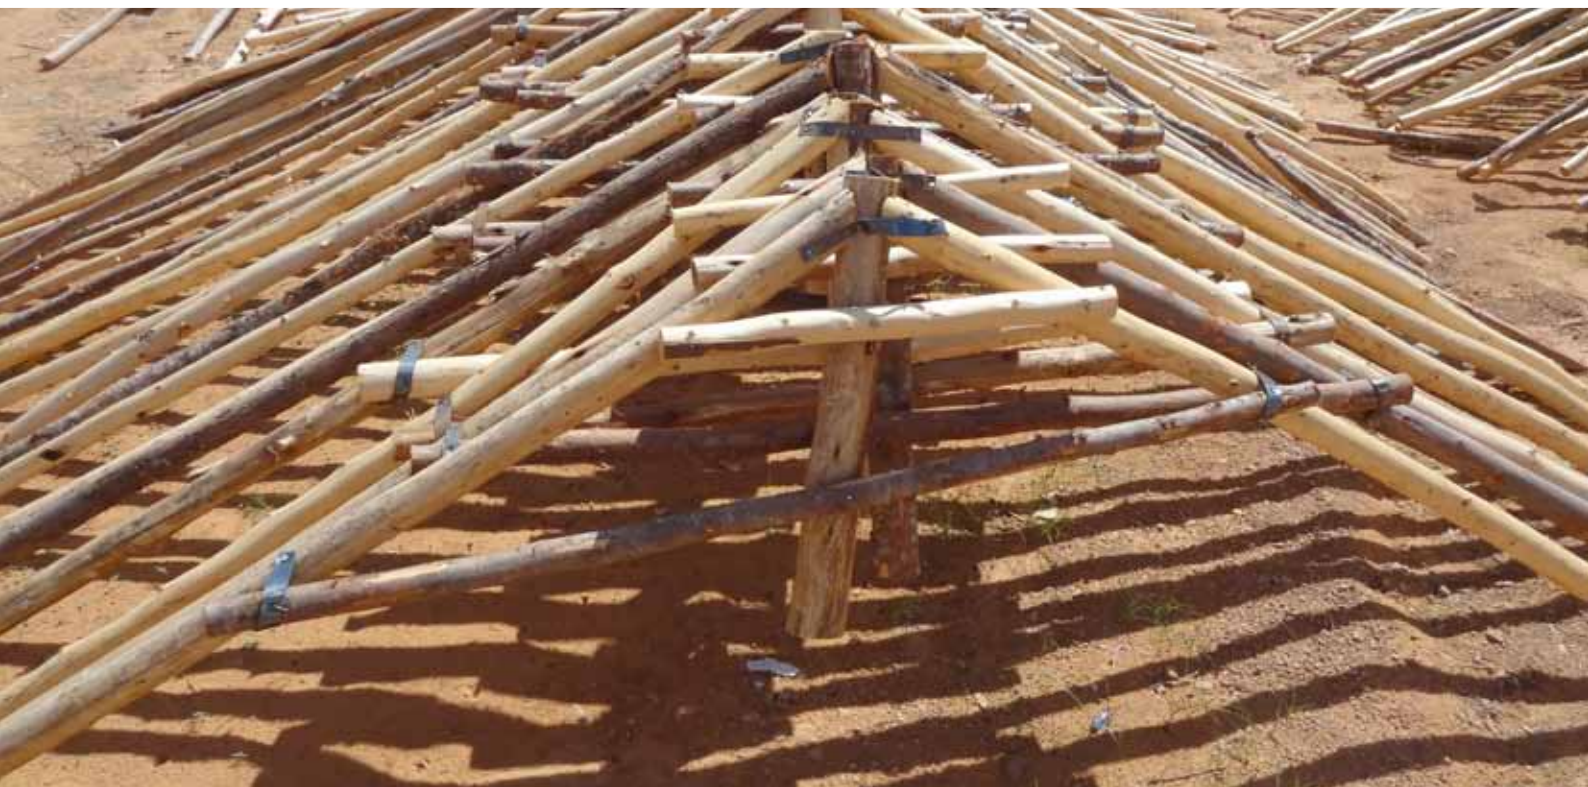
Top: View of a camp before construction. Each organisation established a large workshop in each camp to store materials and prefabricate components. Images: Joseph Ashmore

Training was provided for skilled labourers who were responsible for the on-site construction. On-site works included digging holes for foundations, erecting the frames, fitting the roofing, covering the walls with bamboo slats and fixing windows and doors. Training in mud rendering for walls was given where mud was available.

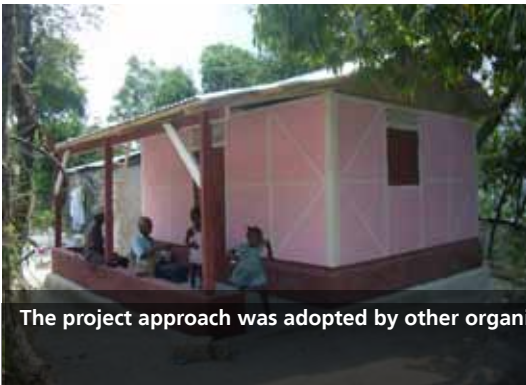
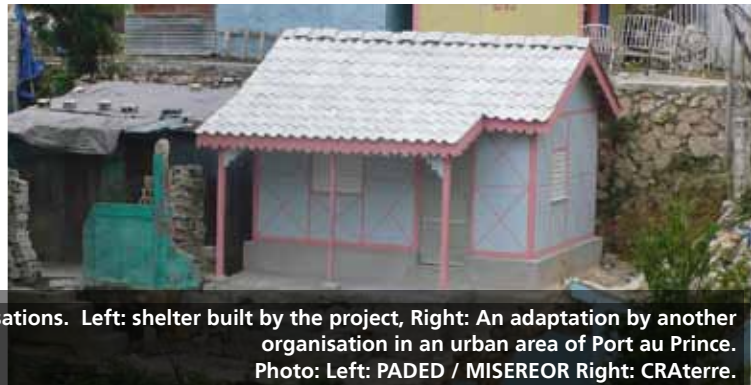
The project approach was adopted by other organisations. Left: shelter built by the project, Right: An adaptation by another organisation in an urban area of Port au Prince. Photo: Left: PADED / MISEREOR Right: CRAterre.

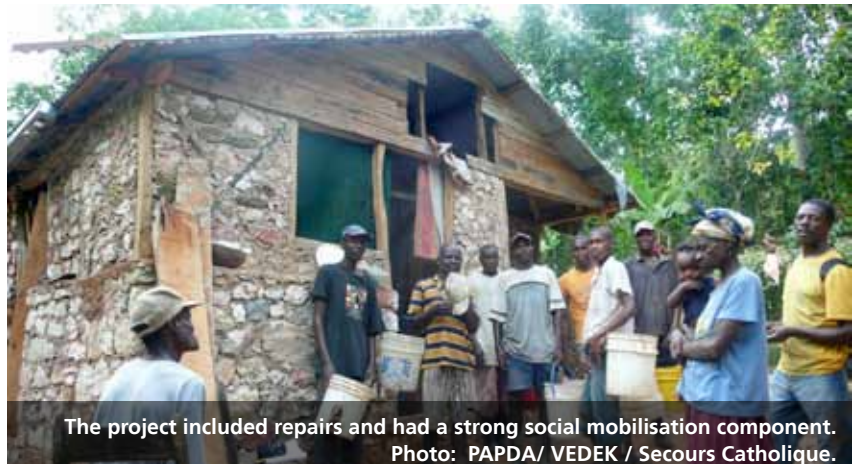
The project included repairs and had a strong social mobilisation component. Photo: PAPDA/ VEDEK / Secours Catholique.

Traditional local houses were built on wooden posts dug directly into the ground which were quickly weakened by rot. The new design added a proper foundation.

Cross-bracing was used in the walls. This reduced the risk of the wall collapsing in cyclones and earthquakes.

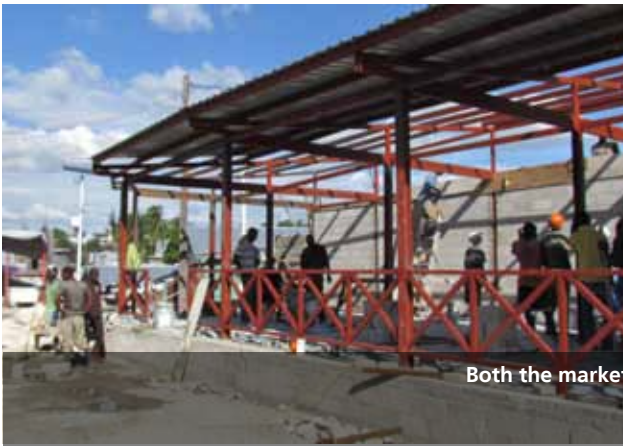
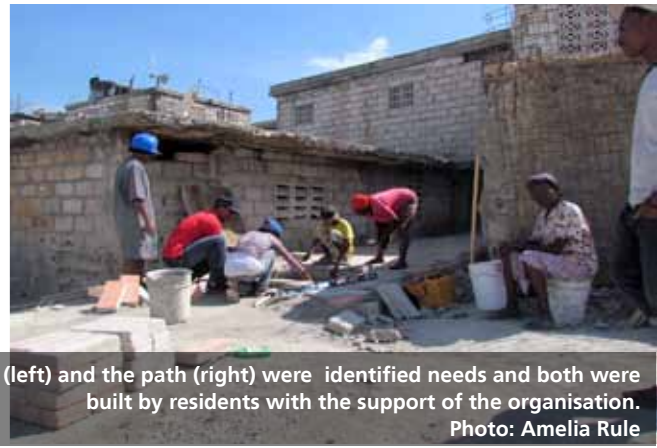
Both the market (left) and the path (right) were identified needs and both were built by residents with the support of the organisation. Photo: Amelia Rule

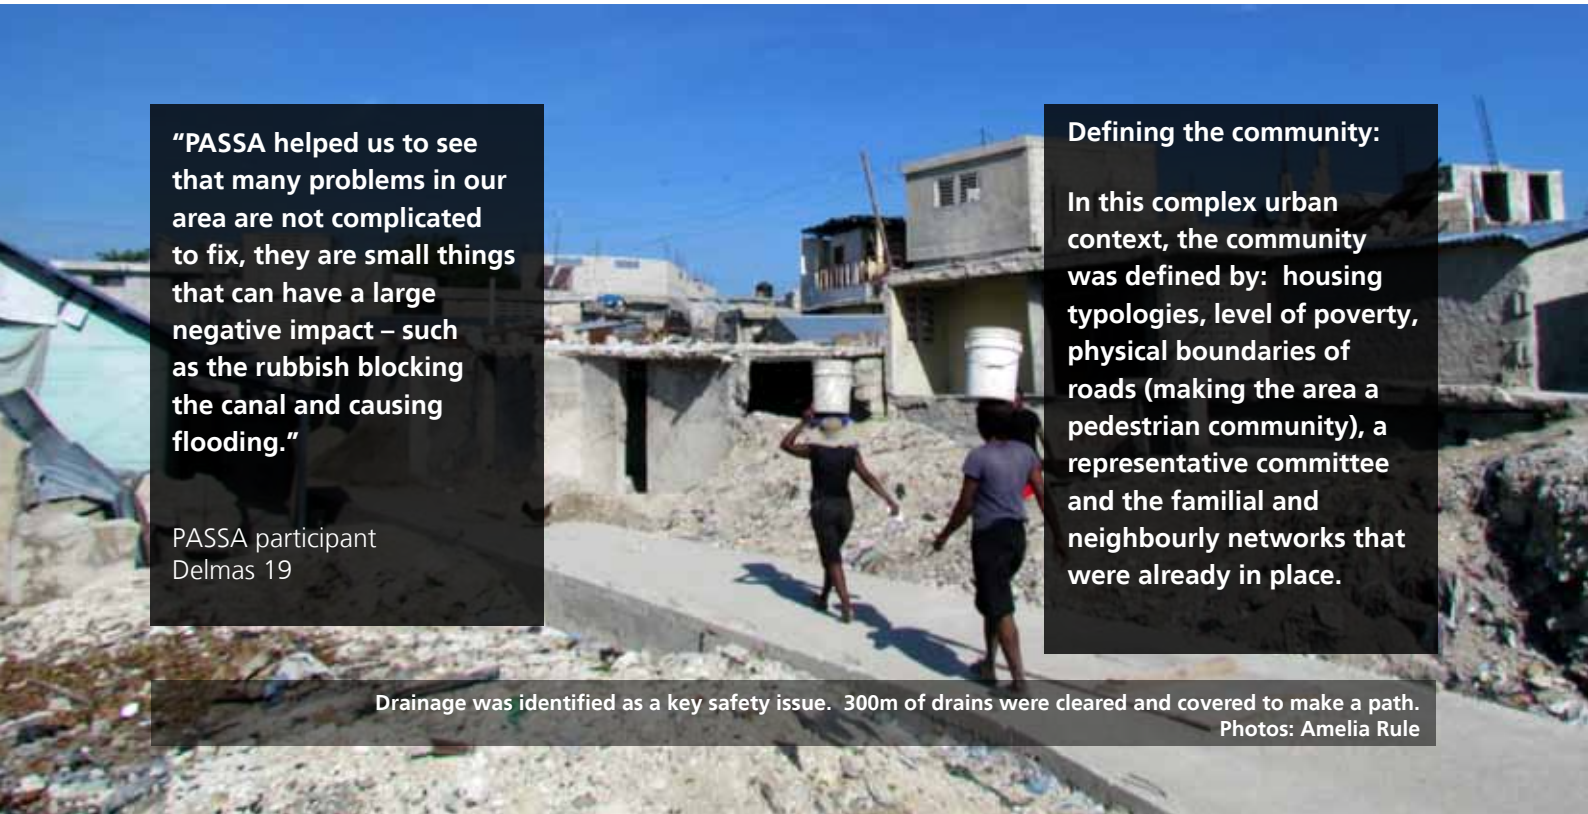
Drainage was identified as a key safety issue. 300m of drains were cleared and covered to make a path.
Photos: Amelia Rule

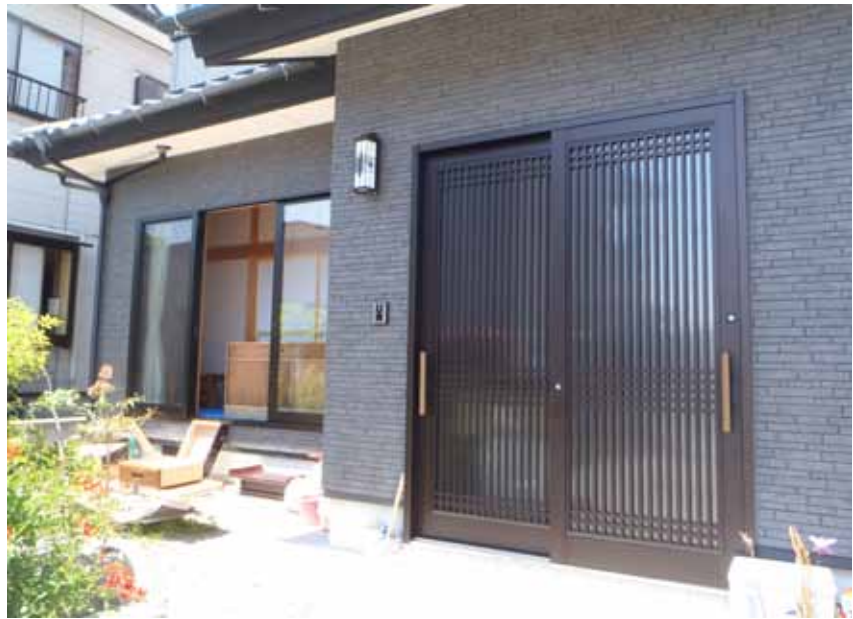
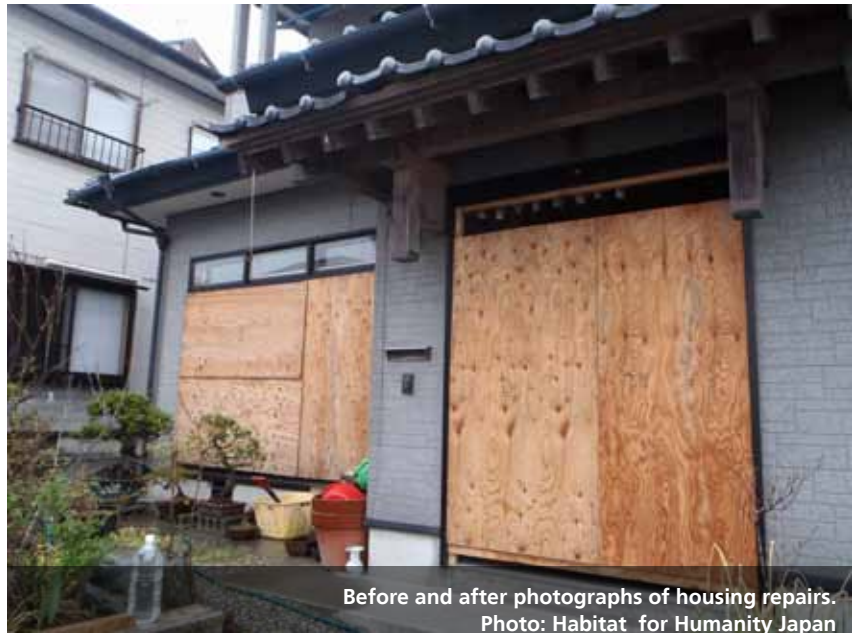
Before and after photographs of housing repairs.
Photo: Habitat for Humanity Japan

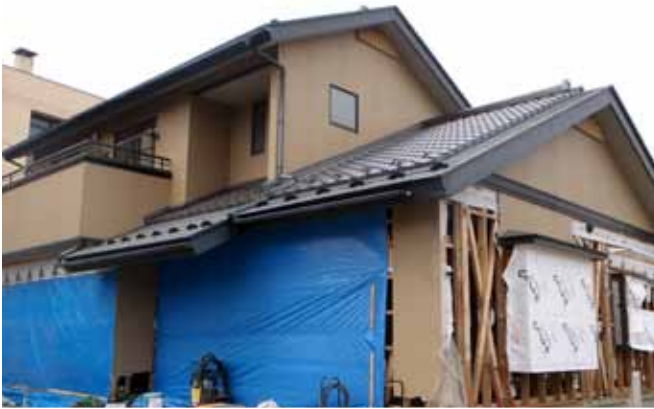
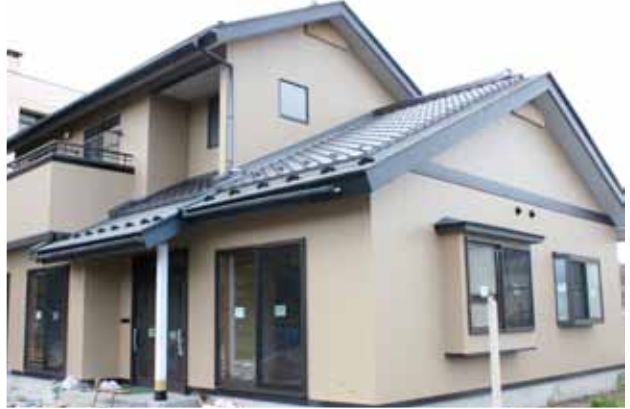
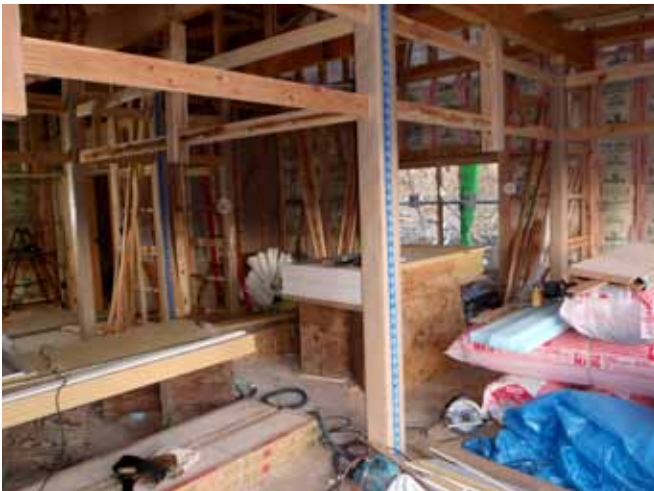
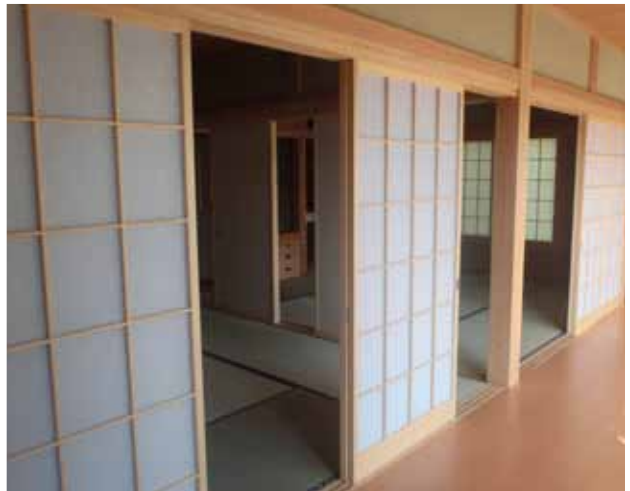
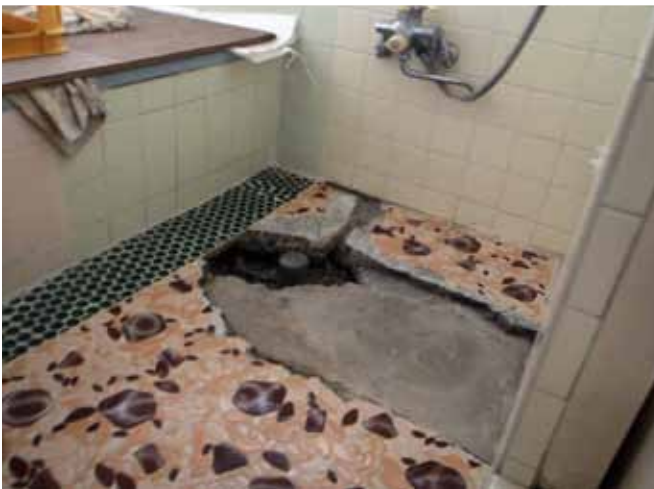
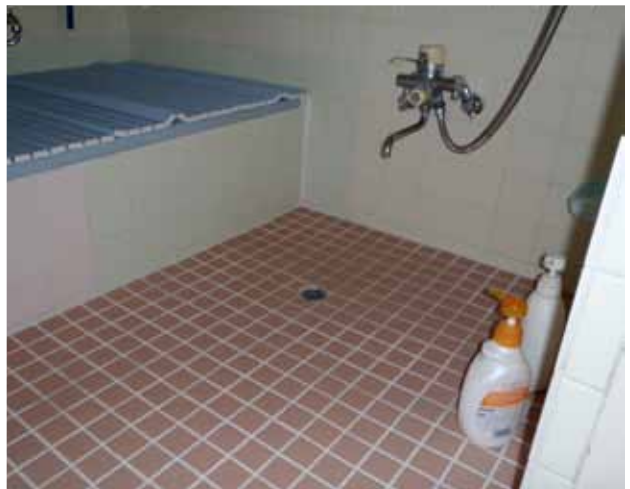
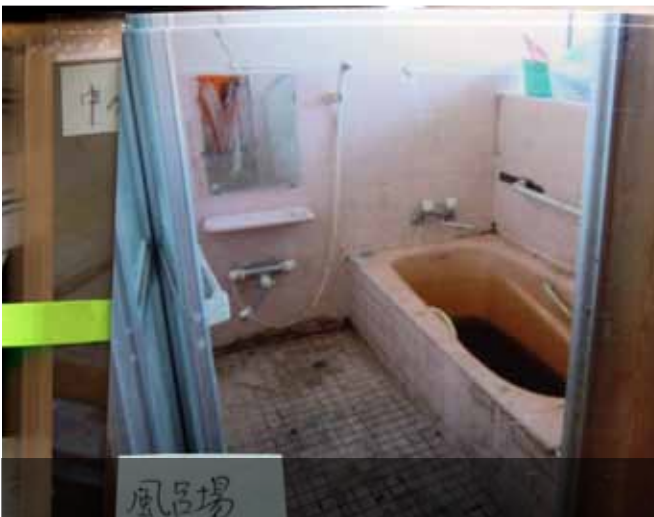
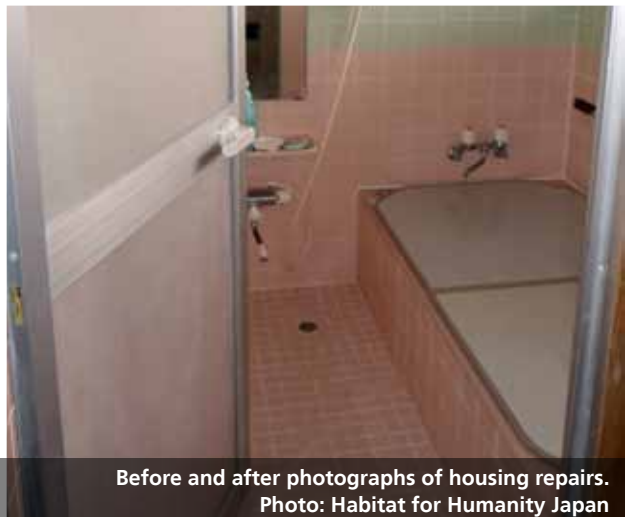
Before and after photographs of housing repairs. Photo: Habitat for Humanity Japan

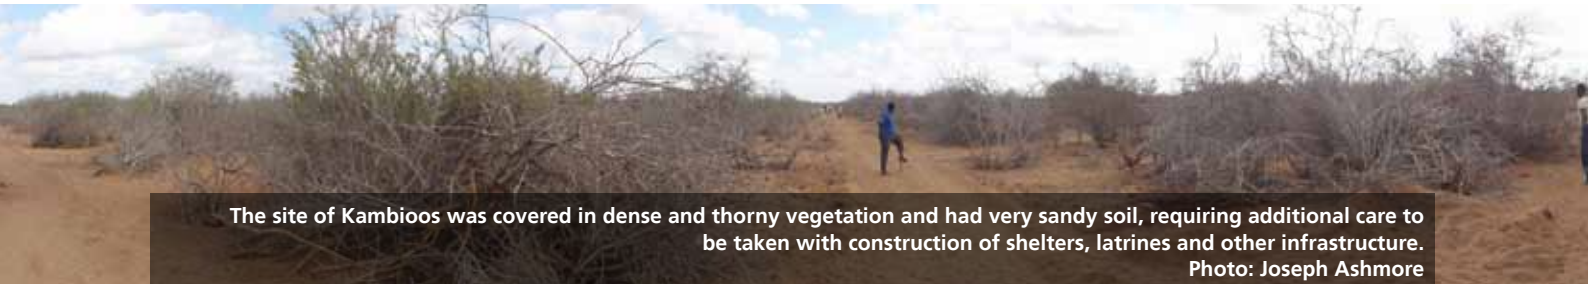
The site of Kambioos was covered in dense and thorny vegetation and had very sandy soil, requiring additional care to be taken with construction of shelters, latrines and other infrastructure. Photo: Joseph Ashmore
