SHELTER PROJECTS

2011-2012

Shelter Projects 2011–2012

Published 2013

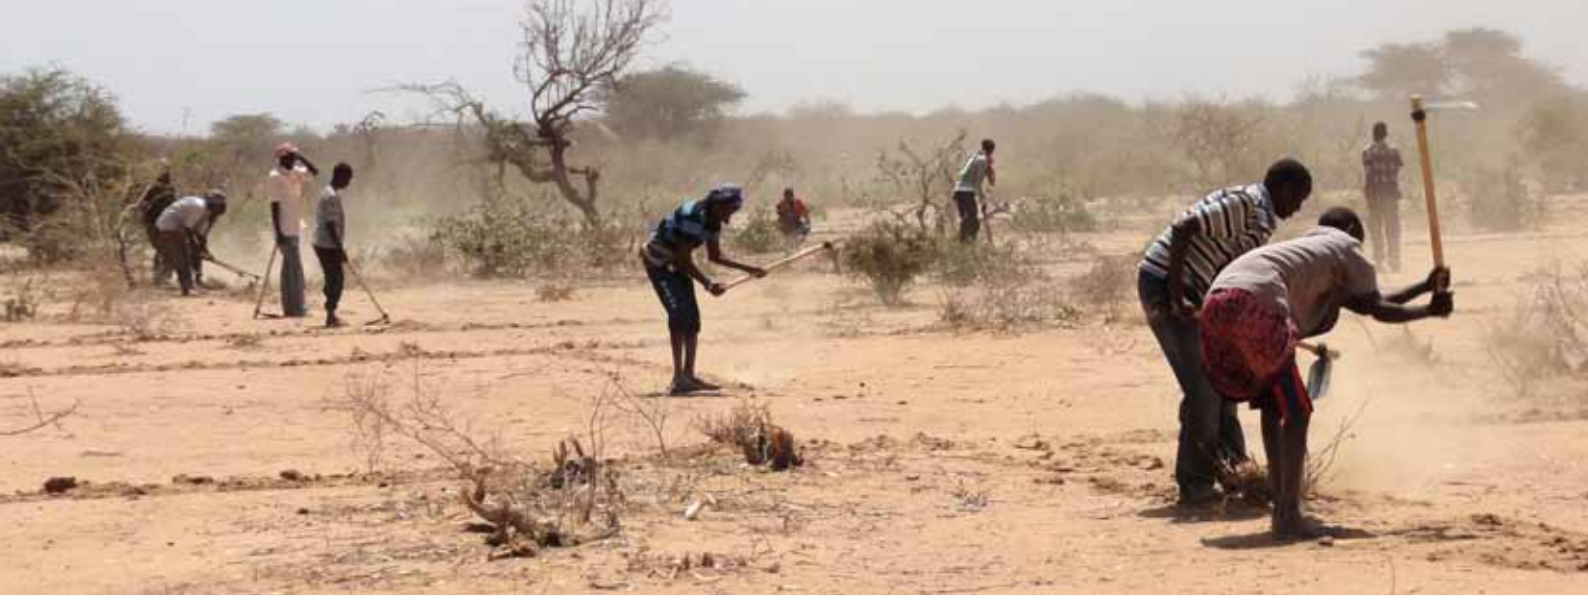
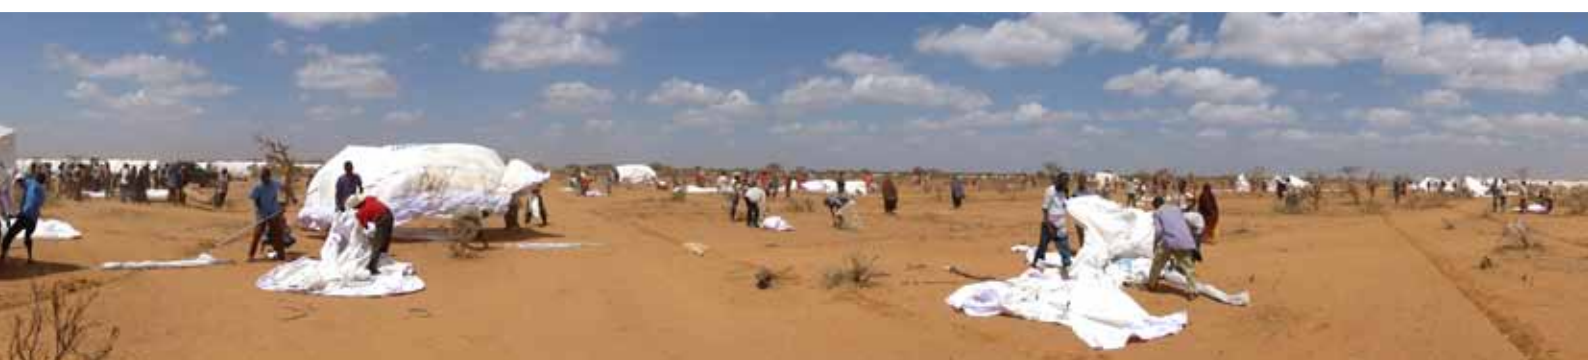
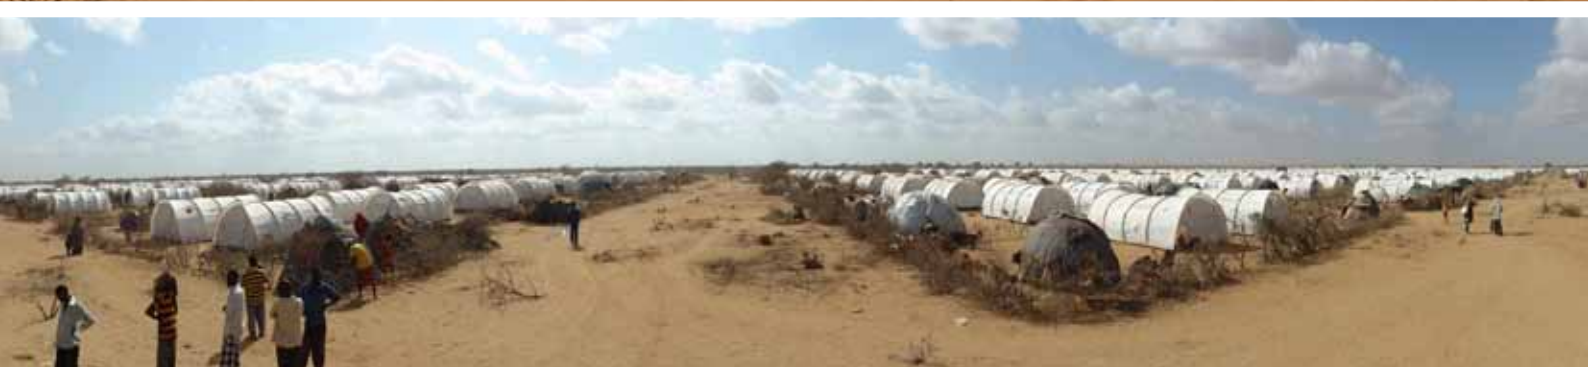
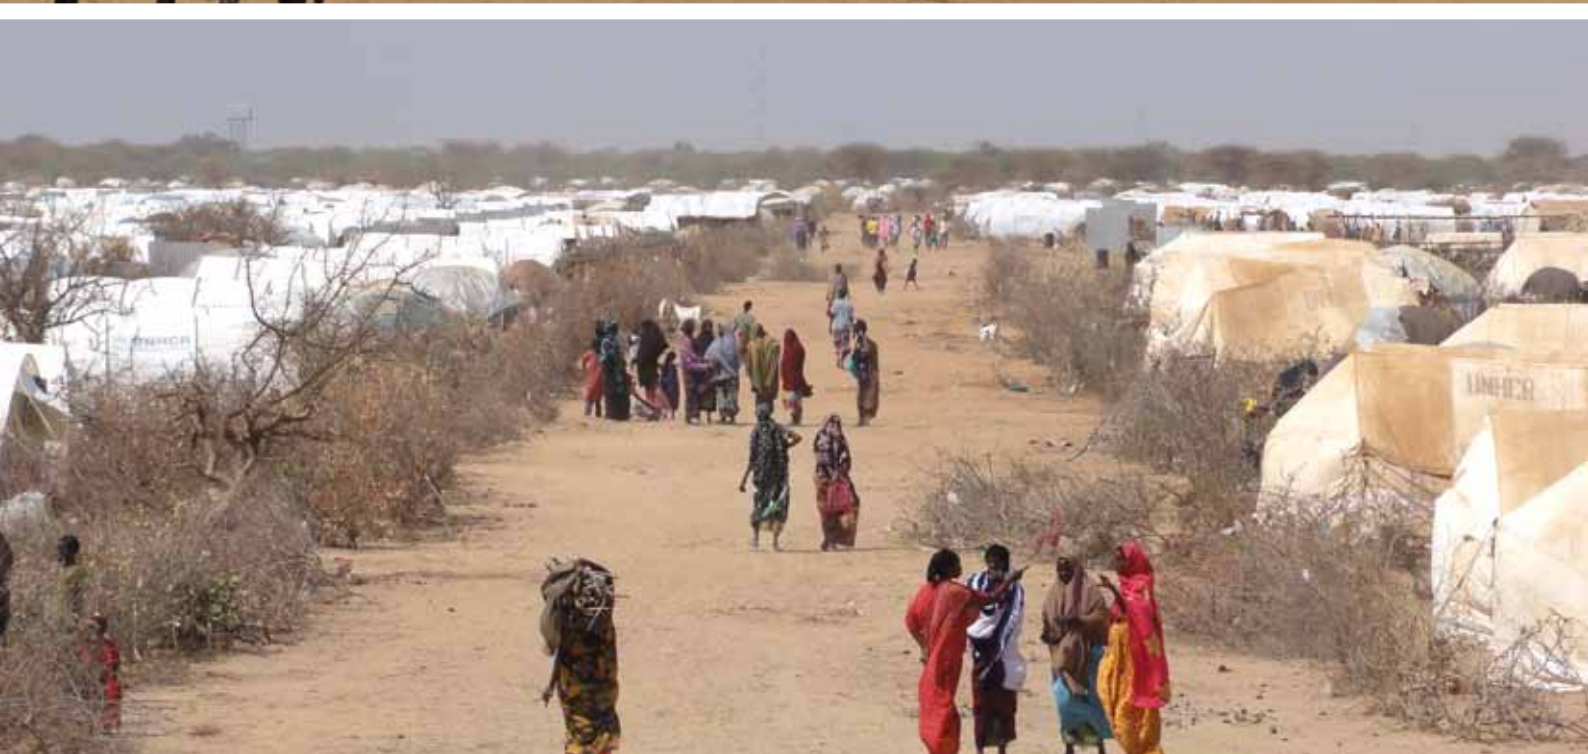
Top to bottom: Site marking; Tent erection on a windy day; Newly established blocks at IFO camp extension. Camps were organised into a) plots, b) communites, c) blocks, and d) sections. Photo: Joseph Ashmore

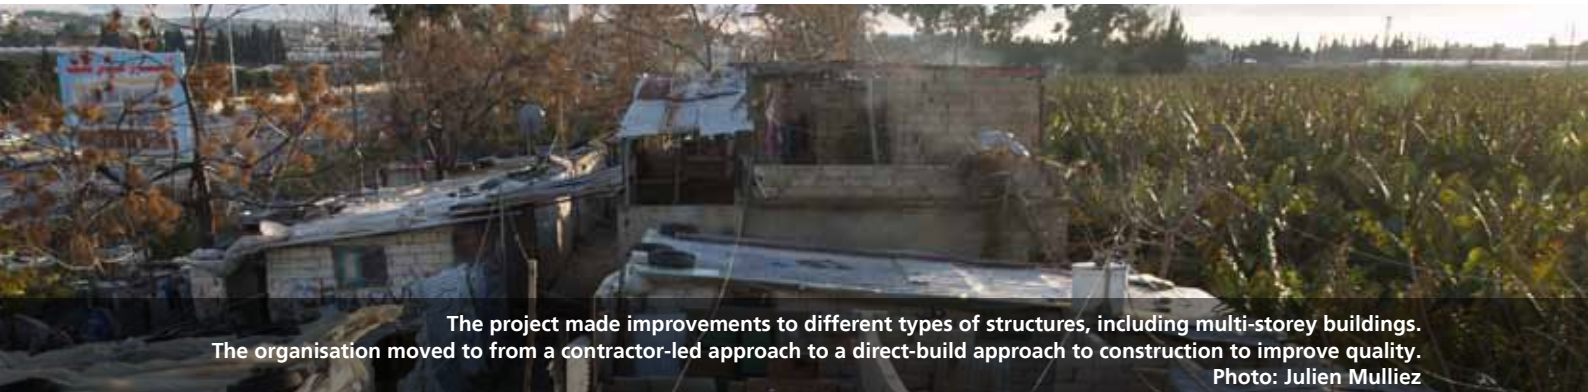
The project made improvements to different types of structures, including multi-storey buildings. The organisation moved from a contractor-led approach to a direct-build approach to construction to improve quality. Photo: Julien Mulliez

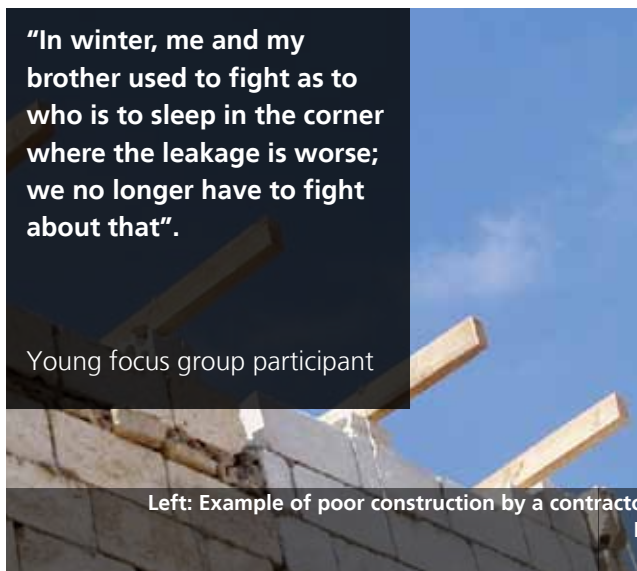
Left: Example of poor construction by a contractor in 2007, Wooden girders insufficient to support the new roof.

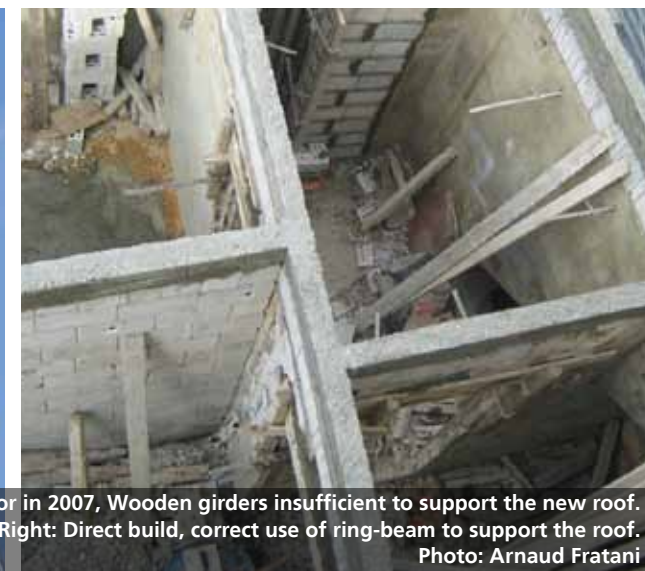
Right: Direct build, correct use of ring-beam to support the roof.

Where possible, the organisation reinforced the structure of shelters in order to improve their earthquake resistance. This included improved foundations, lintels, ring beams, reinforced slabs, and in some cases, additional steel girders supported with steel columns.

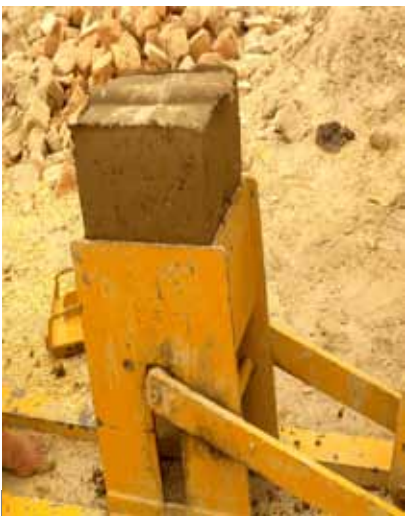
Compressed mud blocks were abandoned after the pilot stage due to a lack of community acceptance and slow production speed. Photo: ACTED

Given these obstacles and the size of the project, the organisation decided not to continue with compressed earth blocks. Instead they provided fired bricks and cement for the lower portions of the walls. The beneficiaries contributed sun-dried or fired bricks from the windowsill level up to the roof. In many cases people were able to find or purchase fired bricks for their contribution.

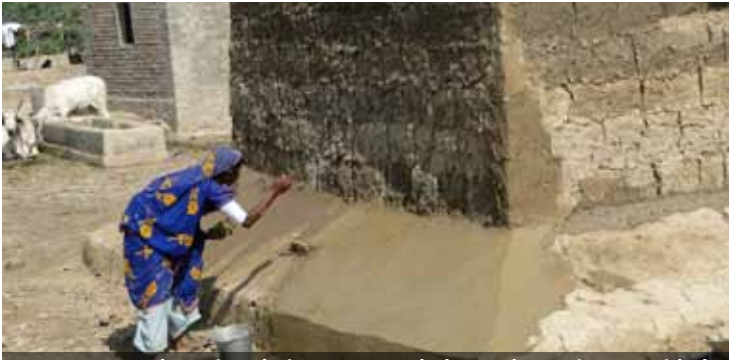
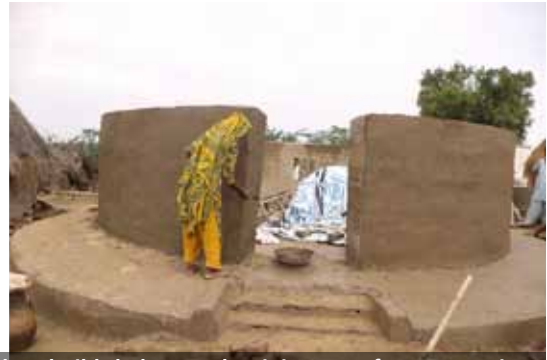
Women plastering their one room shelters. The project provided cash to build shelters and training on safer construction with incremental improvements such as stronger plinths and footings to walls. Households chose their own shelter design.

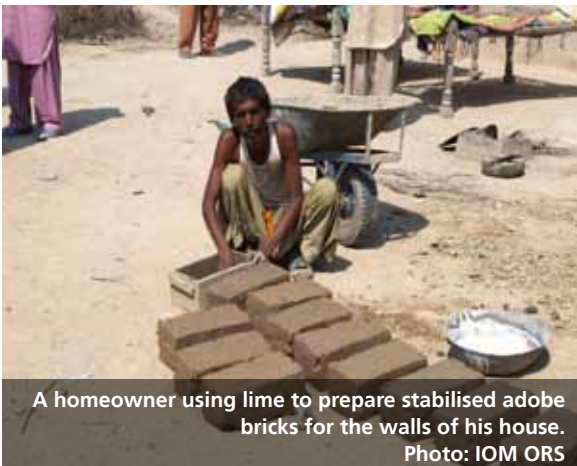
A homeowner using lime to prepare stabilised adobe bricks for the walls of his house.
Photo: IOM ORS

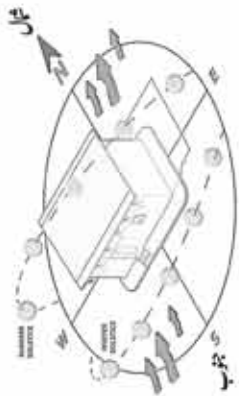
TYPE B-4 with KARAVAN CHAURA ROOF REED/LOH-KHAT MODULE CONSTRUCTION GUIDELINES

- Use soil with 20% - 40% clay using bottle test.
- Soak soil for 1 week and mix thoroughly.
- Begin constructing from the corners. Thickness of the wall should not be less than 18".
- Use mature, well cured bamboo (3 yrs +).
- Do not use bamboo poles with vertical cracks.
- Make sure bamboo ends are protected by lime cream bio-degradable special masala.

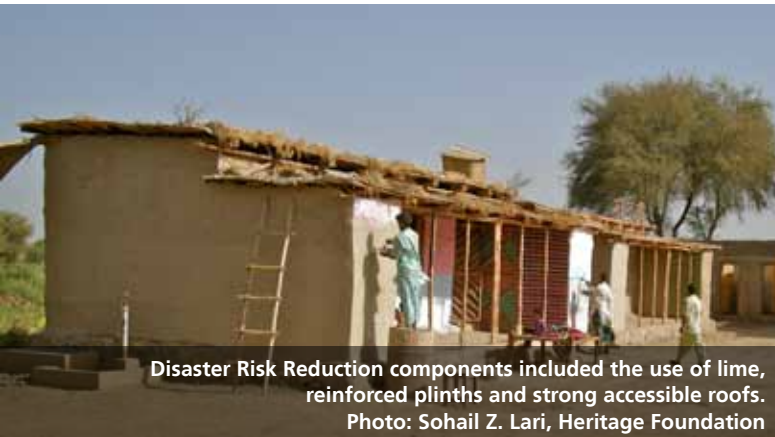
Disaster Risk Reduction components included the use of lime, reinforced plinths and strong accessible roofs.
Photo: Sohail Z. Lari, Heritage Foundation

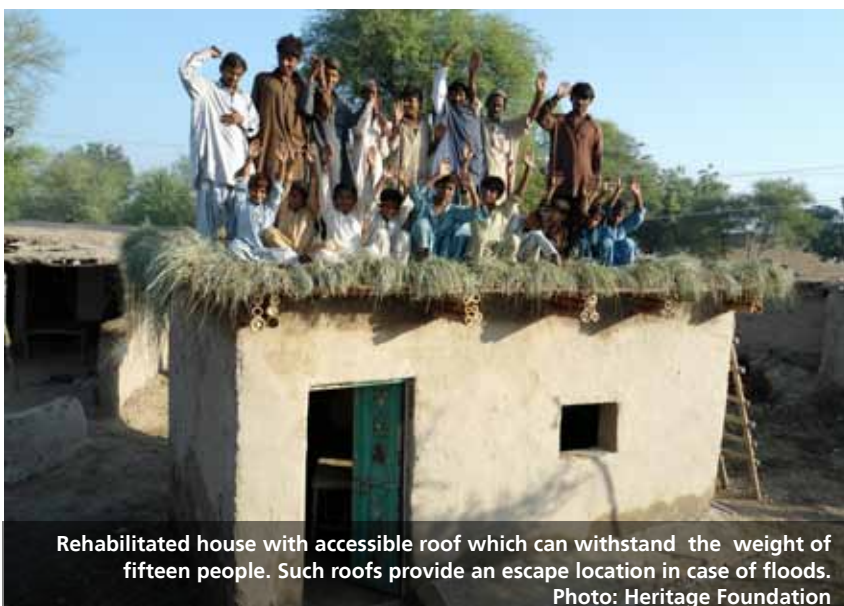
Rehabilitated house with accessible roof which can withstand the weight of fifteen people. Such roofs provide an escape location in case of floods. Photo: Heritage Foundation

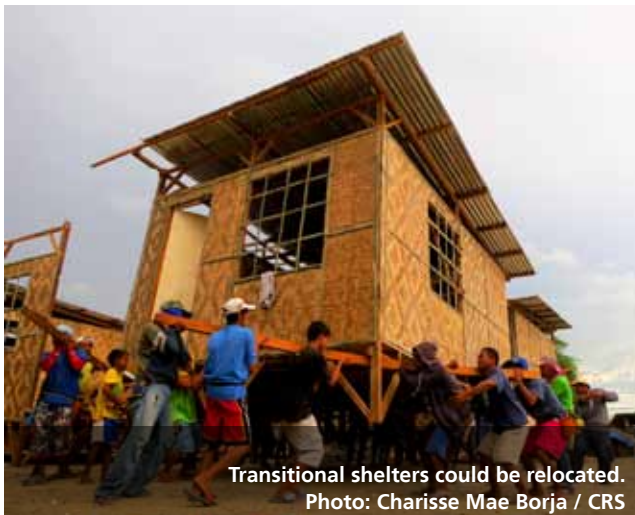
Transitional shelters could be relocated.
Photo: Charisse Mae Borja / CRS

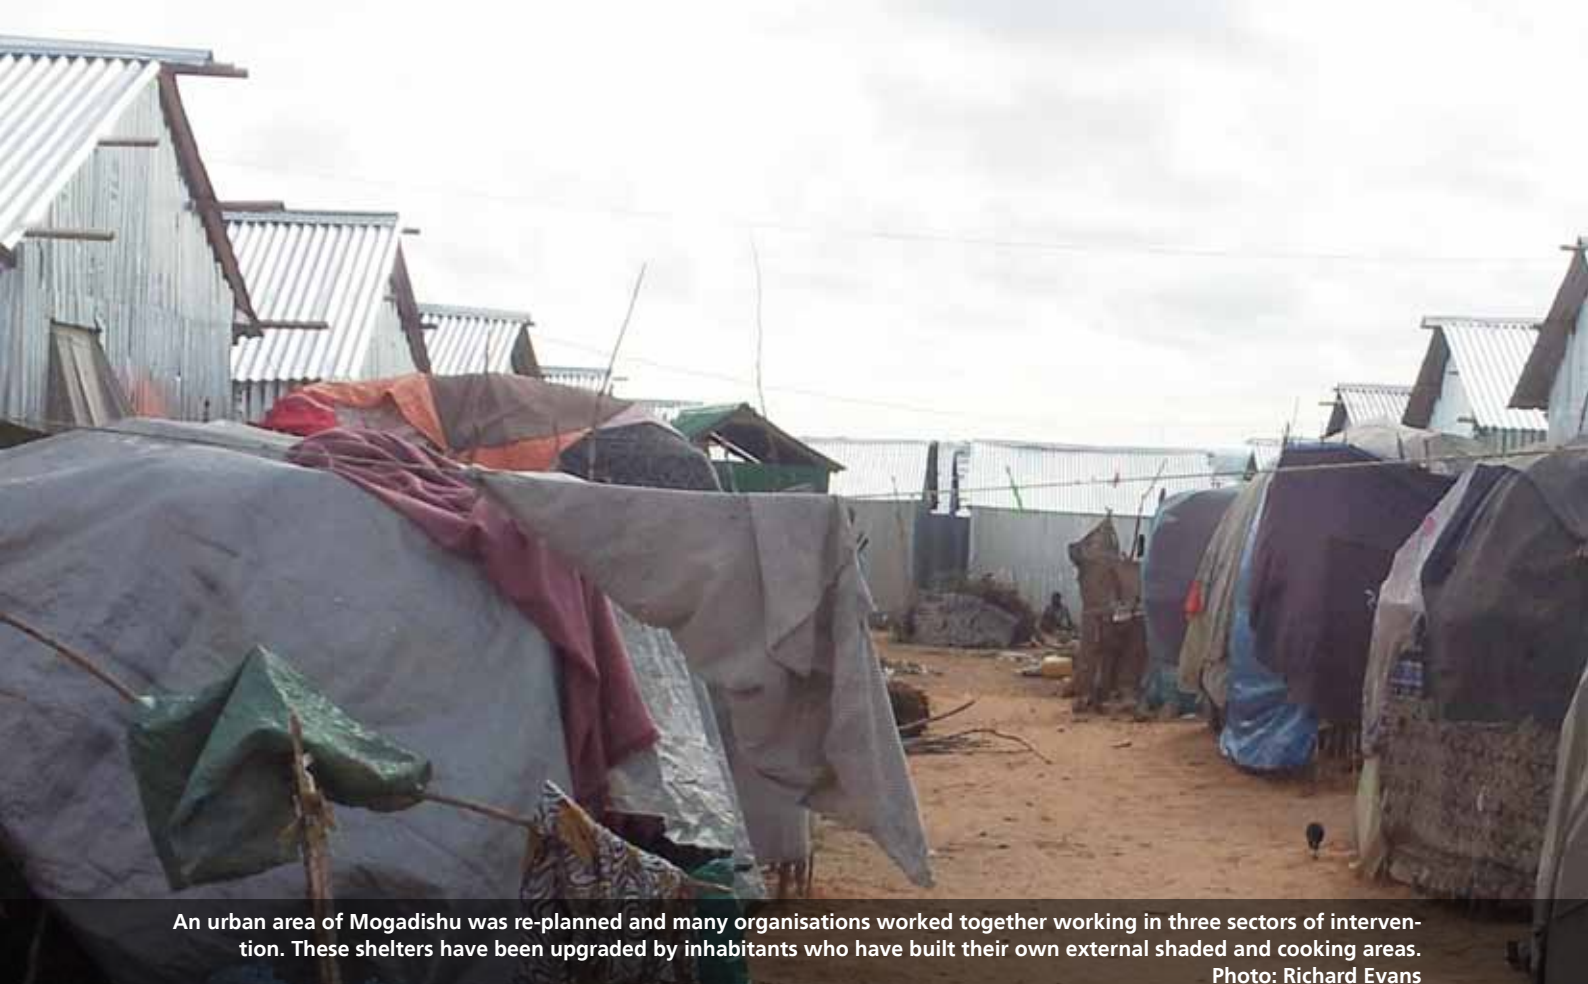
An urban area of Mogadishu was re-planned and many organisations worked together working in three sectors of intervention. These shelters have been upgraded by inhabitants who have built their own external shaded and cooking areas. Photo: Richard Evans

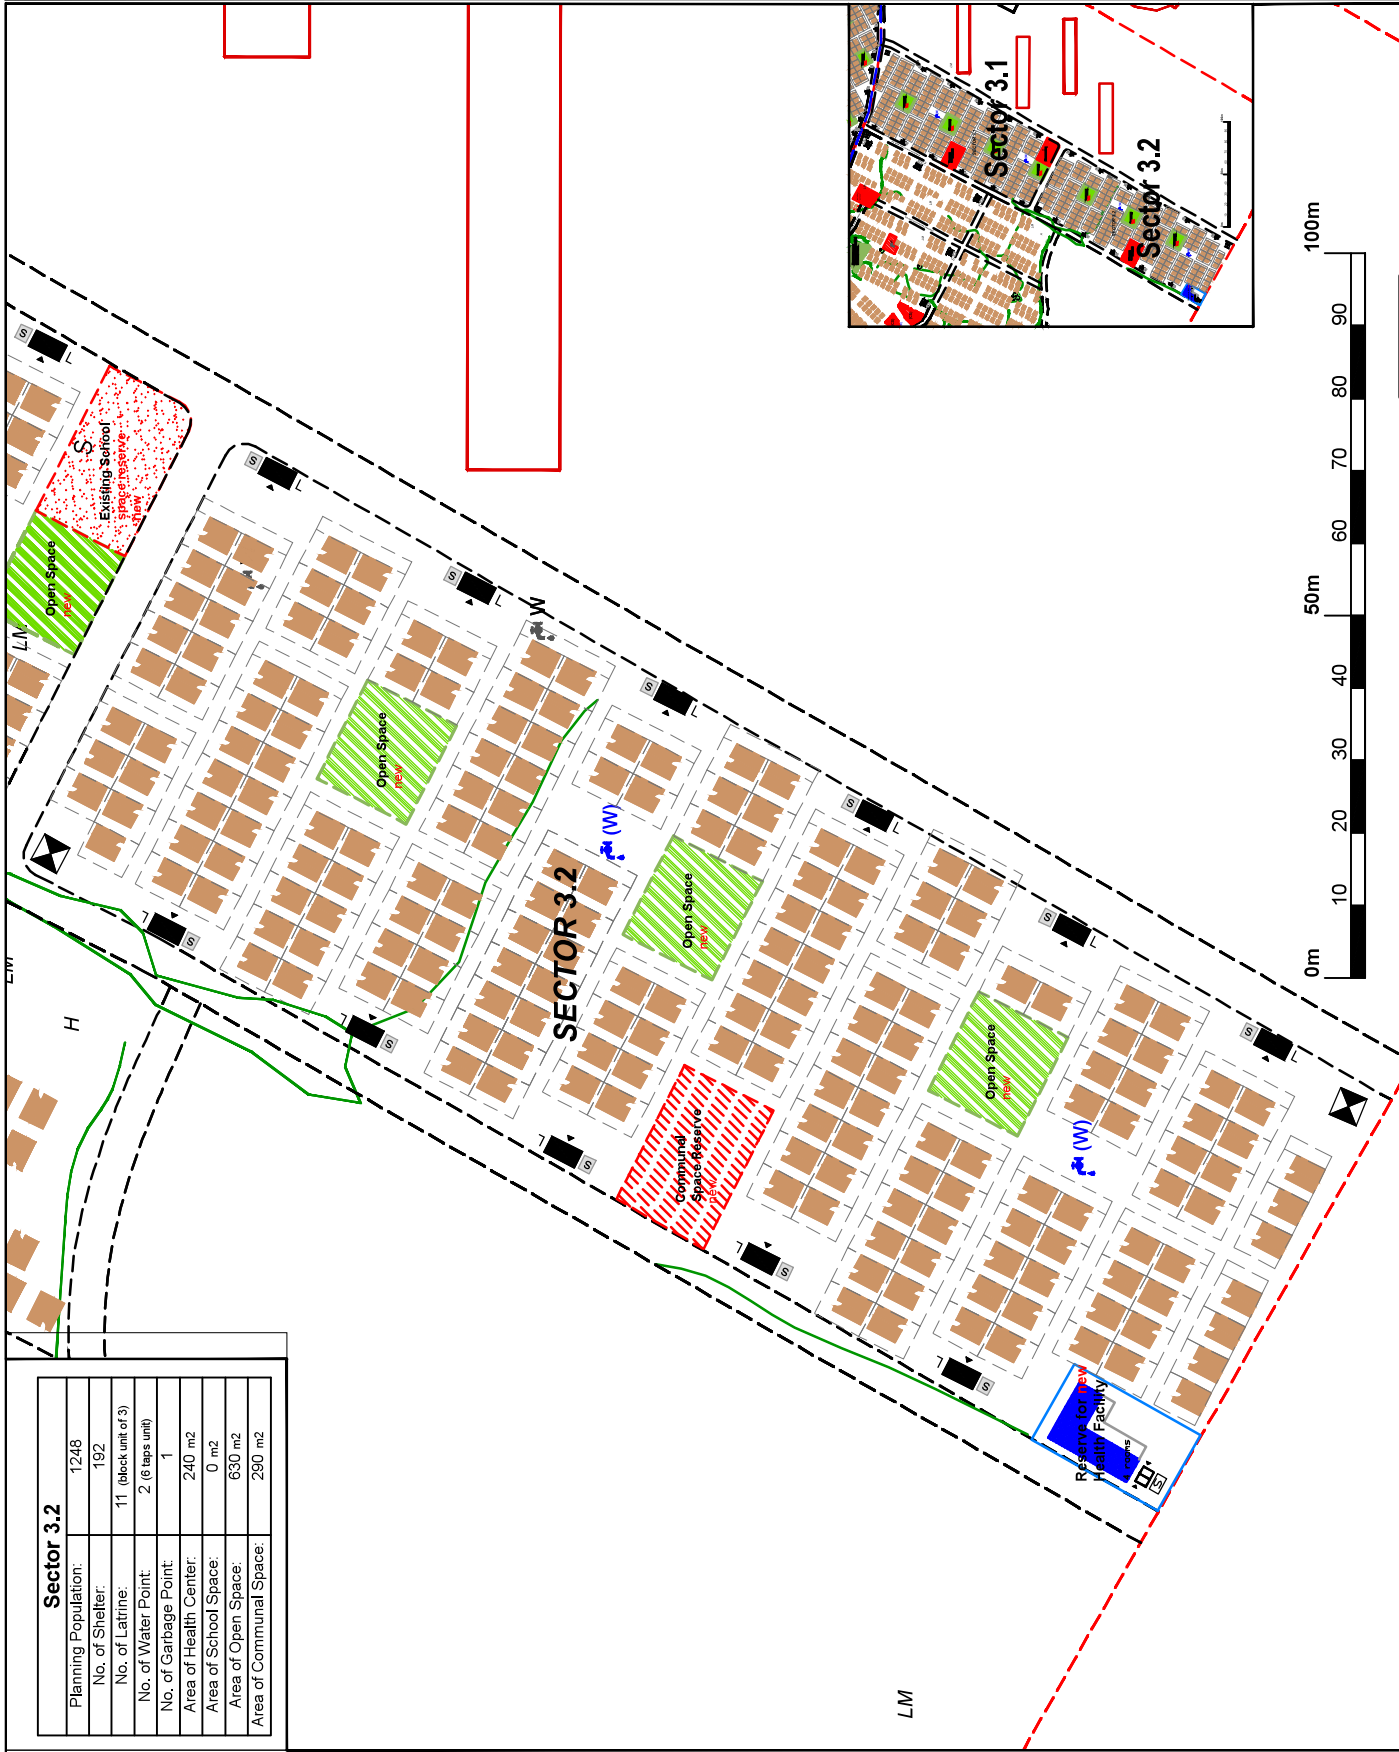
Sector 3.2	
Planning Population:	1248
No. of Shelter:	192
No. of Latrine:	11 (block unit of 3)
No. of Water Point:	2 (6 taps unit)
No. of Garbage Point:	1
Area of Health Center:	240 m ²
Area of School Space:	0 m ²
Area of Open Space:	630 m ²
Area of Communal Space:	290 m ²

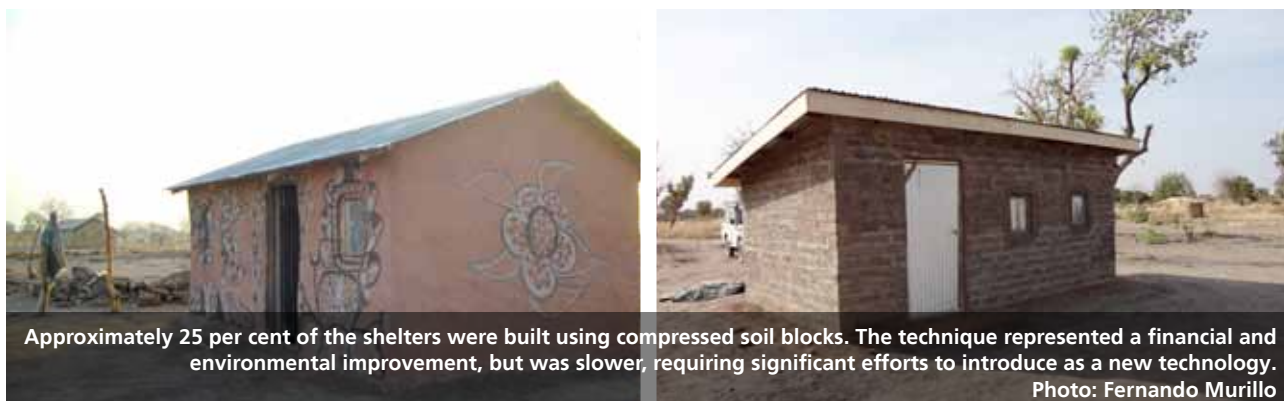
Approximately 25 per cent of the shelters were built using compressed soil blocks. The technique represented a financial and environmental improvement, but was slower, requiring significant efforts to introduce as a new technology.

- ✗ Construction using compressed mud blocks required a highly-skilled lead builder. In some early cases, skills were lacking and build quality was poor.
- ✗ Due to unexpectedly slow block production, the number of mud block shelters was cut by 800.
- ✗ Plans to use drainage activities to supply the mud required for blocks failed due to the lack of organisation at the community level.
- ✗ The project was too big and created unsustainable demands for materials, leading to concerns over the destruction of national forests.
- Compressed mud-blocks needed to be plastered with burnt oil, sandy soil and Arabic gum.
- As the compressed mud-block technique was new to some areas, its performance over time remains untested.

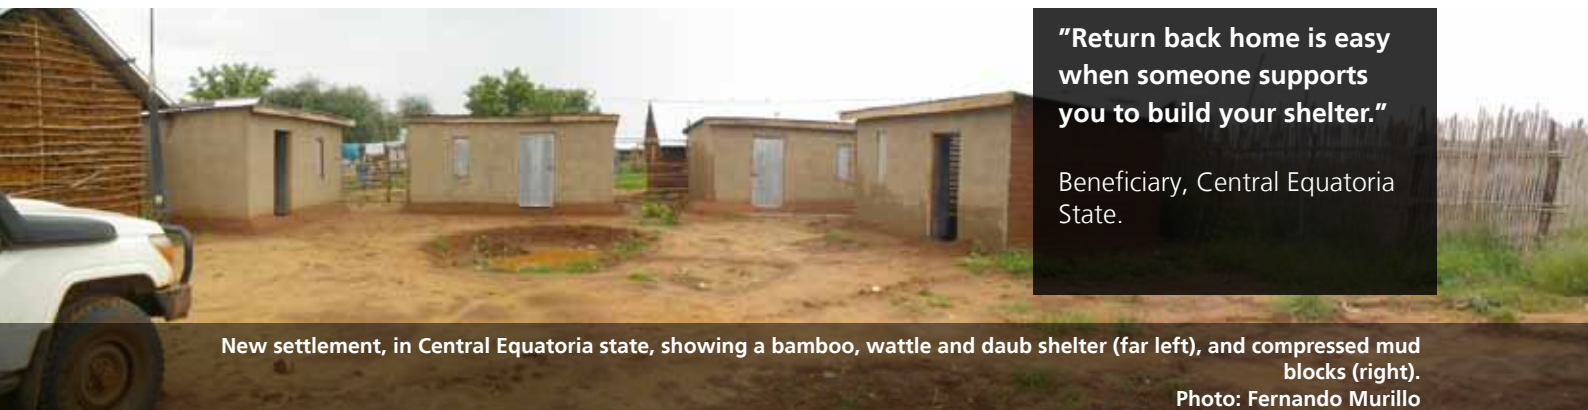
New settlement, in Central Equatoria state, showing a bamboo, wattle and daub shelter (far left), and compressed mud blocks (right).

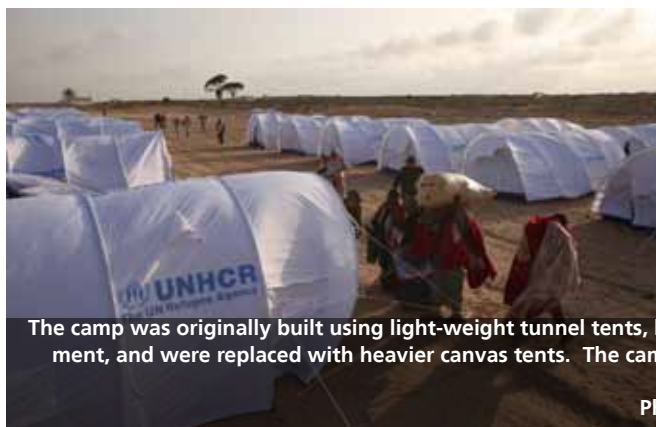
The camp was originally built using light-weight tunnel tents, but these had a limited lifespan in the hot and windy environment, and were replaced with heavier canvas tents. The camp later burned down and was replanned to take into account the population's different nationalities.

The tents were also very fragile, breaking very easily. They did not have any exterior shading and were blown away by the wind. After a few weeks, the white tunnel tents were replaced by heavier green canvas tents. These tents were easier to build and a little more robust. However, the roof pole (horizontal beam) was weak and regularly broke.

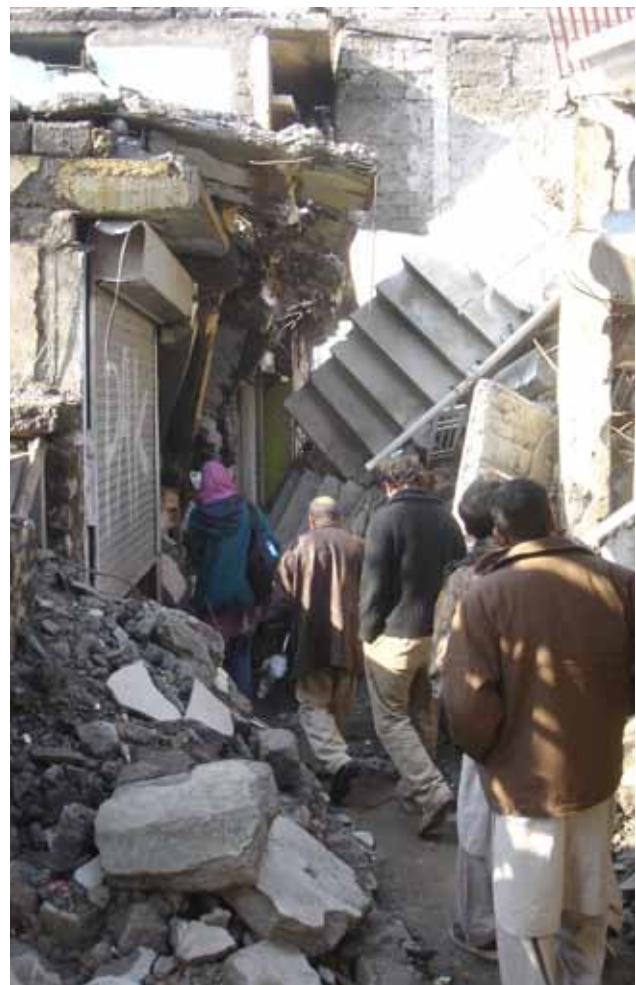
“Debris removal is decisive... Drainage is essential...”
Photo: Joseph Ashmore

Debris removal is decisive. Even relief response cannot effectively start without rubble removal, much less recovery or development. Drainage is essential because it will dictate the quality of the storm water (which affects floods) and waste water systems (which affects sanitation). Drainage will be tied to a mitigating topology which is also important because most of the places in which responders serve involve hazardous lands.
