# SHELTER PROJECTS

# 2013-2014

## **Shelter Projects 2013–2014**

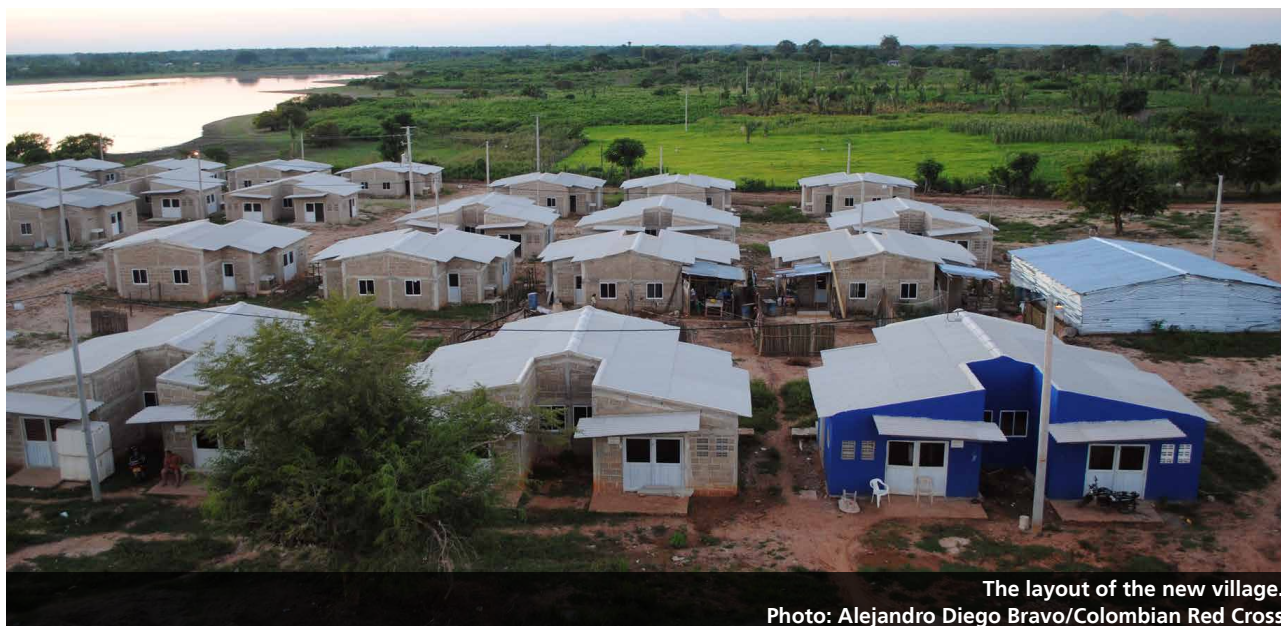
The layout of the new village.  
Photo: Alejandro Diego Bravo/Colombian Red Cross

- The design and construction of durable housing, based on minimum space standards and disaster-resistant features.
- Water pumping with filtering beds to clean waste-water before it returned to the lagoon.
- Rainwater harvesting.

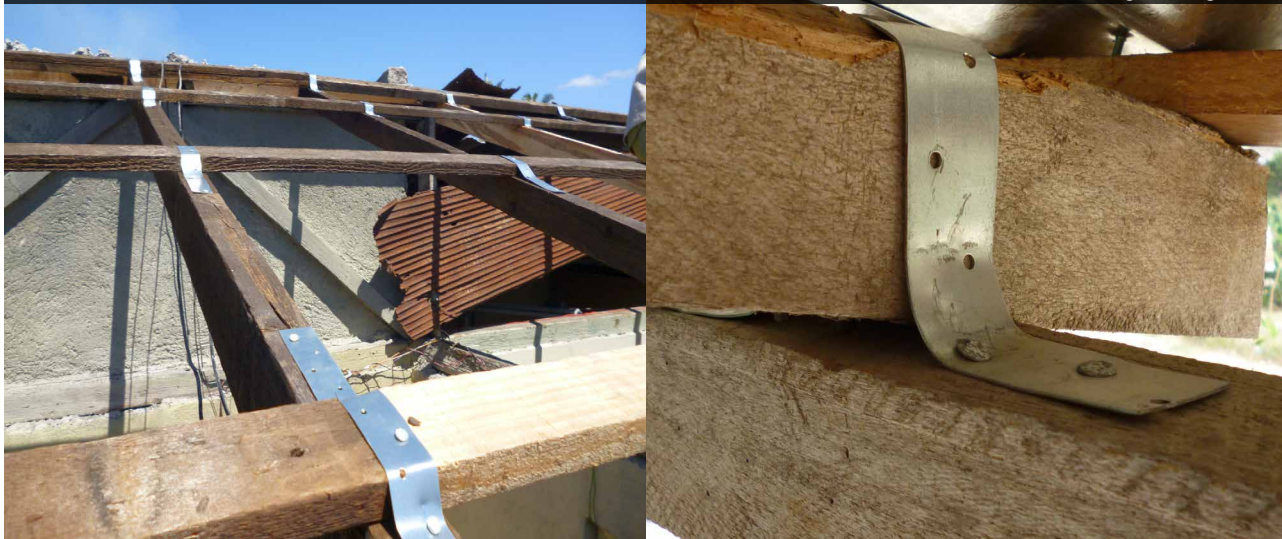
Organisation B introduced the new technology of Hurricane straps to Cuba. The straps were not always folded down correctly so training and site inspections were organised to reduce incorrect application. Photos: Santiago Luengo/IFRC

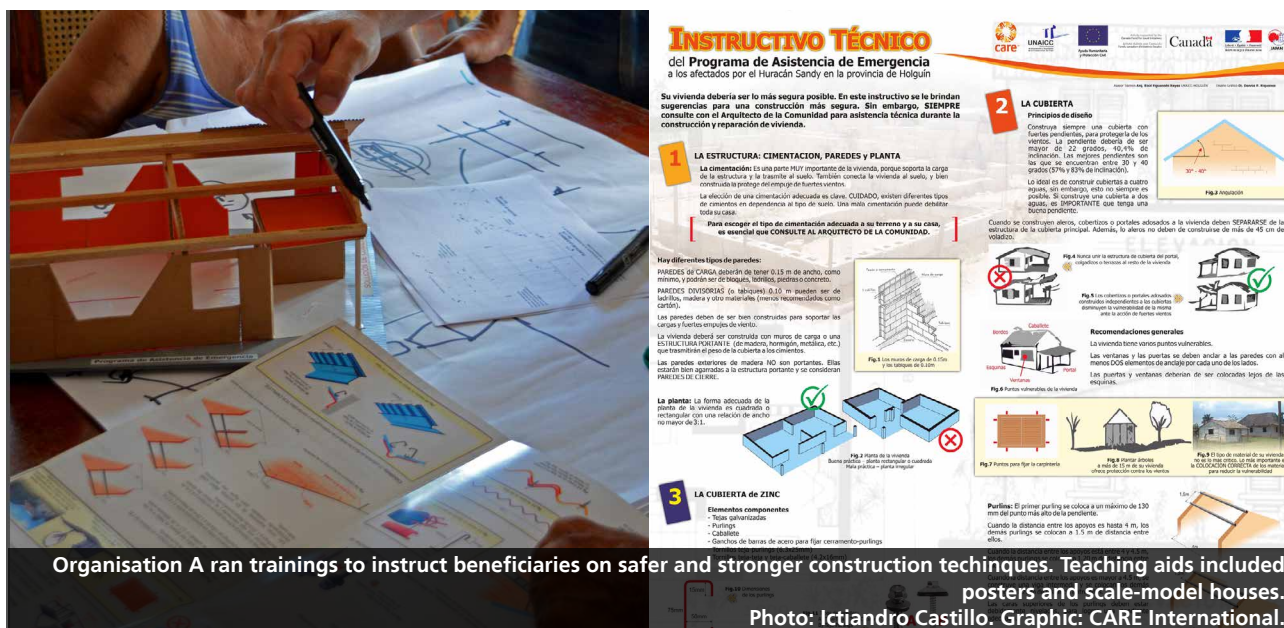
Organisation A ran trainings to instruct beneficiaries on safer and stronger construction techniques. Teaching aids included posters and scale-model houses. Photo: Ictiandro Castillo. Graphic: CARE International.

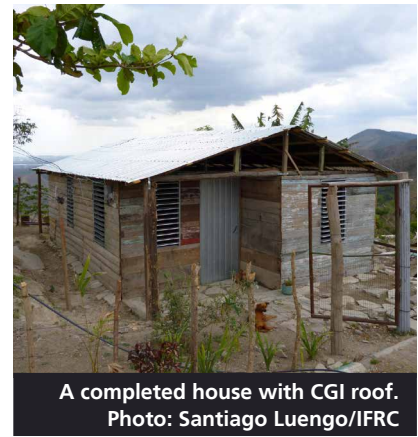
**A completed house with CGI roof.**  
Photo: Santiago Luengo/IFRC

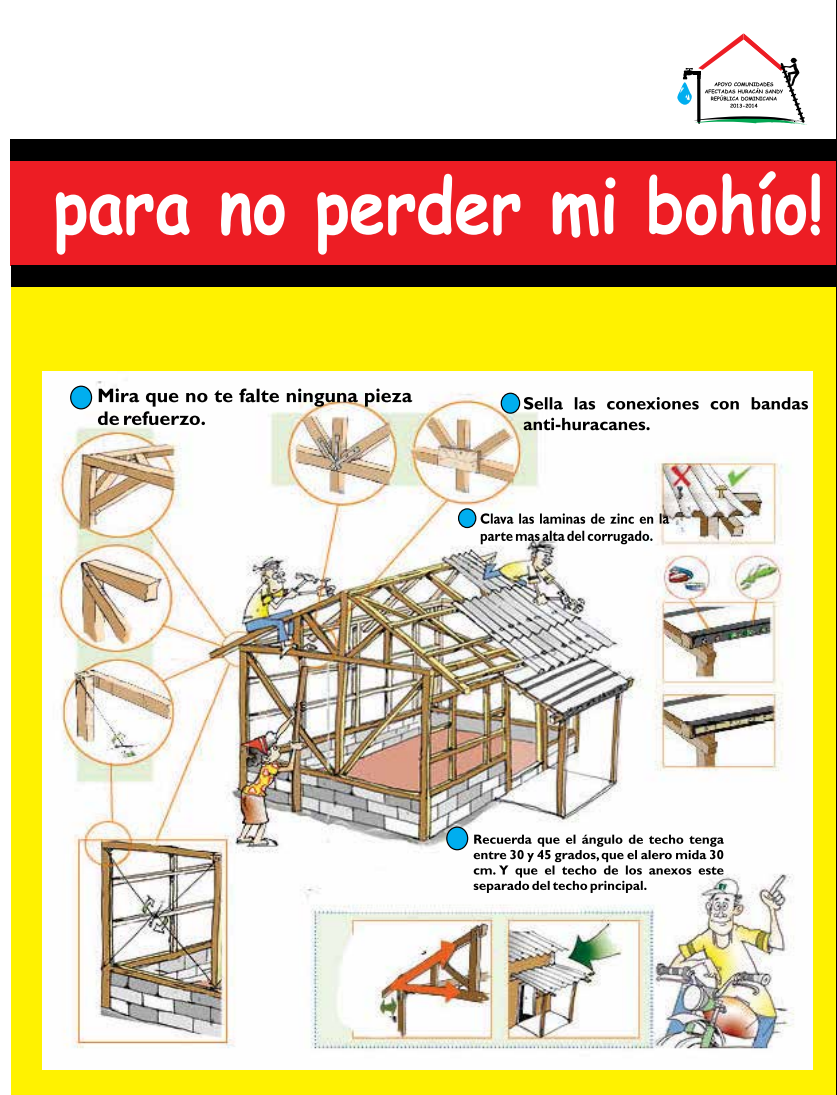
Safe construction techniques were communicated through a construction manual, posters and leaflets.  
Graphic: Cruz Roja Española

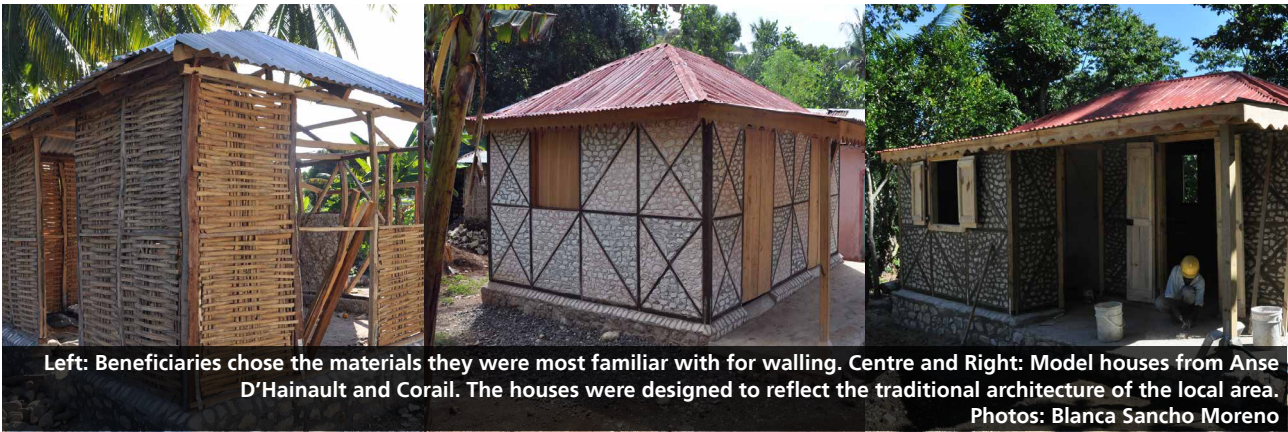
Left: Beneficiaries chose the materials they were most familiar with for walling. Centre and Right: Model houses from Anse D'Hainault and Corail. The houses were designed to reflect the traditional architecture of the local area. Photos: Blanca Sancho Moreno

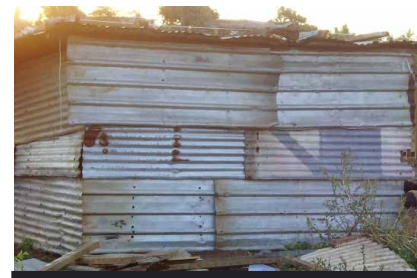
An example of the poor quality shelters characteristic of the "informal" sector.  
Photo: Habitat for Humanity Fiji.

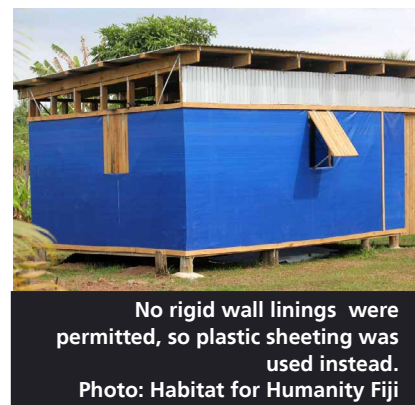
No rigid wall linings were permitted, so plastic sheeting was used instead. Photo: Habitat for Humanity Fiji

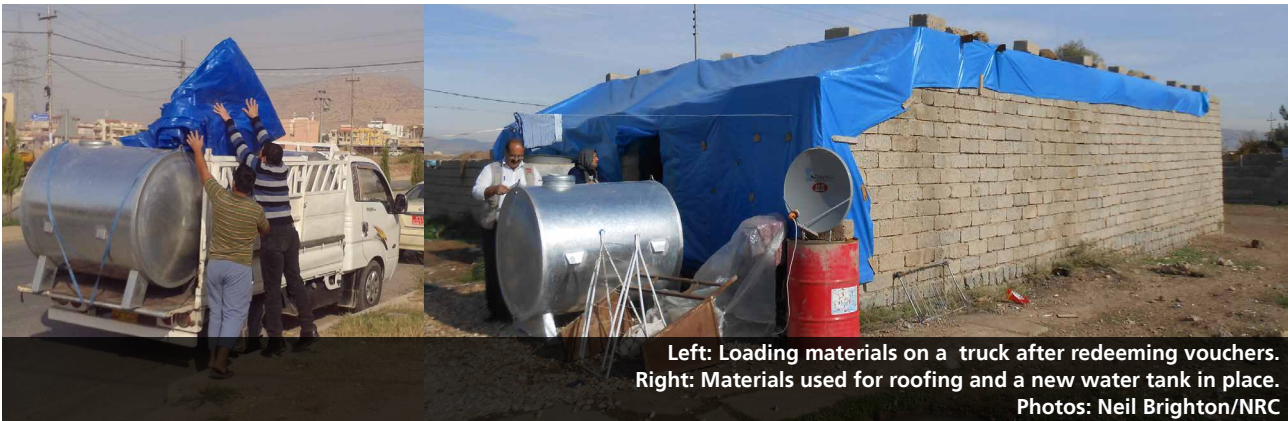
Left: Loading materials on a truck after redeeming vouchers.  
Right: Materials used for roofing and a new water tank in place.  
Photos: Neil Brighton/NRC

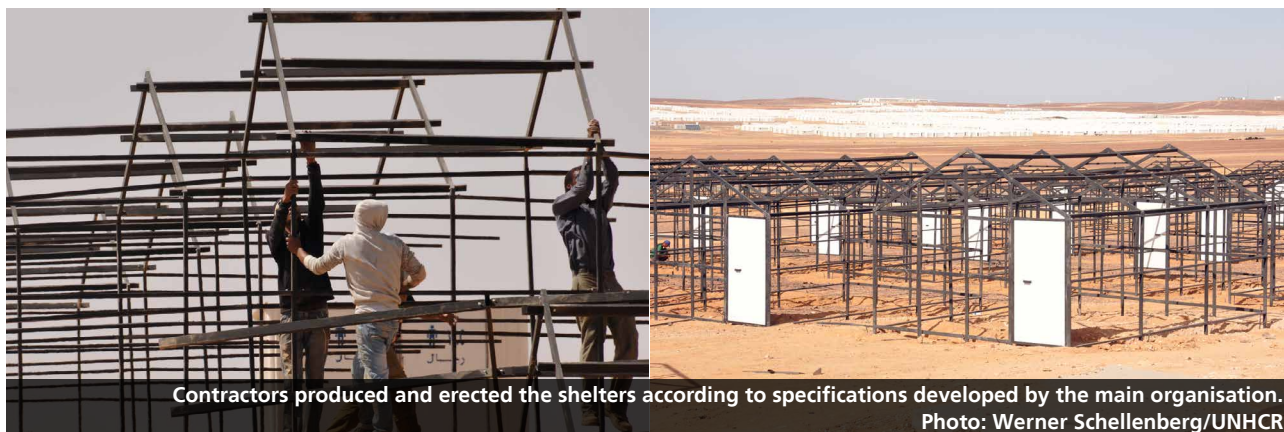
Contractors produced and erected the shelters according to specifications developed by the main organisation. Photo: Werner Schellenberg/UNHCR

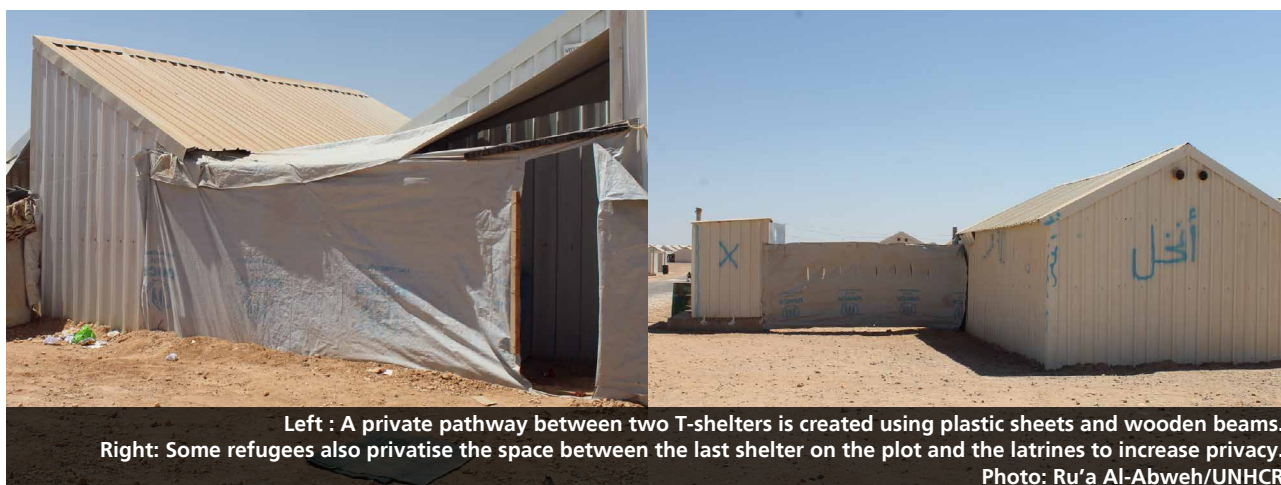
Left : A private pathway between two T-shelters is created using plastic sheets and wooden beams. Right: Some refugees also privatise the space between the last shelter on the plot and the latrines to increase privacy. Photo: Ru'a Al-Abweh/UNHCR

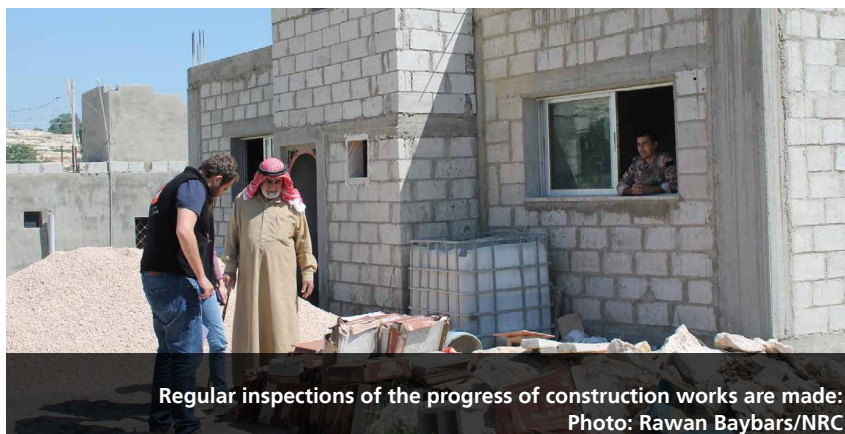
Regular inspections of the progress of construction works are made:  
Photo: Rawan Baybars/NRC

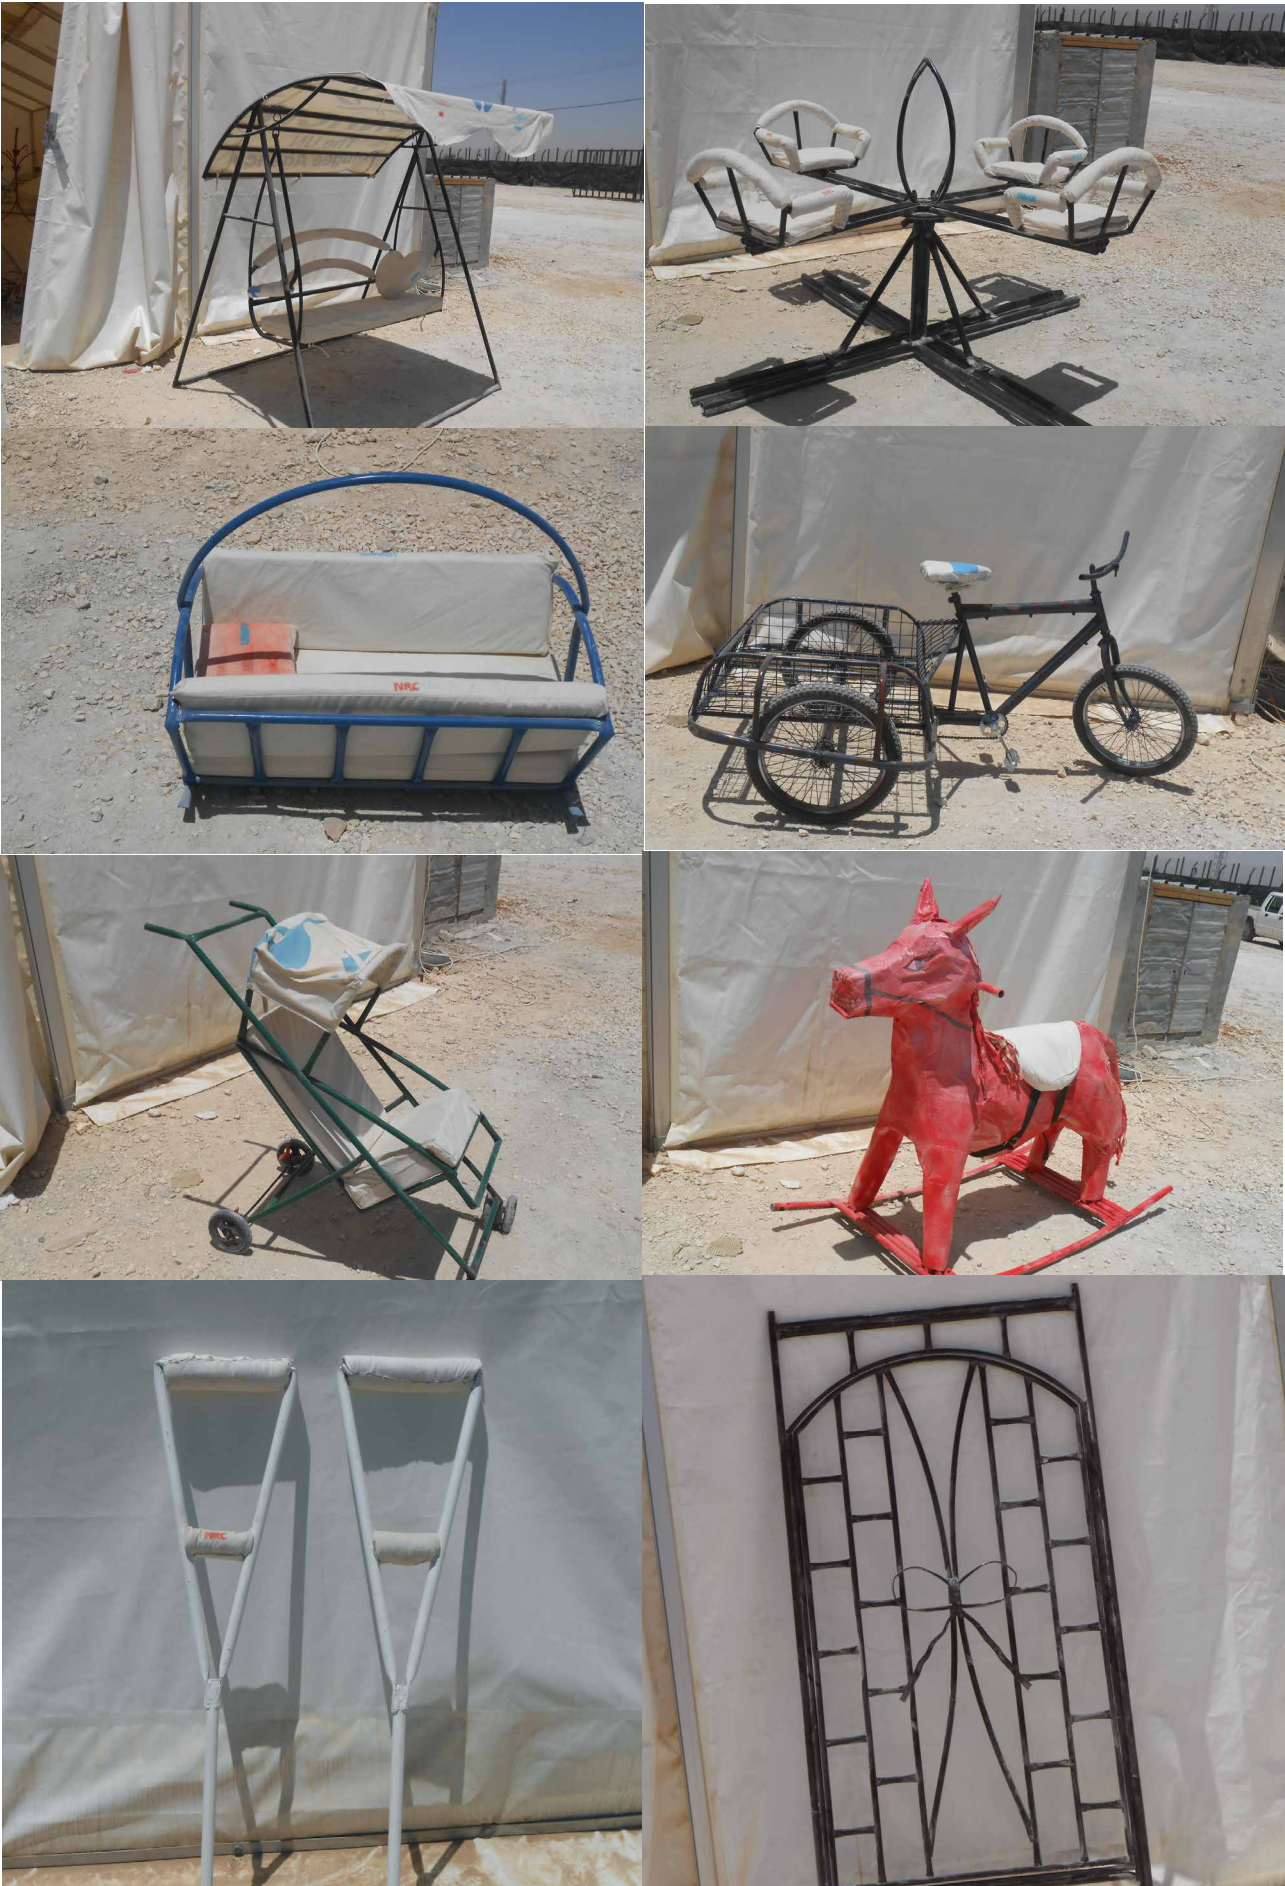
Examples of furniture, play equipment, and disability aids made out of left-over materials from the tent recycling project. Photo: Fadi Al Masarweh/NRC

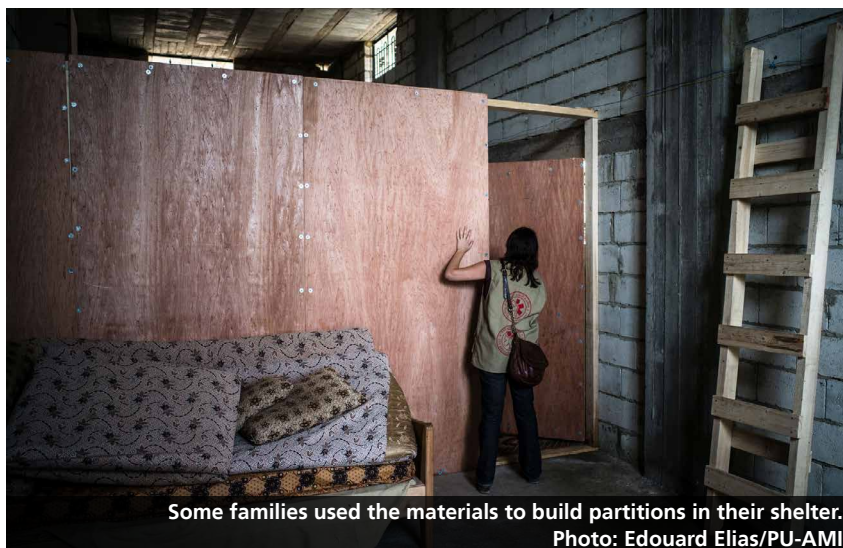
Some families used the materials to build partitions in their shelter.  
Photo: Edouard Elias/PU-AMI

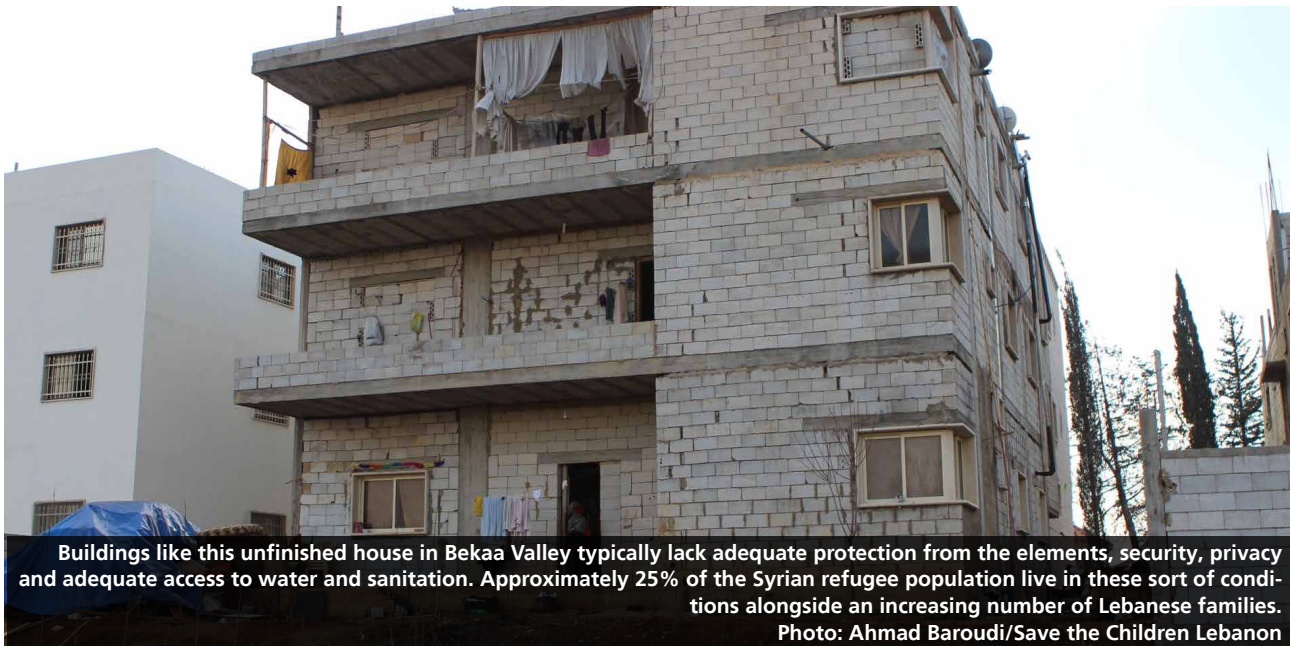
Buildings like this unfinished house in Bekaa Valley typically lack adequate protection from the elements, security, privacy and adequate access to water and sanitation. Approximately 25% of the Syrian refugee population live in these sort of conditions alongside an increasing number of Lebanese families. Photo: Ahmad Baroudi/Save the Children Lebanon

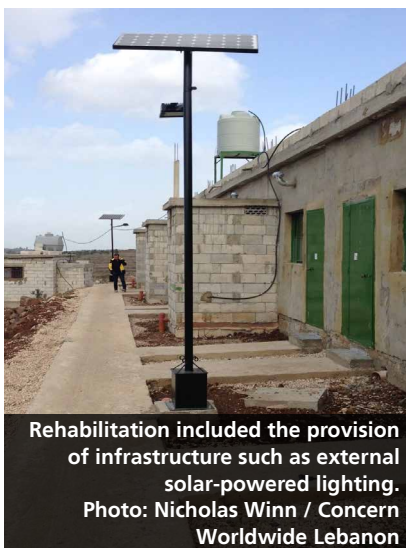
Rehabilitation included the provision of infrastructure such as external solar-powered lighting. Photo: Nicholas Winn / Concern Worldwide Lebanon

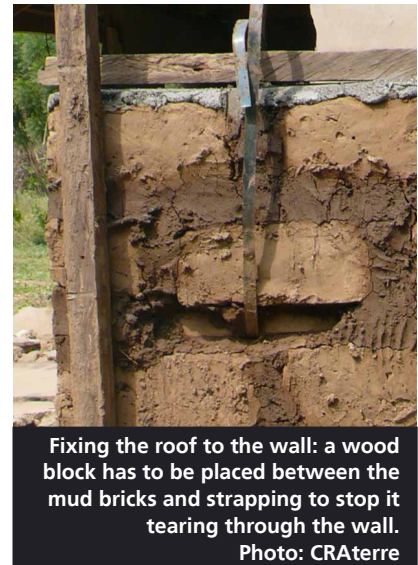
Fixing the roof to the wall: a wood block has to be placed between the mud bricks and strapping to stop it tearing through the wall.  
Photo: CRAterre

The training was conducted by a team made up of the organisation's own shelter experts, the organisation's technical partner, and a university-based expert. The training focussed on improved roof-fixing methods, constructing a damp course, and bracing techniques.

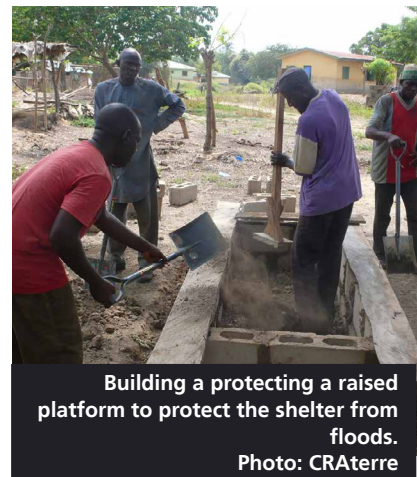
Building a protecting a raised platform to protect the shelter from floods.  
Photo: CRAterre

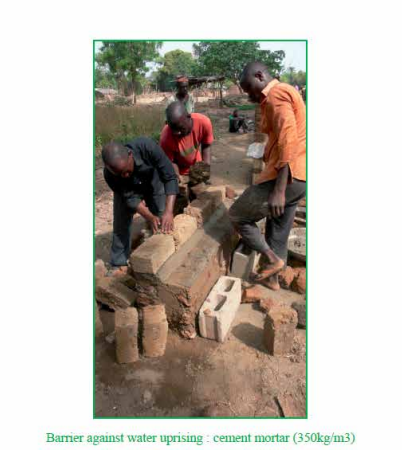
The technical partner produced training material that included a focus on how best to protect walls from water damage. Graphics: CRAterre / Nigerian Red Cross

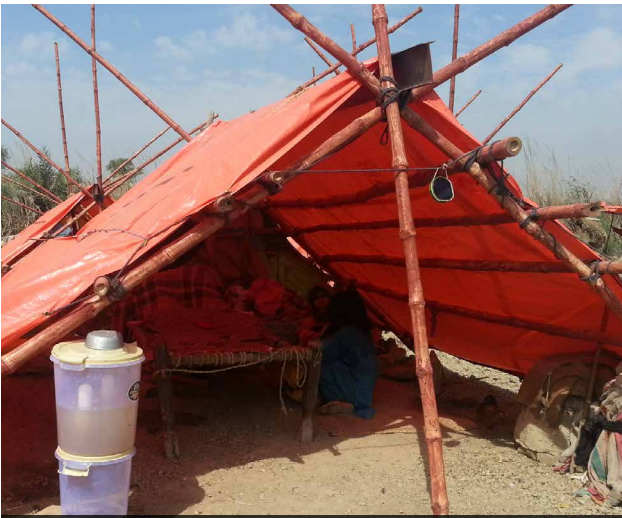
An example of an emergency roofing kit which will later be used for a transitional shelter then again for the roofing elements of a permanent flood resistant shelter.  
Photo: Magnus Wolfe Murray

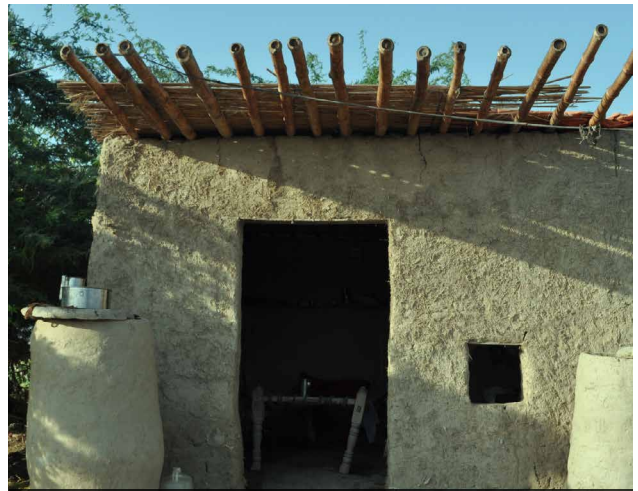
The second, transitional stage in the life of a roofing kit. This temporary hut, lived in for about a year, will be dismantled and the roof will be used for a permanent house. This saves around US\$ 111 from the cost of the new shelter.  
Photo: Magnus Wolfe Murray

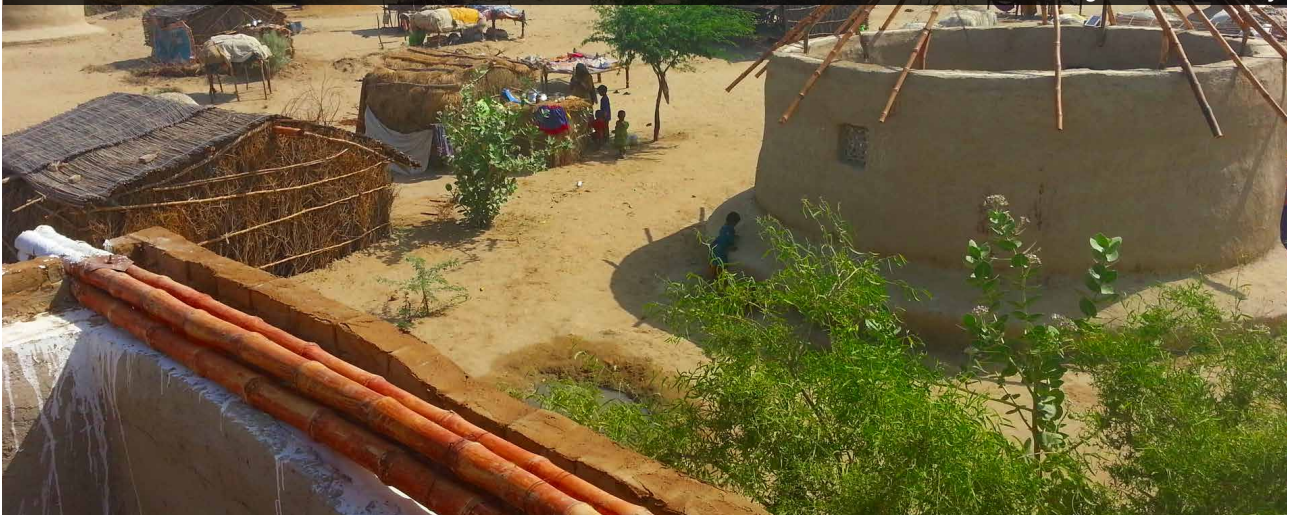
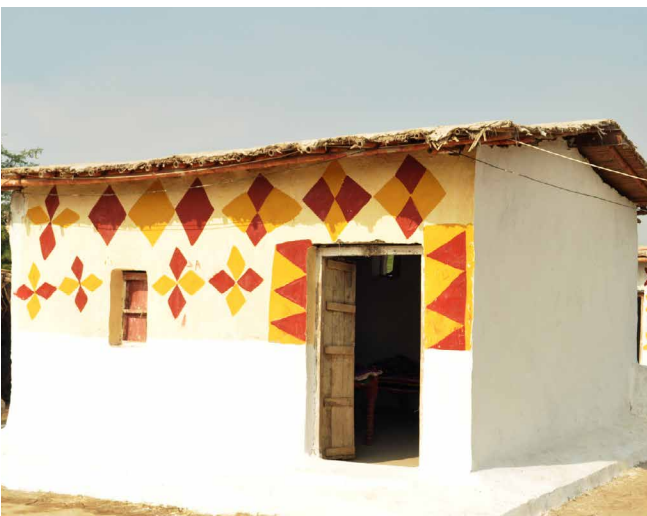
Sangar district, Southern Sindh, December 2013. Lime stabilised mud brick foundations and walls. Flood resistant with pitched, not flat, roof.  
Photo: Magnus Wolfe Murray

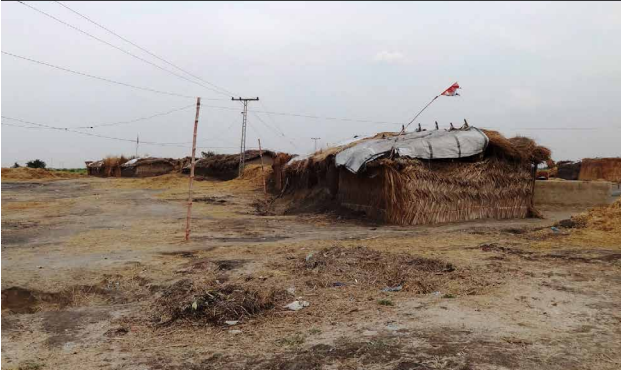
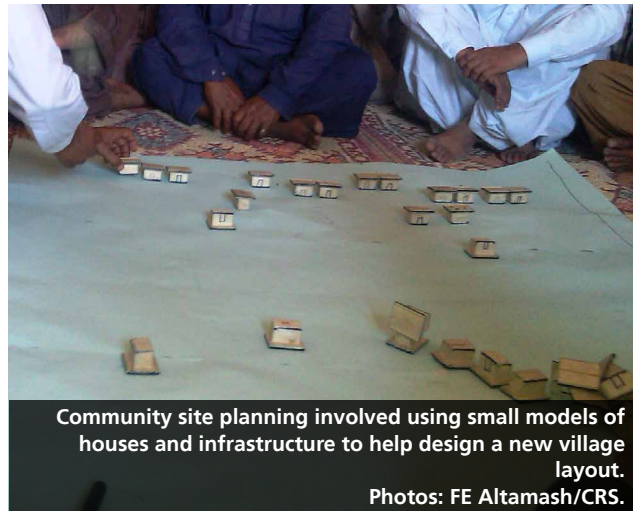
Community site planning involved using small models of houses and infrastructure to help design a new village layout.  
Photos: FE Altamash/CRS.

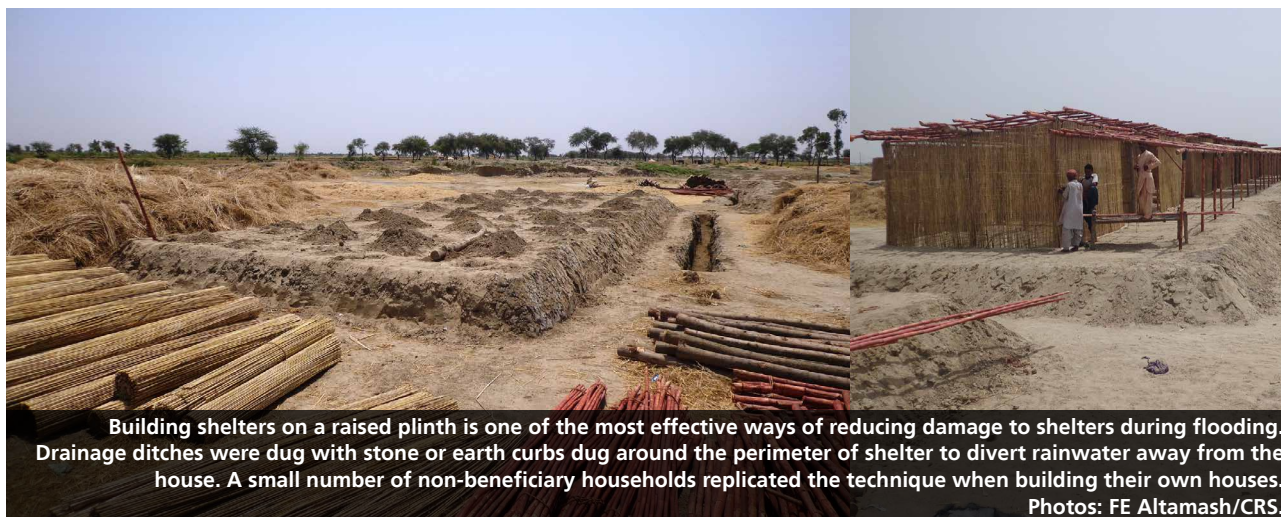
Building shelters on a raised plinth is one of the most effective ways of reducing damage to shelters during flooding. Drainage ditches were dug with stone or earth curbs dug around the perimeter of shelter to divert rainwater away from the house. A small number of non-beneficiary households replicated the technique when building their own houses. Photos: FE Altamash/CRS.

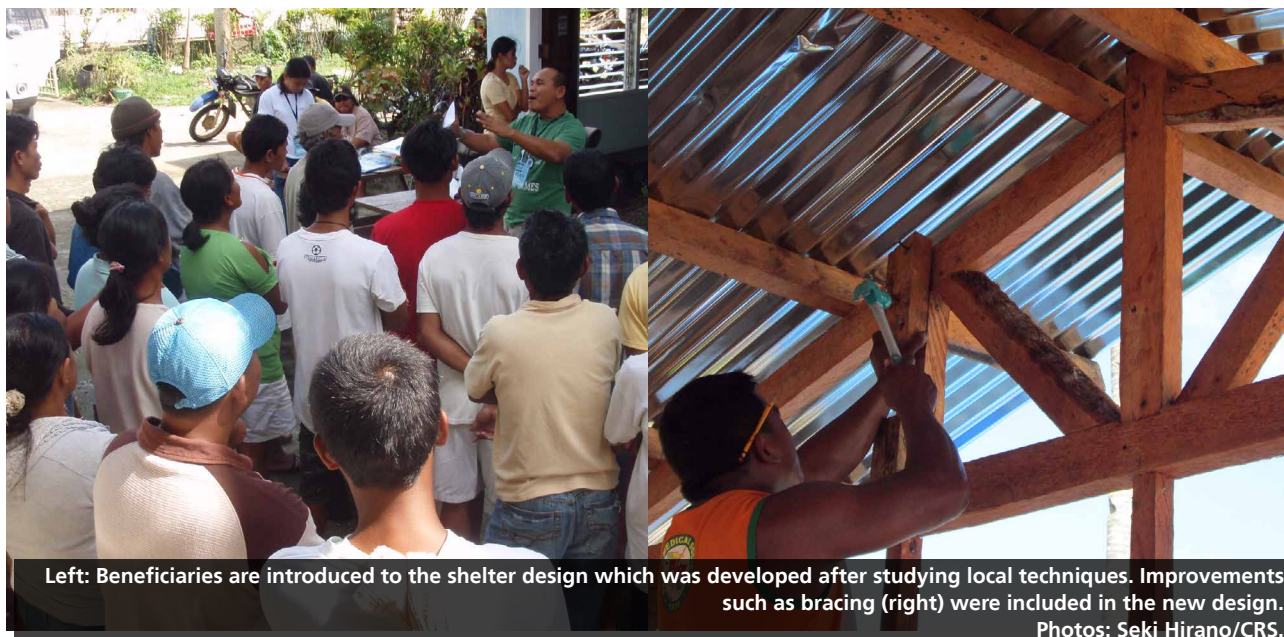
Left: Beneficiaries are introduced to the shelter design which was developed after studying local techniques. Improvements such as bracing (right) were included in the new design. Photos: Seki Hirano/CRS.

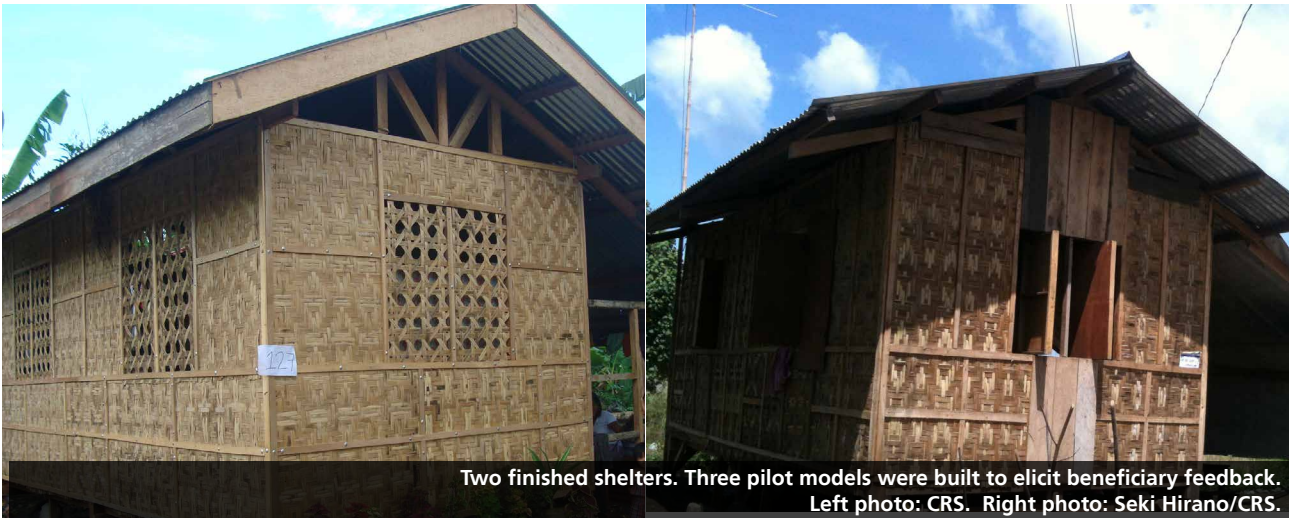
Two finished shelters. Three pilot models were built to elicit beneficiary feedback. Left photo: CRS. Right photo: Seki Hirano/CRS.

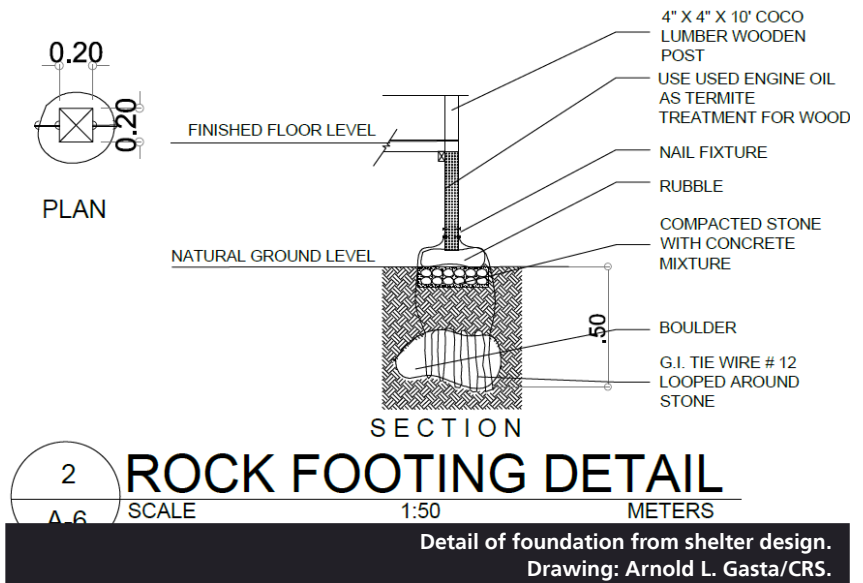
Detail of foundation from shelter design. Drawing: Arnold L. Gasta/CRS.

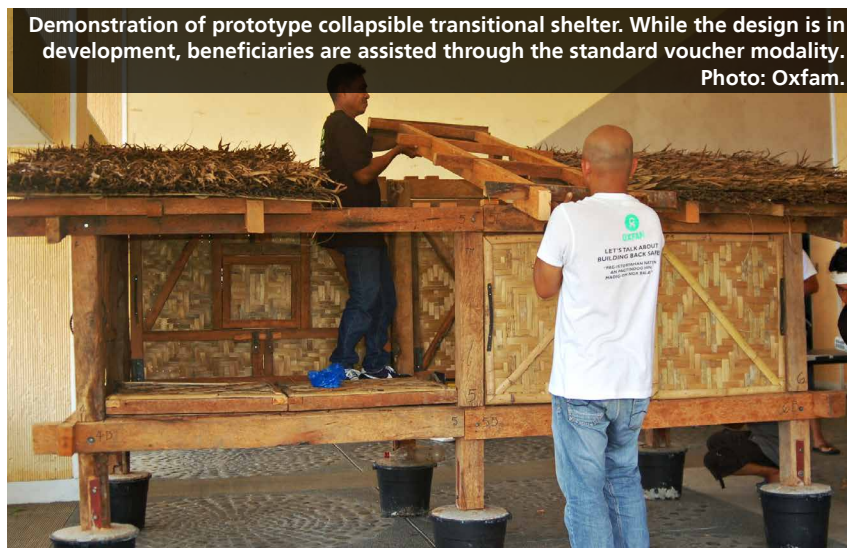
Demonstration of prototype collapsible transitional shelter. While the design is in development, beneficiaries are assisted through the standard voucher modality. Photo: Oxfam.

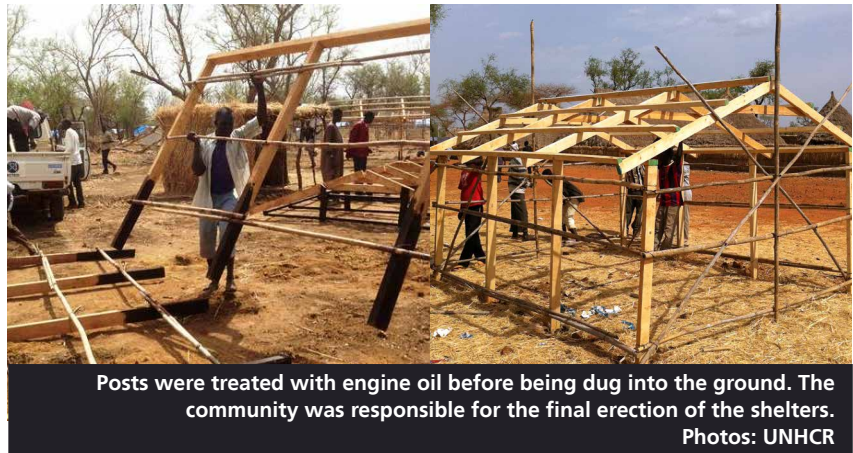
Posts were treated with engine oil before being dug into the ground. The community was responsible for the final erection of the shelters.

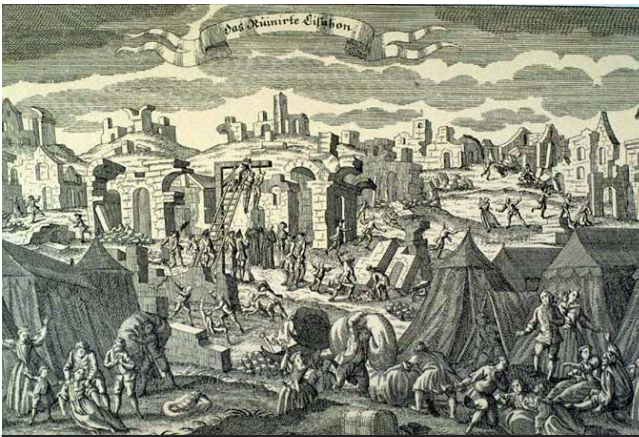
Following the earthquake, Lisbon was hit by a tidal wave and then a fire that burned for six days. Many in the clergy believed that people were being punished for their sins. Image: 1755 German copperplate image, "The Ruins of Lisbon" Wikimedia Commons, public domain

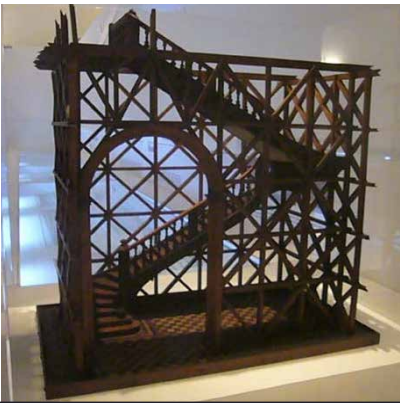
A model showing the Pombaline cage design. The design is said to have been tested by getting the army to walk up and down on the roof of a full-size model.

The new anti-seismic design by Carlos Mardel included an internal timber-frame with an embedded post-and-beam construction with high levels of bracing. The frame was filled with rubble and then plastered to add protection against fire. The design became known as the "Pombaline Cage" and the first building began in 1759, a year after

The design was apparently tested by running a stress-test on a full-scale model in the city's main square. The military were ordered to march in uncoordinated, uneven rhythms on top of the building to simulate the tremor conditions of an earthquake (Mata dos Santos 2008).

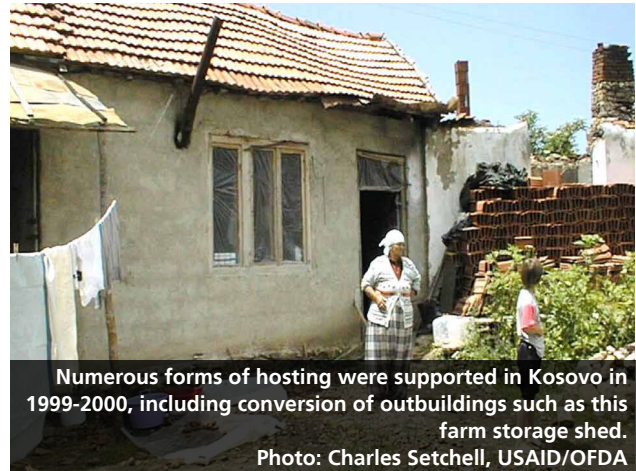
Numerous forms of hosting were supported in Kosovo in 1999-2000, including conversion of outbuildings such as this farm storage shed.
