CASE STUDY **ETHIOPIA 2014-2016 / S. SUDAN CRISIS**

**KEYWORDS:** Transitional shelter, Site planning, Training, Local techniques

**PROJECT SUMMARY**

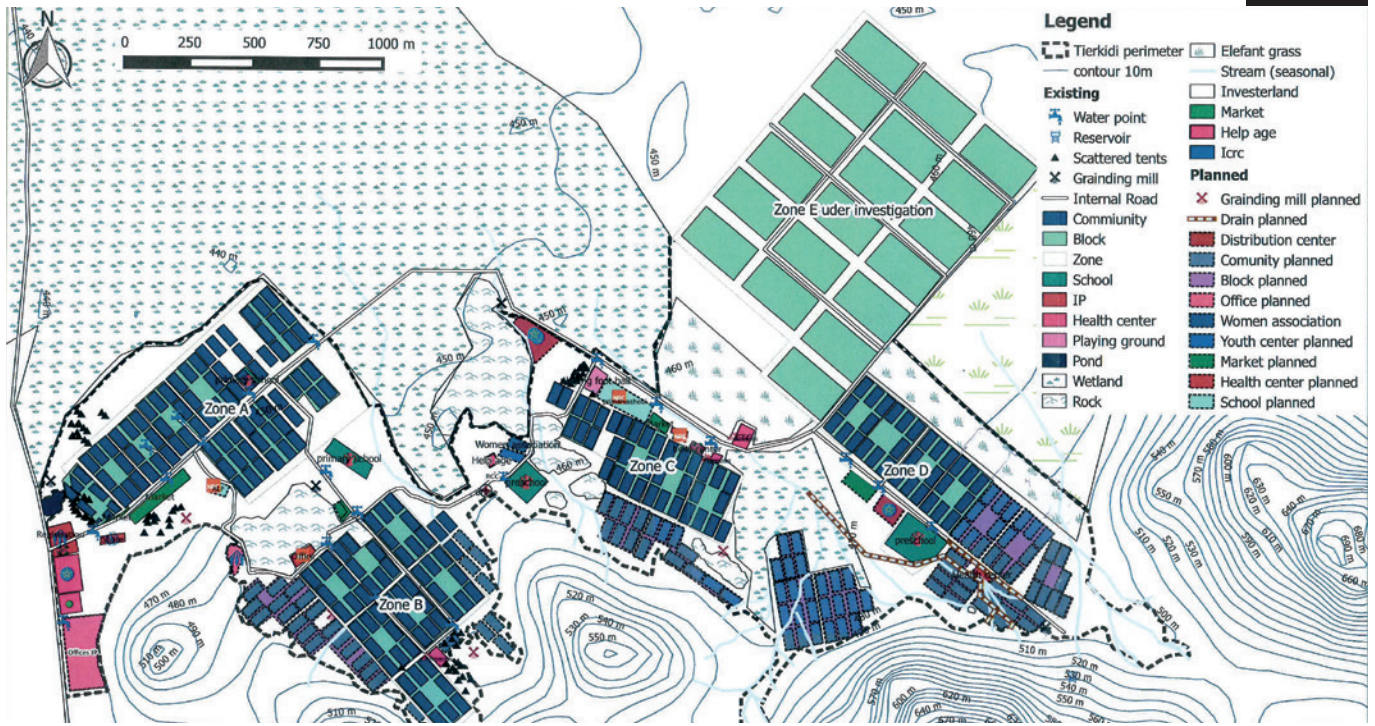
The shelter project built shelters in areas D and C of Tierkidi, a planned refugee camp (plan as of January 2015).

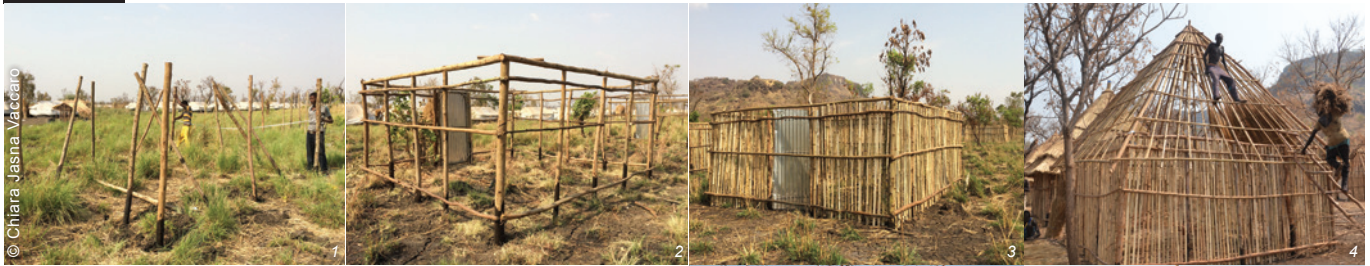
Skilled workers were paid to build shelters in the following stages: 1. The site was demarcated and structural poles were erected. 2. The structure and door were built. 3. Wall matting was added. 4. The roof structure was built. 5. The roof was thatched. 6. Once the thatching was complete, the *Tukul* was ready to be plastered with mud (see picture on the opposite page).

The chosen design consisted of a mud *tukul* (traditional house) with a eucalyptus wooden structure finished with bamboo or grass-thatch matting for the mud render. The shape, as well as the thick mud layer, protect the structure from the elements and helps in maintaining a cooler indoor temperature. The materials, grown in large plantations, are normally abundant in the region. However, a quick market survey showed the possibility of a shortage of bamboo, so the project chose to use primarily grass lattices.

- Treated eucalyptus posts (with anti-termite solution using engine oil);
- Bamboo split-bracings, tied to vertical posts with nails, ropes, or grass thatch;
- Mud-plaster made with termite soil;
- Steep-sloped grass roof, on top of treated eucalyptus rafters and purlins (top height 5m);
- Lockable door made from eucalyptus pole frames and corrugated iron sheet;
- 60cm gap above the walls, left open for ventilation.

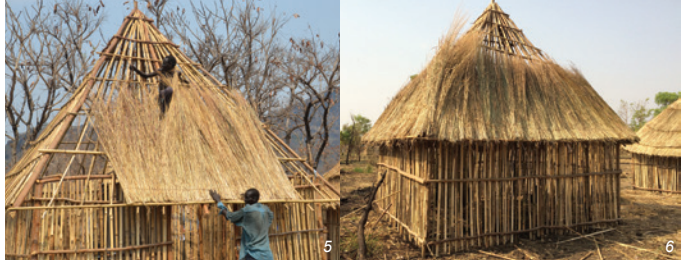
- Refugees then organized, in self-help groups, and were provided with the necessary local materials, tools and technical assistance to **undertake the mud rendering**

- **and the raised embankments** to protect from flooding.
- **Regular technical assistance and supervision** was provided, according to the design and agreed criteria.
- **Coordination and monitoring** of the process was ensured with the organization staff, ARRA and other implementing partners, to address any problems that may have arisen.
- The organization conducted a **post-implementation assessment**, collecting sex and age disaggregated data. The majority of beneficiaries reported to be satisfied (over 80%) or very satisfied (over 10%) with the shelter design and materials. The results were shared with the Shelter Working Group and its members.

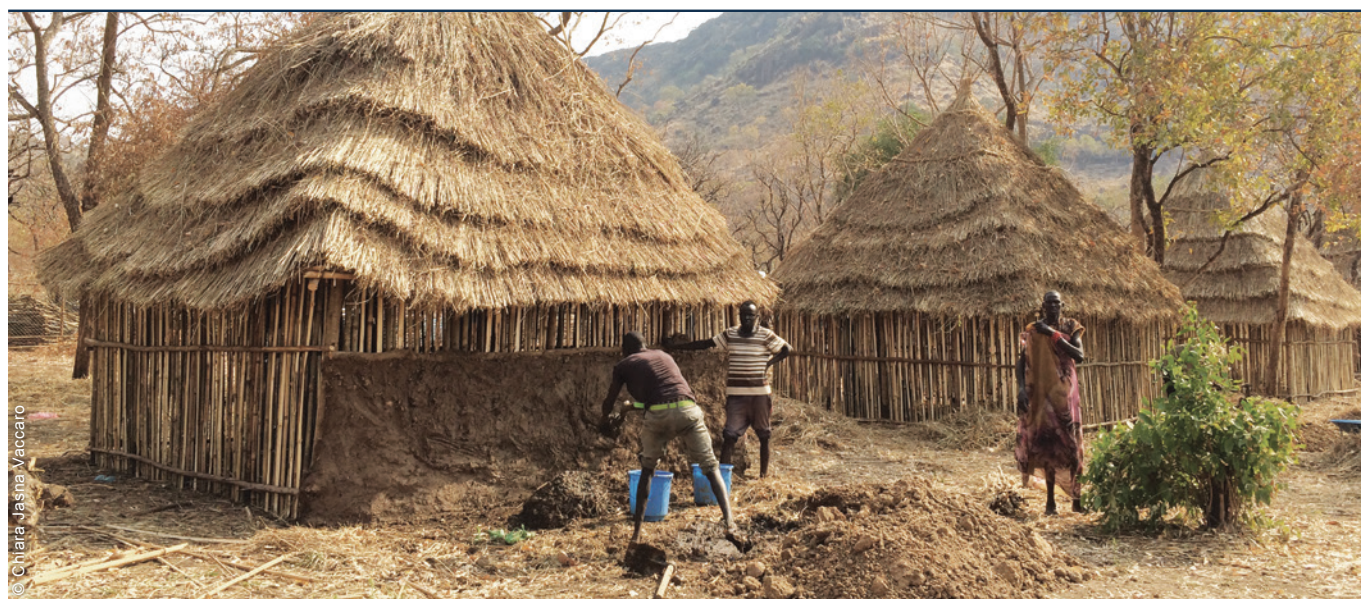
Refugees plastered the walls of the shelters with mud, made from soil sourced by the refugees themselves, in areas agreed with authorities and host communities.
