CASE STUDY GAZA (PALESTINE) 2014-2016 / CONFLICT

KEYWORDS: Transitional shelter, Cash assistance, Infrastructure, Training, Guidelines

PROJECT SUMMARY

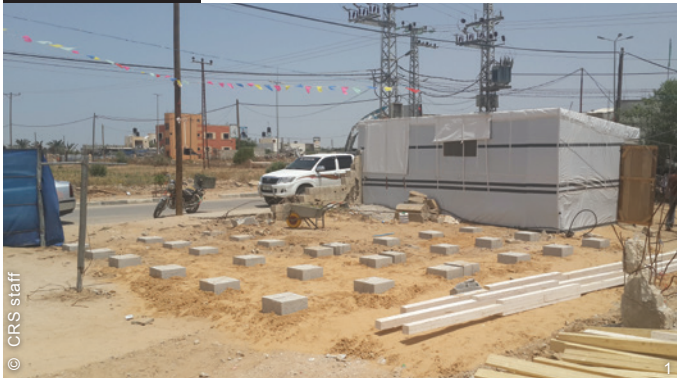
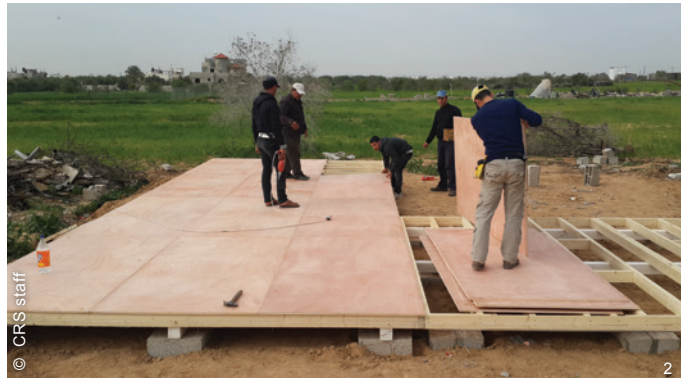
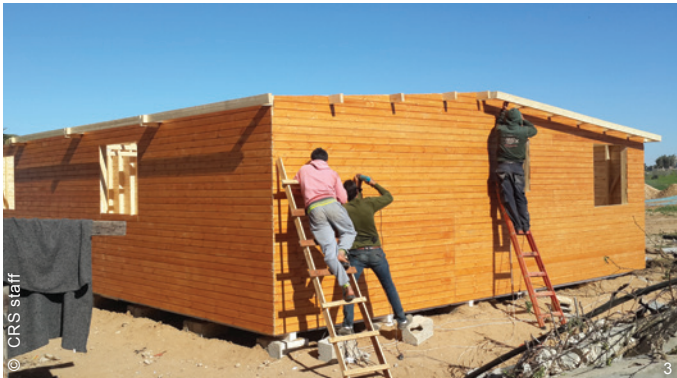
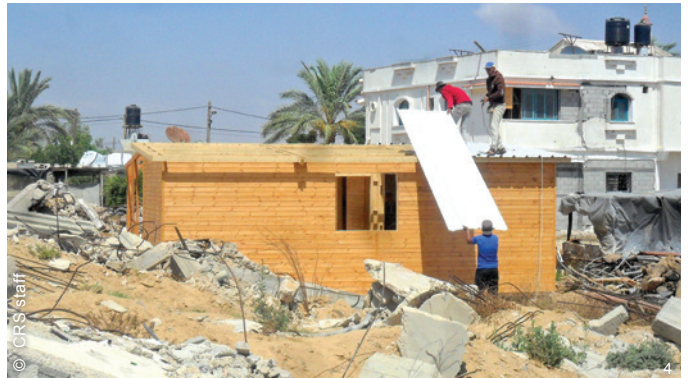
Timber-frame buildings were built on a platform with a plywood floor. From left to right, top: 1. Laying the foundation and ground beams for the transitional shelter. 2. Installing plywood layer over the ground beams. Bottom: 3. Fixing the external wall cladding with screws. 4. Contractor staff placing CGI roofing on the shelter.

The timber frames were constructed in a workshop and then transported by truck to the site. Once erected, the cladding, flooring and roofing materials were delivered and fitted to the frames. Other building trades, such as electricians, plumbers and dry-lining wall fitters completed the building. This **combination of on- and off-site** method of working allowed for greater speed, efficiency and quality control.

The project used an adaptation of modern platform-timber-frame construction, where the panels are the load-bearing structure – as opposed to the post-and-beam technique. The shelters were built with floor frames (a frame of floor joists) covered with a decking material, which created the platform. The walls of each level were then fitted to the platforms. To meet the challenge of limited space, two-storey buildings were constructed using this approach. A timber frame structural engineer checked all the designs prior to implementation.

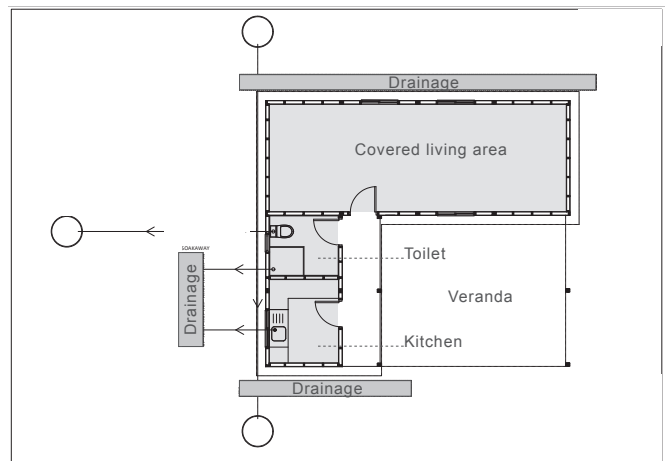
The project built shelters of different sizes, to adapt to the different family sizes. Shelters included a bedroom/living area, a toilet, a kitchen and an open veranda, that could be used to expand the covered space, by adding walls. People had to take care of the external sanitation system, e.g. septic tank.

Each shelter consisted of three rooms – a bedroom, a kitchen and a bathroom – and was designed to meet cultural needs and expectations, especially privacy and dignity of women. This led to a density of more than 5m² per person, above recommended standards. Moreover, the shelter was specifically intended to be upgraded, extended and re-purposed after the estimated life span of five years. The L-shape design with the veranda allows households to easily construct perimeter walls using timber posts and sheeting material, to expand the living space and allow greater privacy and freedom of movement for women. Examples of modifications included installation of electricity, addition of room dividers, construction of external walls, lining of ceilings, landscaping around the shelter and a variety of other decorative and functional upgrades.

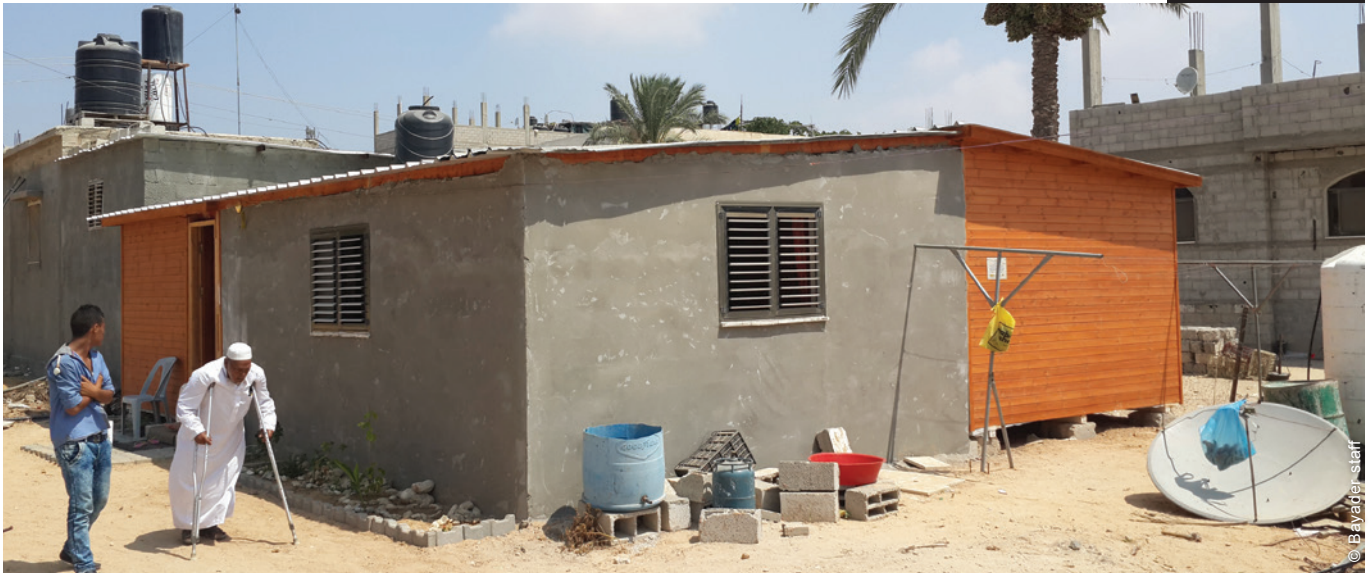
Some people were able to extend the shelters, by closing the open sides of the veranda.

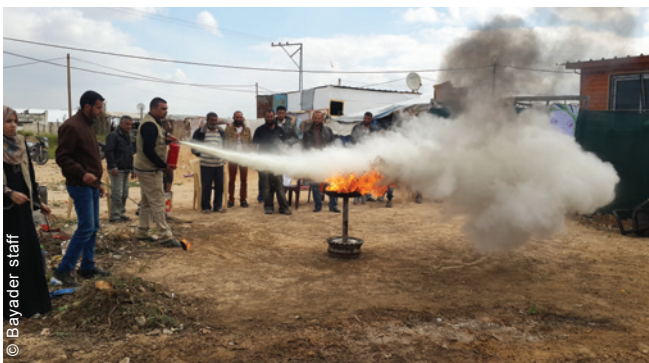
Given the risk of wooden structures catching fire, shelter owners were given fire safety trainings and were provided with fire extinguishers.

Training was provided to avoid risks associated with unexploded remnants of war and also hazardous waste, such as asbestos. The organization initially considered using rubble for construction, but was advised against and therefore avoided using it. The project included the distribution of fire extinguishers and electric lanterns and delivery of fire safety training to all shelter beneficiaries, to reduce fire hazards and improve safety.

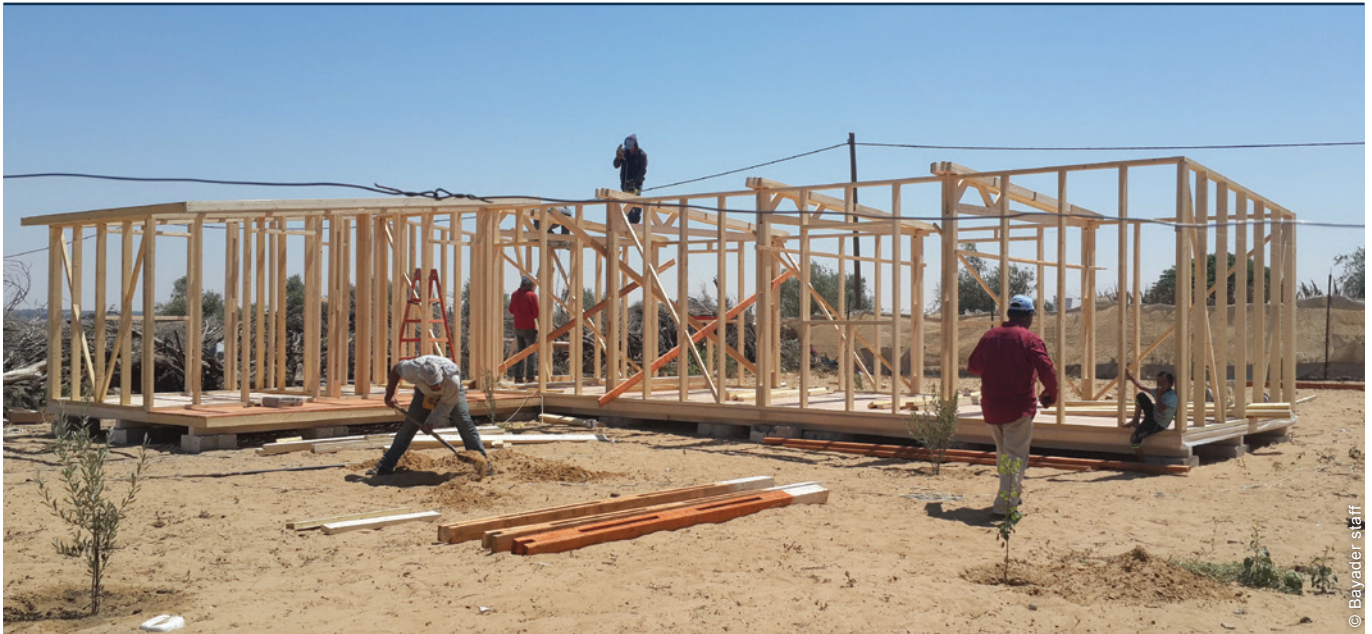
The timber-frame construction was new to the country, thus an experienced consultant was hired and, with senior staff from the organization, supervised the contractor.

Because of the embargo on most building materials other than timber, the organization decided to use a timber frame structure. **The organization then employed a consultant** with experience in timber construction, to assist the procurement and implementation of the project. Timber construction was not common in Gaza and, due to the available time and skills, as well as for quality control, the wooden panels were assembled off-site, and construction done using a **building contractor**. This was selected through a competitive tender process and training was provided by the organization and the consultant. Once the first shelters were built, the contractor worked independently, with supervision from the organization and partners.
