CASE STUDY

BANGLADESH 2021–2022 / FIRE RESPONSE

KEYWORDS: Community engagement, Disaster Risk Reduction, Site planning, Transitional Shelter

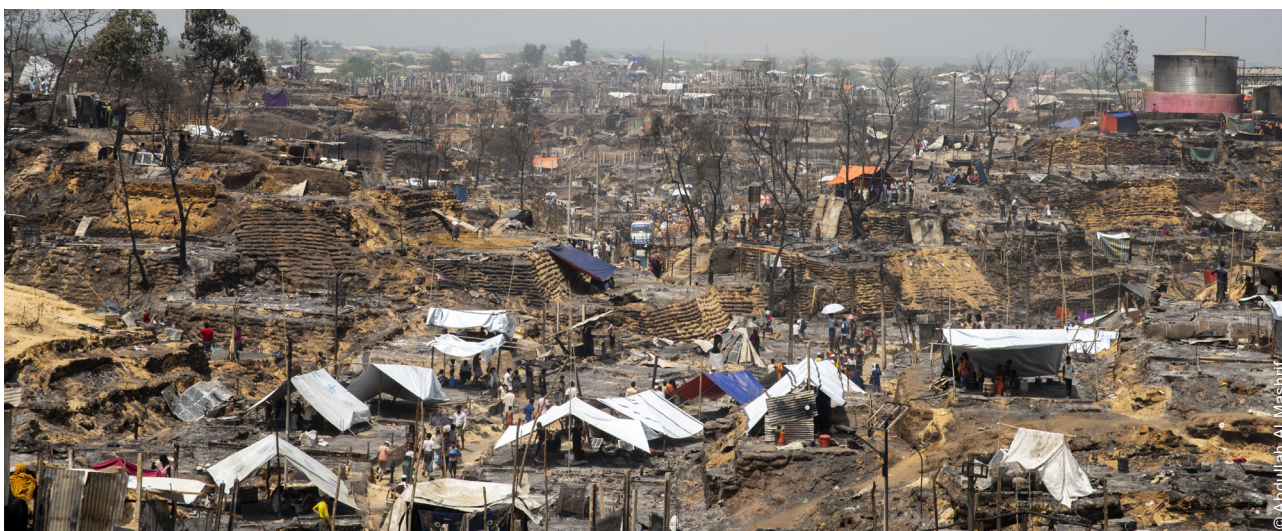
A view of the affected area in Camps 9, 8E, 8W, the day after the fire in March 2021.

The fire incident in March 2021 spread across 63,590 m² in Camps 8E, 8W, and 9, impacting 48,300 individuals directly (including 11 fatalities) and destroying 10,100 shelters and all major facilities in one of the most highly congested areas of the camps. Slope stabilization in the area was largely affected, and accessibility, drainage networks, and solar streetlights were also damaged. Despite generous funding dedicated to reconstruction, gaps remained in infrastructure coverage in the fire-affected area more than one year after the incident.

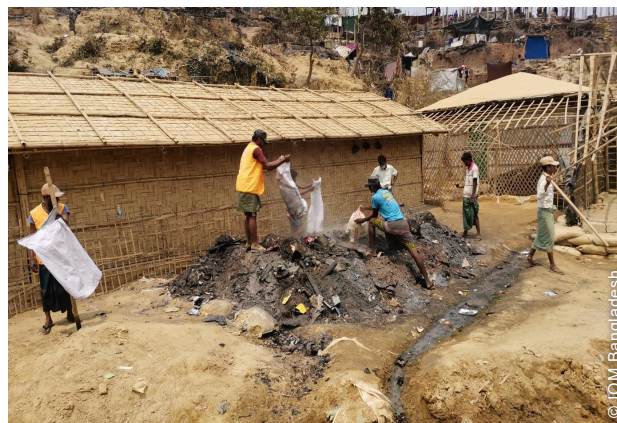
Debris removal started immediately in the initial phase of the response in both the fire incidents, involving many community volunteers and laborers.

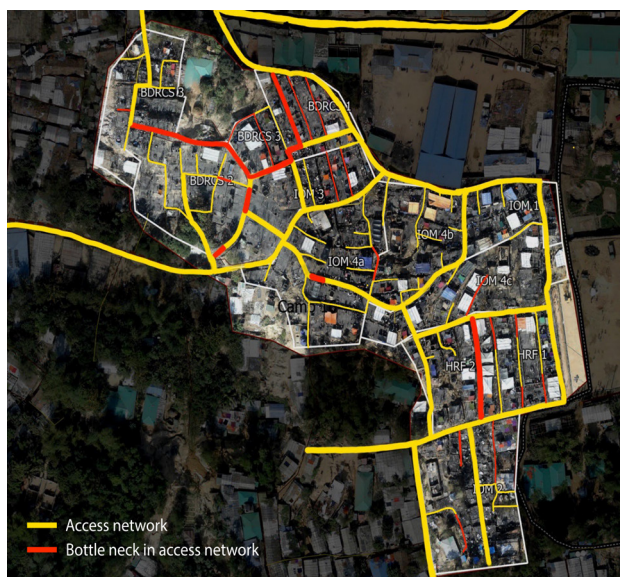
A map of the 'Existing Access Network' with network bottlenecks prepared in order to address them by replanning. (Second fire response, January 2022).

- **Initial Phase:** Debris cleaning and emergency support, including temporary shelter and WASH and NFI kit distribution, began immediately. Communication to communities regarding the steps of the response was also delivered from the beginning. The initial phase also included a needs assessment for shelter and site development works and – from the site planning perspective – the identification of bottlenecks and opportunities to improve overall access, fire breaks and drainage networks.

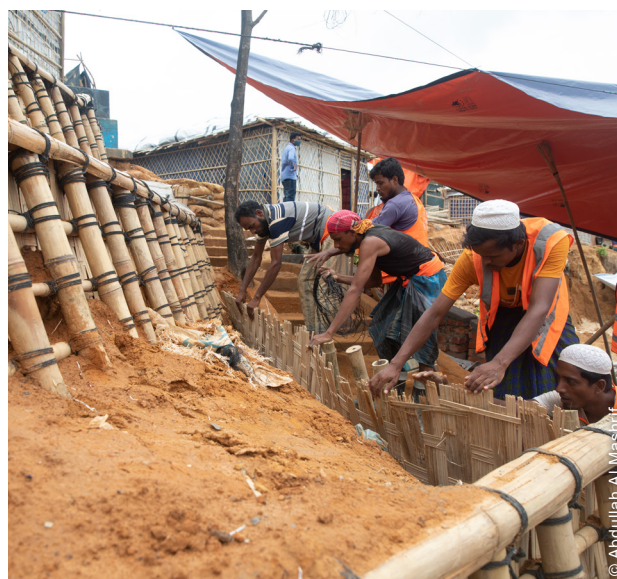
Site development work of reconstruction of bamboo slope stabilisation and access carried out by people engaged in Cash for Work, February 2022.

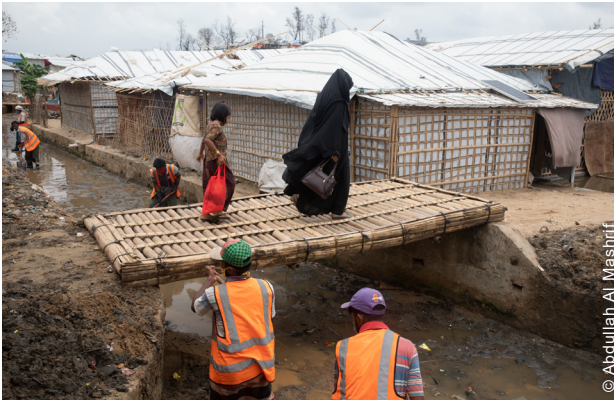
(Left) Re-planning of the fire affected areas focused on access and drainage, amongst others. (Right) View of the reconstruction phase with emergency and transitional shelters.

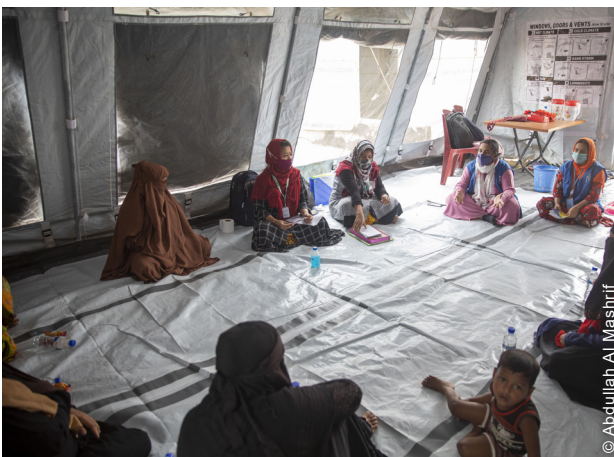
The Communicating with Communities (CwC) team engaged with the community groups to understand their needs and priorities, which helped the Site Planning team to develop the plans for replanning.

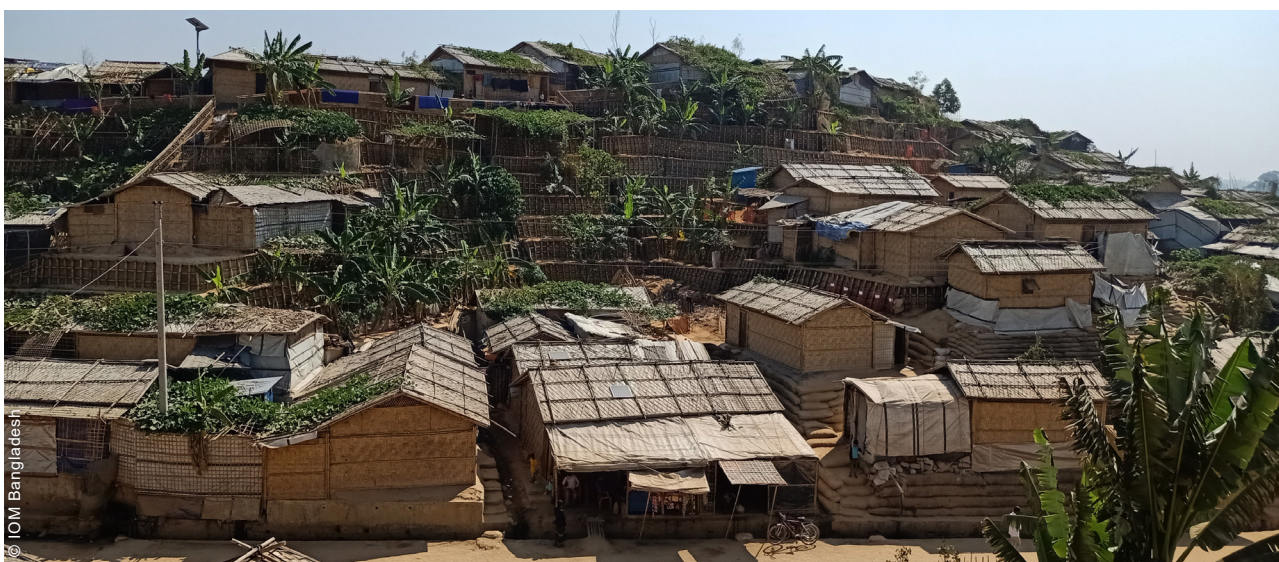
A view of Camp 9 after the reconstruction in April 2022.

Improved living conditions through replanning (reduction of bottlenecks for access and drainage) and increasing the number of WASH facilities by 19 percent (2nd fire incident) were primary outcomes of the project. Improved accessibility ensured safe movement and access to facilities – especially for Persons with Disabilities and EVIs. This created further emergency evacuation routes while improvements to the drainage network helped flood mitigation and ensured the safe discharge of grey water and rainwater by preventing water to get inside shelters. Slope stabilization works contributed to overall safety from land erosion of shelter and facilities plots, and access and created opportunities for plantation.

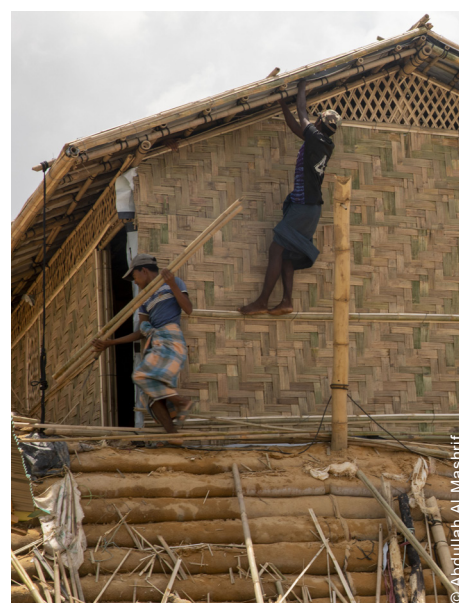
Reconstruction of the fire affected shelters in Camp 9 through Cash-for-Work.

replace their recently rebuilt shelter with the government-approved design. The households were registered, and community members willing to take part as labor for camp reconstruction were trained on the techniques used. During the following months, more than 90 percent of the affected households agreed to have their shelter reconstructed, as the new one (while slightly smaller), would be built using bamboo poles treated against insect infections, metal footings anchoring the frame to the ground while preventing its degrading by the ground dampness, and steel-rod connections between the main frame elements.
