CASE STUDY

INDONESIA 2021 / EARTHQUAKE

KEYWORDS: Community engagement, Gender mainstreaming, Housing repair and retrofitting, Training

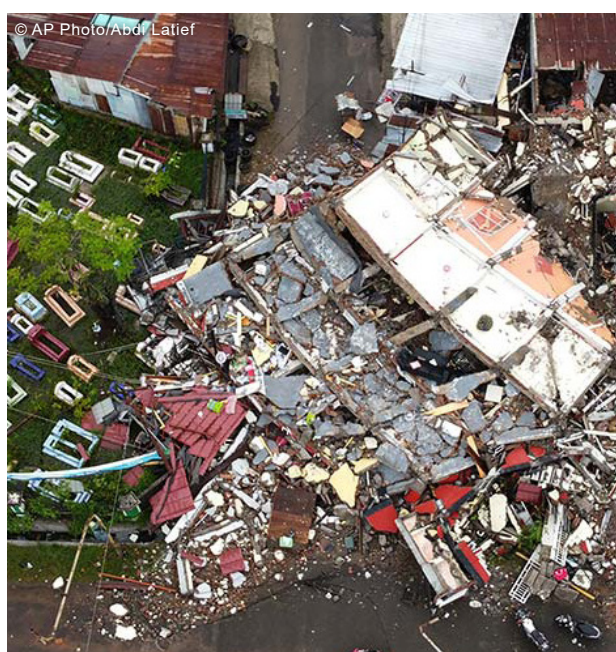
An aerial view of a damaged building following the earthquake in Mamuju, West Sulawesi.

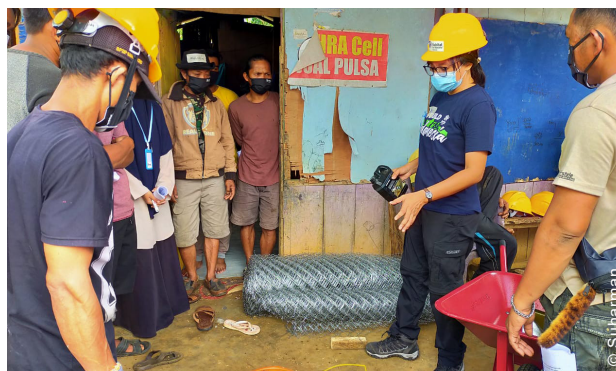
The technical consultant presented the building technique in construction training for homeowners and local builders.

The exit strategy applied was to provide training on retrofitting (ferro-cement) methods to the community. The method installed ferro-cement layers with chicken wire on both sides of the wall, so that it is wrapped in a layer of ferro-cement to enhance durability when shaken during an earthquake. This method was very suitable for the situation and economic conditions of the area. Through enhanced knowledge of more durable retrofitting measures, the community was able to utilize the practice in the construction and repair of homes post-project conclusion.

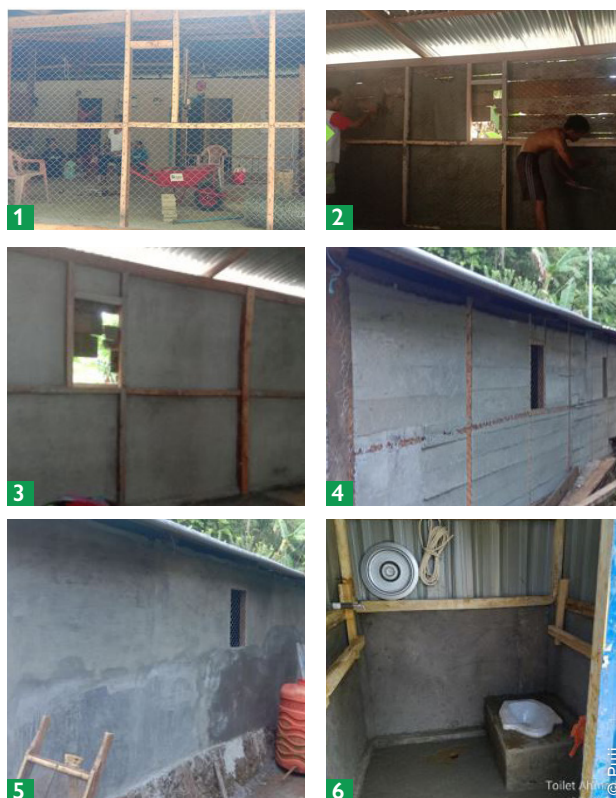
Process of Ferrocement Construction

1: Construction training; 2: First formwork; 3: Inner plastering; 4: Outer plastering; 5: Outer plastering completed; 06: View of a completed room.

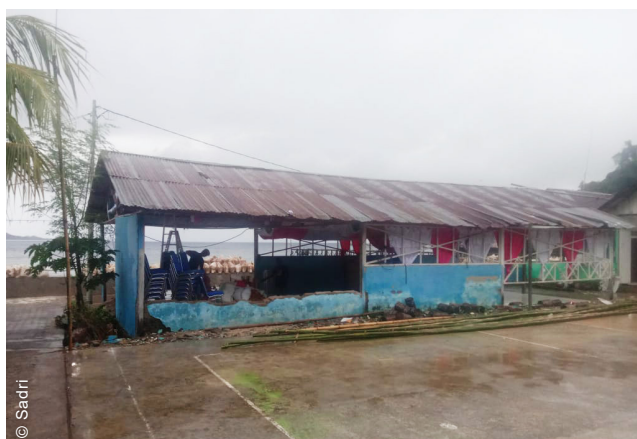
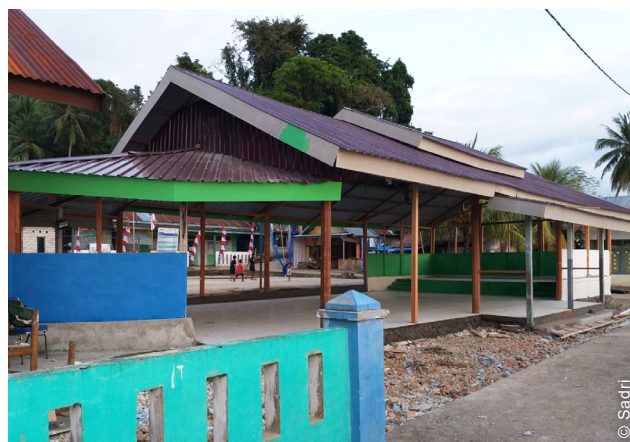
The Karampuang Village Community Hall before and after reconstruction. The project facilitated the community in Karampuang to renovate two Community Centres. The renovations were carried out using retrofitting and ferro-cement methods. The renovation focused to improve better space, ventilation and lighting.

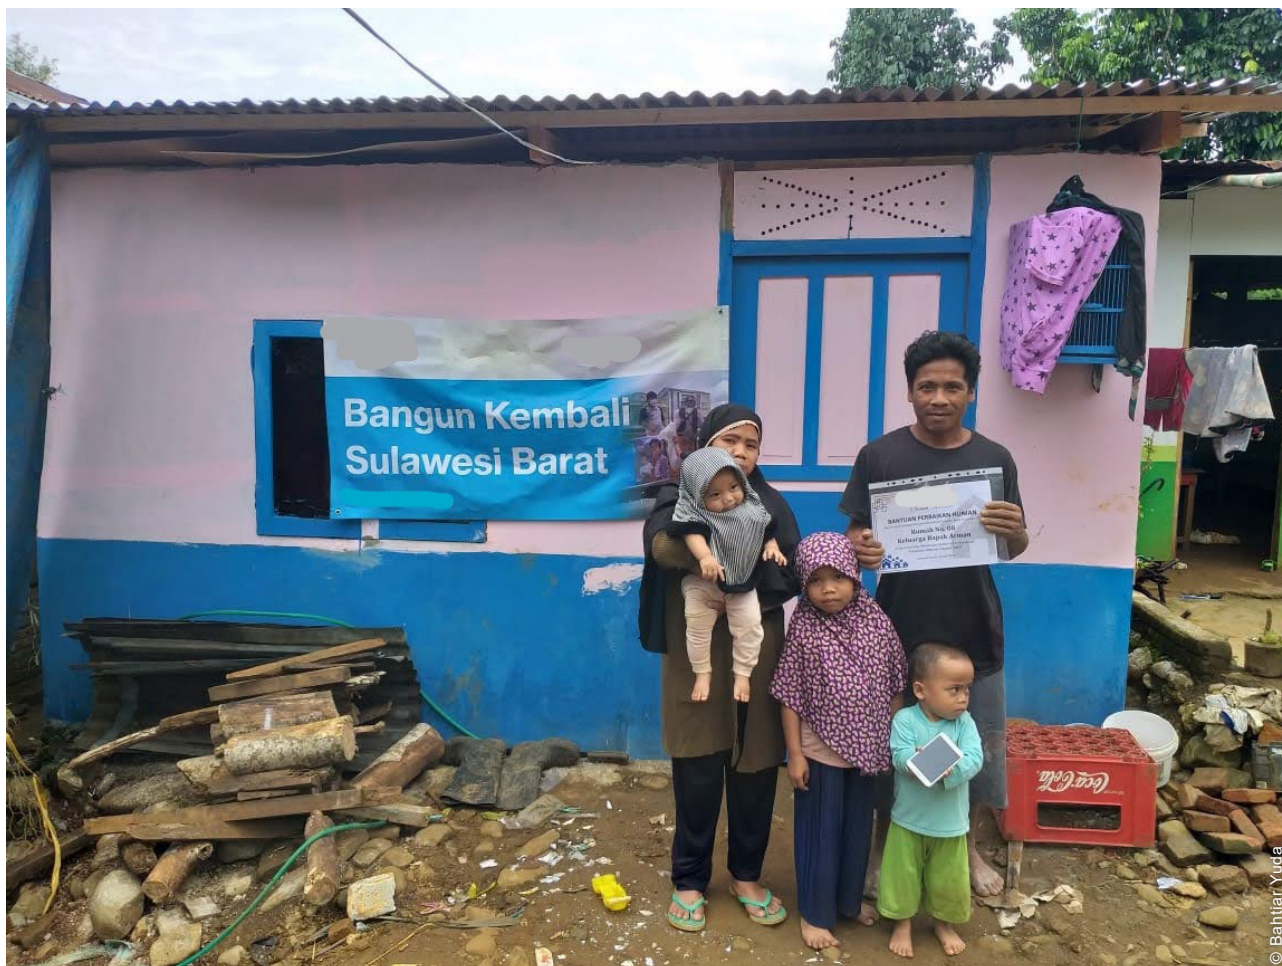
A family outside their completed transitional shelter. 67 houses were retrofitted in total across the project.

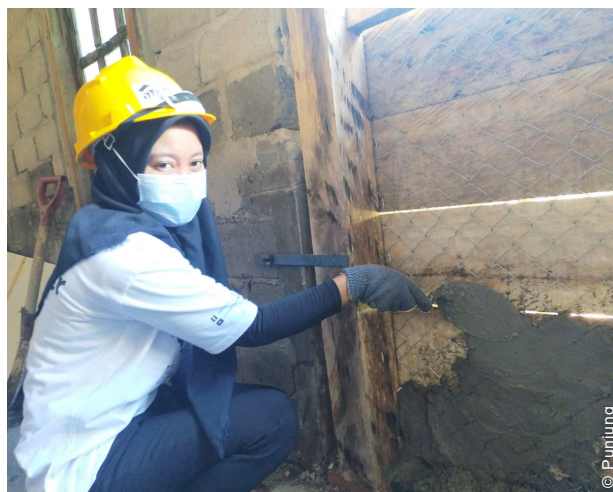
Construction training using retrofitting method (ferrocement) for women in Karampuang Village.
