CASE STUDY

LEBANON 2020–2022 / BEIRUT PORT BLAST

KEYWORDS: Area based approach, Housing rehabilitation, Infrastructure, Urban neighborhoods

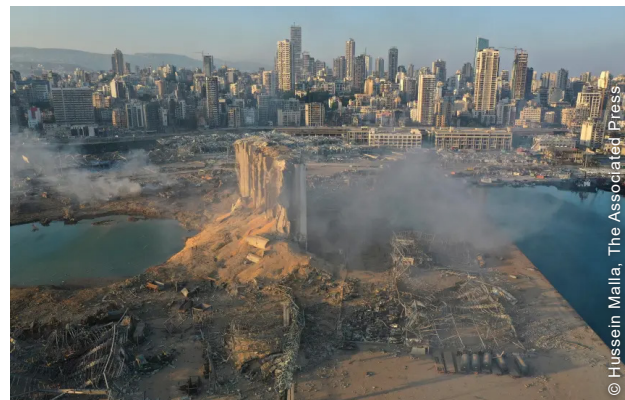
A massive explosion damaged 9,200 buildings across the city of Beirut, sending a giant mushroom cloud into the sky while leaving 300,000 people displaced.

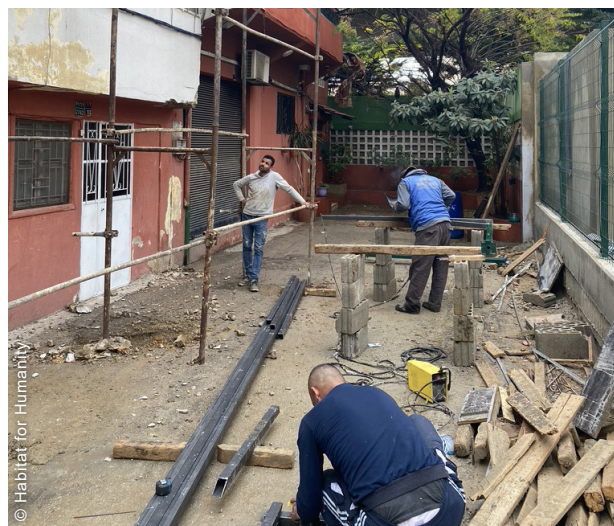
Construction work on a building facade as part of the urban recovery project.

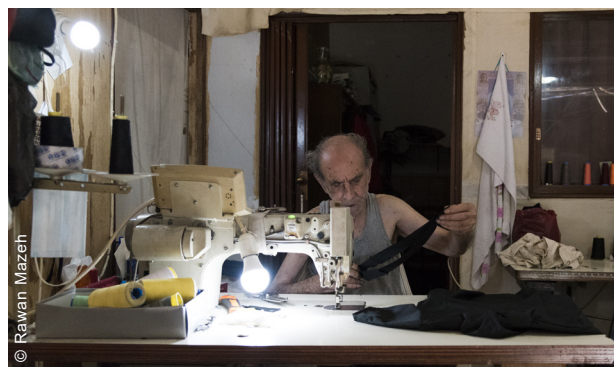
Small businesses were unable to cover the repairs cost. They were at high risk of closing down and required assistance in fixing damage caused by the blast.

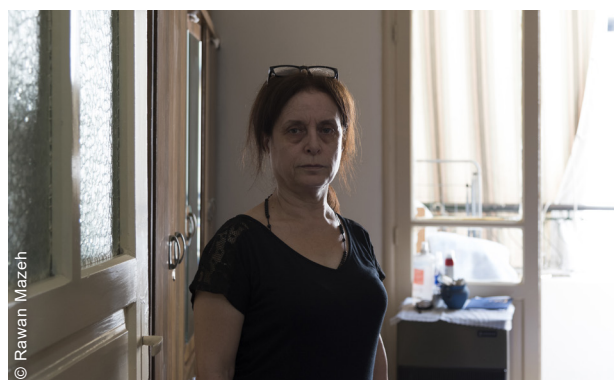
A house repaired after the explosion including windows and doors restoration, fixing of plumbing lines, and installation of water heater.

Various additional tasks were undertaken, such as the repairing or reinstalling of windows and doors, installing safer electrical and lighting solutions to reduce the risk of fire, upgrading kitchen and bathroom facilities to improve functionality, weatherproofing to prevent moisture, and addressing any dampness or mold on walls and ceilings that could cause health issues. These tasks were essential in restoring minimum habitability standards and creating a comfortable living environment for participants.

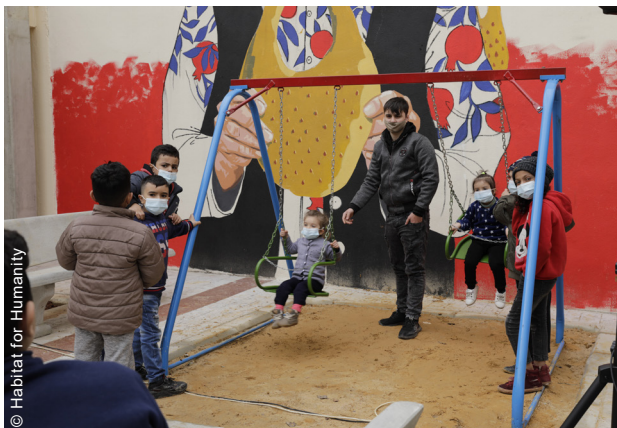
The urban recovery intervention aimed to enhance the community's well-being and contribute to social cohesion within the neighborhood.

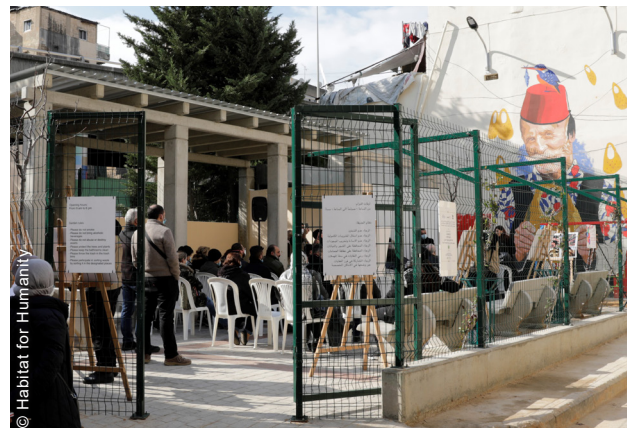
An official opening ceremony of the public space took place and included municipal officials and community members, for a formal handover.

One urban recovery and rehabilitation project in the Maraash neighborhood of Burj Hammoud in Beirut was conducted. Urban recovery activities included the installation of 21 energy-efficient streetlights and electric cable management along 230 linear meters of streets, essential repairs to 11 building facades, and the creation of a green and open-public space prioritized for use by women, youth, and the elderly.

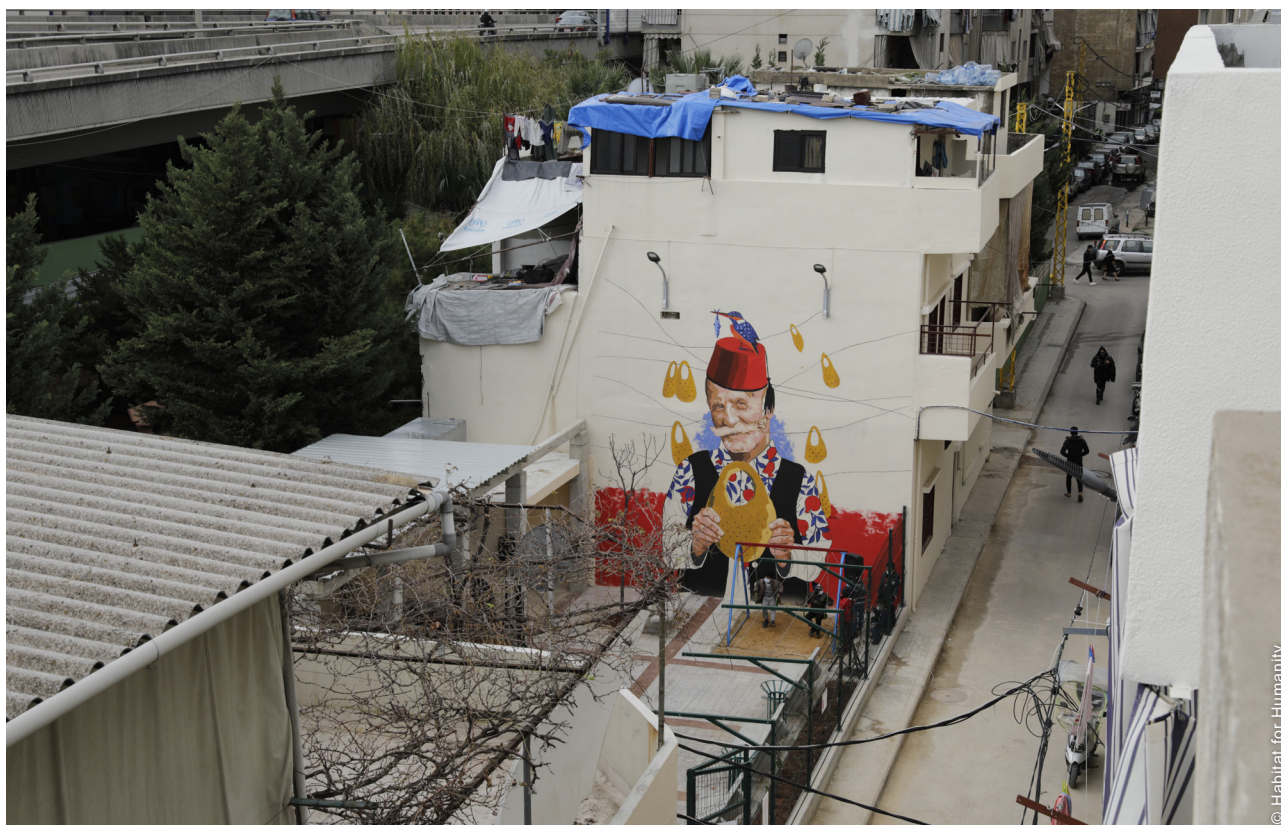
Urban recovery intervention focused on four components: an open space upgrade, managing entangled cables, lighting streets, and rehabilitating building facades.

This urban recovery intervention aimed to enhance the community's well-being and contribute to social cohesion within the neighborhood and focused on four components: an open space upgrade, managing entangled cables, lighting streets, and rehabilitating building facades.
