CASE STUDY

# SYRIAN ARAB REP. 2021–2022 / SYRIAN CRISIS

KEYWORDS: Emergency shelter, Habitability, NFI distribution, Winterization

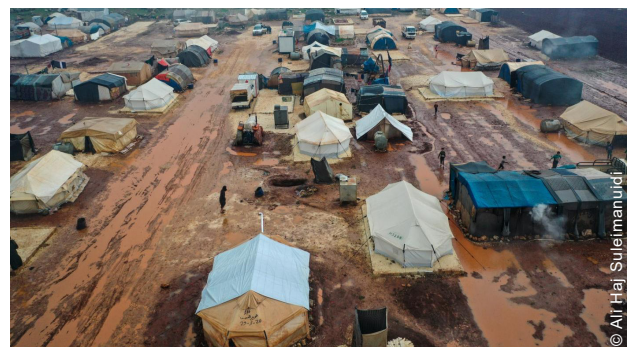
Aerial image of a camp in Idlib devastated by the heavy floods, forcing many families to leave their homes during the night and take shelter elsewhere.

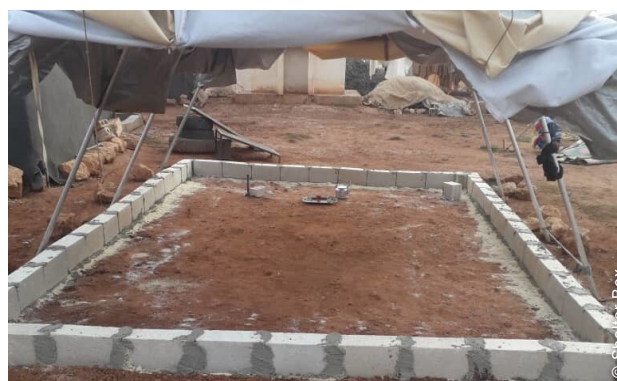
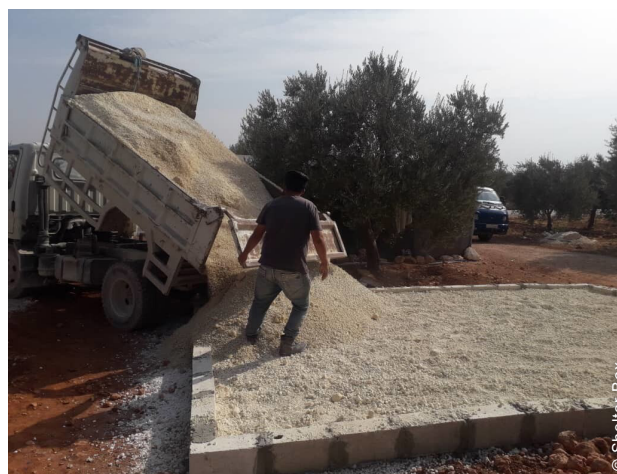
*Tent leveling construction activities - (above) Building of the tent base perimeter with mortar blocks, November 2021. (below) Filling of the tent base with aggregate before the final cement layer, November 2021.*

<b>Step 1</b>	Materials were delivered and unloaded at each tent location on the day of its construction to mitigate family obstruction.
<b>Step 2</b>	Families' belongings were removed from the tent. The tent canvas was then either rolled up from the ground or the entire tent was disassembled.
<b>Step 3</b>	The tent base outline was measured and marked out.
<b>Step 4</b>	The surface of the ground was cleared of any rocks or debris to place the gravel and blocks.
<b>Step 5</b>	A layer of fine gravel was laid and leveled to provide a base for the concrete mix and blocks.
<b>Step 6</b>	A string line was set to mark the height of the base. The blocks were placed and fixed with concrete.
<b>Step 7</b>	Once the block layer was complete, the concrete was left to cure before the addition of gravel.
<b>Step 8</b>	Once the concrete was cured, a 15cm layer of coarse gravel was placed and leveled within the base.

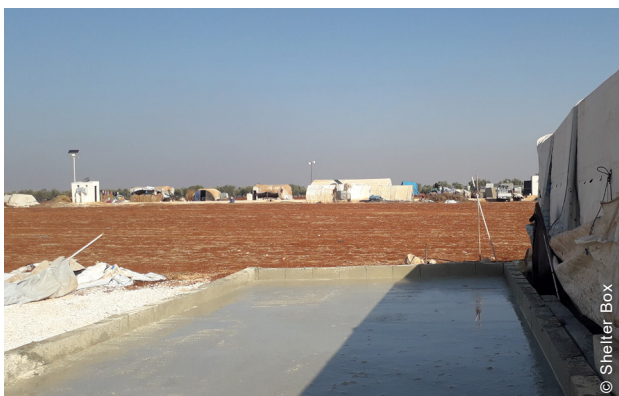
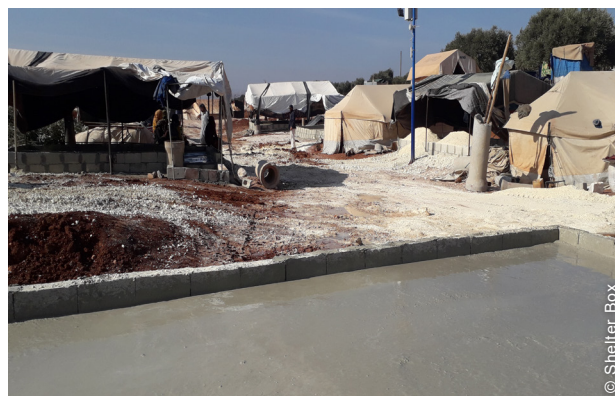
Cementing of the tent bases, November 2021. Size of the different tents were measured, and the tent bases were constructed according to the tent sizes.

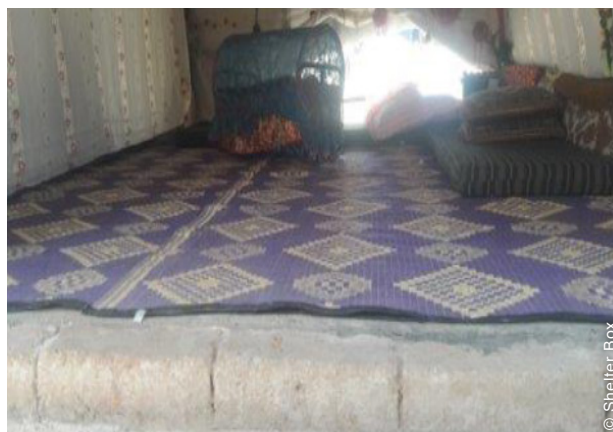
Interior view of a tent after the construction of the tent base.
