A.15 Somalia, Puntland - 2009 - Conflict

Urban shelter upgrade

Somalia conflict.
Displacement sites in Bosaso and Galkayo.

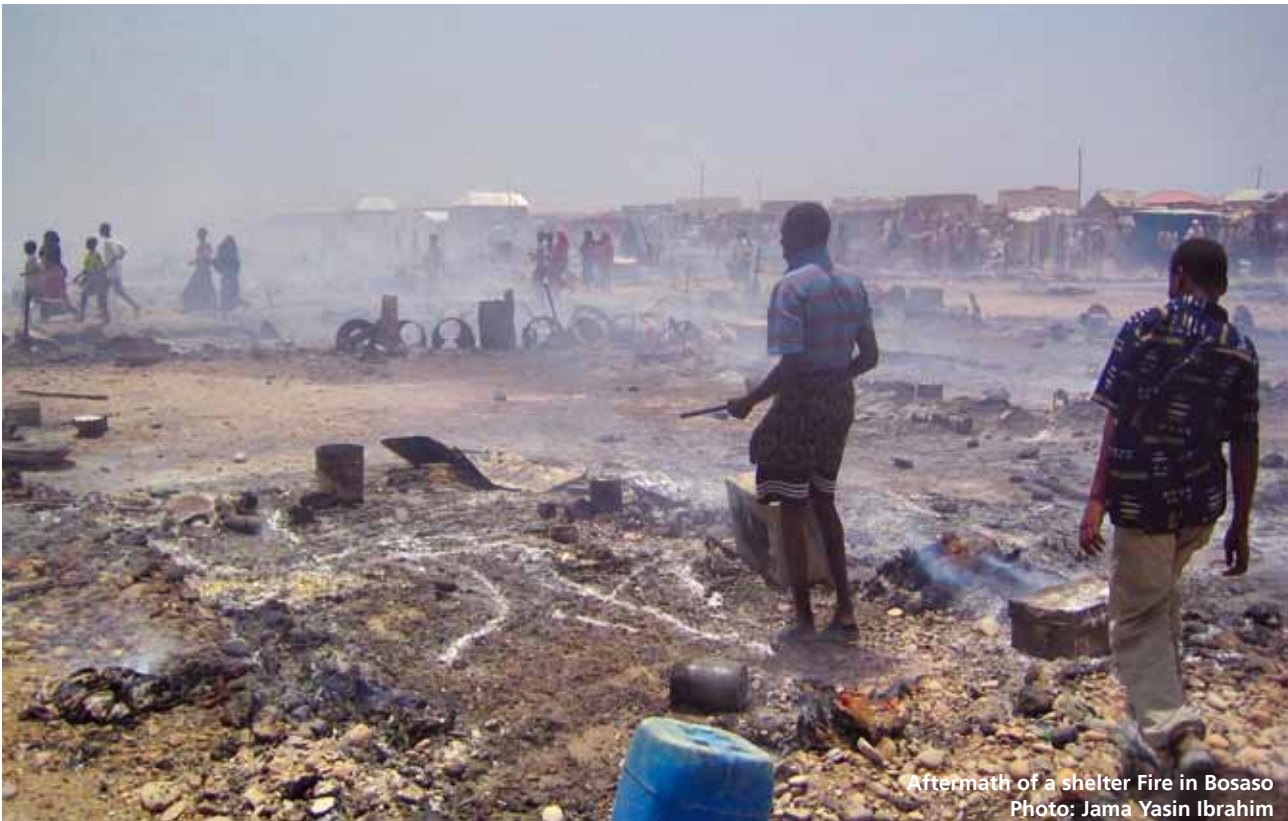
Aftermath of a shelter fire in Bosaso
Photo: Jama Yasin Ibrahim

In Bosaso, the climate is exceptionally hot and dry (with annual rainfall under 100mm), and there are strong winds. Galkaiyo is less windy but still hot and dry. Climate combined with overcrowding, poor sanitation and social tensions means that large groups of shelters were frequently destroyed by fire.

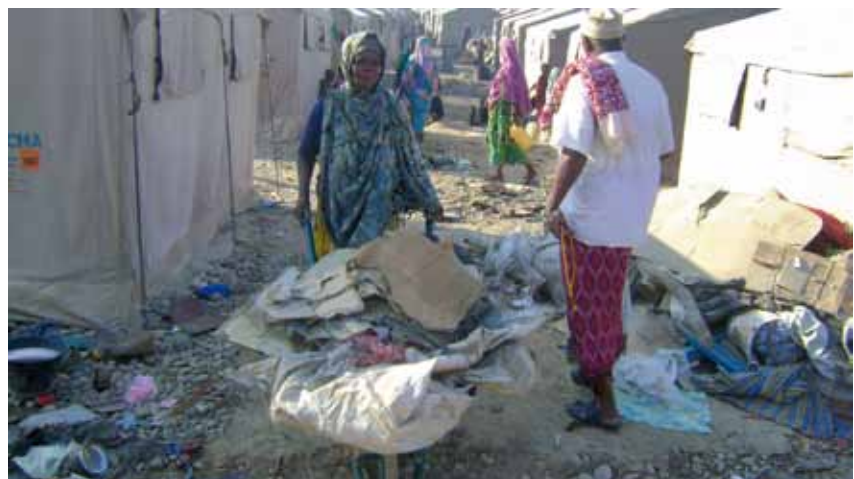
Left: Shelter materials distribution. Right: cleaning up a shelter site
Photos: Jama Yasin Ibrahim
